TANG FRAGMENT OF A KNIFE HR-6246 - TIN BRONZE - LATE BRONZE AGE - SWITZERLAND

Artefact name	Tang fragment of a knife HR-6246
Authors	Marianne. Senn (Empa, Dübendorf, Zurich, Switzerland) & Christian. Degrigny (HE-Arc CR, Neuchâtel, Neuchâtel, Switzerland) & Naima. Gutknecht (HE-Arc CR, Neuchâtel, Neuchâtel, Switzerland) & Rémy. Léopold (HE-Arc CR, Neuchâtel, Neuchâtel, Switzerland)
Url	/artefacts/1230/

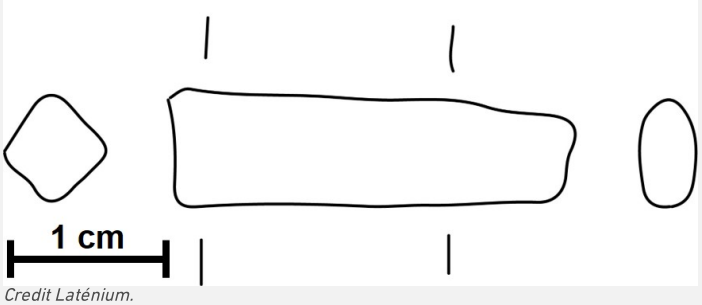
Fig. 1: Tang fragment of a knife (after Rychner-Faraggi 1983, plate 35.35),

Fig. 2: Shiny yellow and green-blue corrosion products on the surface of the tang fragment of a knife,

Description of the artefact	Tang fragment of a knife with shiny yellow and green-blue corrosion products (Figs. 1 & 2). Dimensions: L = 2.7cm; Ø = around 5mm; WT = 5.8g.
Type of artefact	Household implement
Origin	Hauterive - Champréveyres, Neuchâtel, Neuchâtel, Switzerland
Recovering date	Excavation 1983-1985, object from layer 1 (layer with material from Bronze Age till 20th cent.)
Chronology category	Late Bronze Age
chronology tpq	1050 B.C.
chronology taq	800 B.C.
Chronology comment	Hallstatt A/B

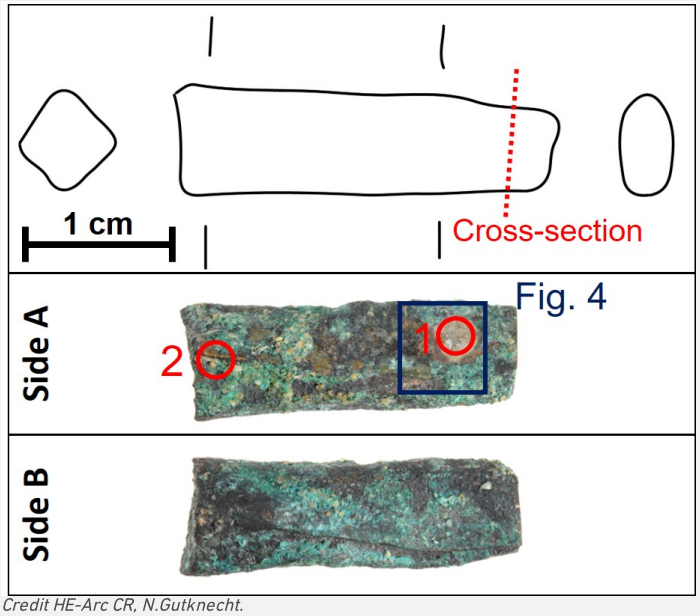
Fig. 3: Location of the cross-section before sampling and both sides of the fragment not sampled with location of the detail of Fig. 4 (blue square) and XRF analysis areas (red circles),

XRF analyses of the tang fragment were carried out on two representative areas (Fig. 3). Point 1 was done in a lacuna of the green-blue corrosion layer, while point 2 was performed on a black corrosion layer (CP4) where all strata (soil, corrosion products, and metal) are analyzed at the same time.

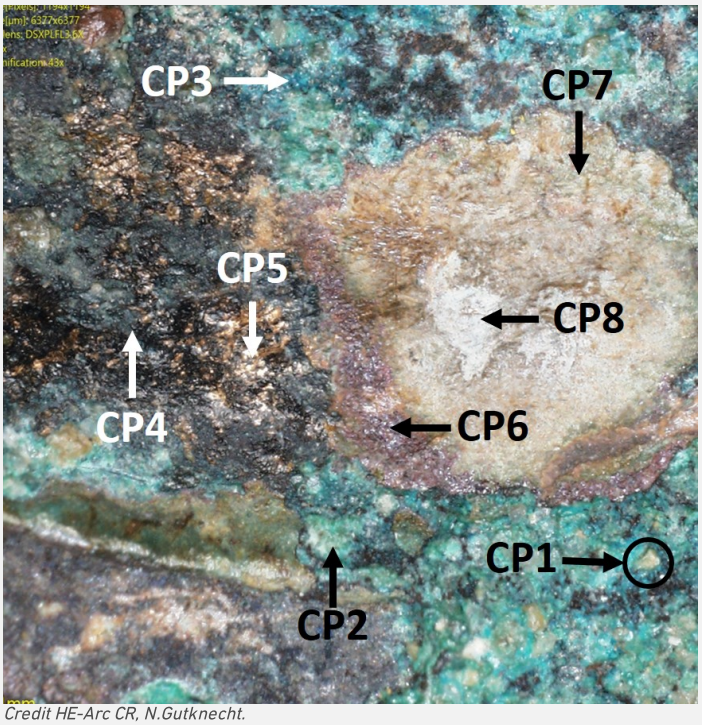
Fig. 4: Corrosion structure (detail) from Fig. 3 showing some of the documented strata,

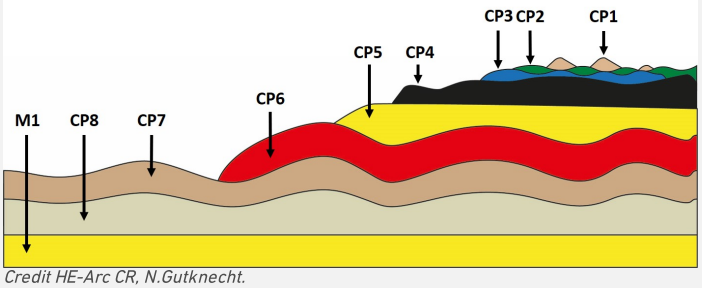
Fig. 5: Stratigraphic representation of the corrosion structure of the tang by macroscopic and binocular observation with reference to Fig. 4,

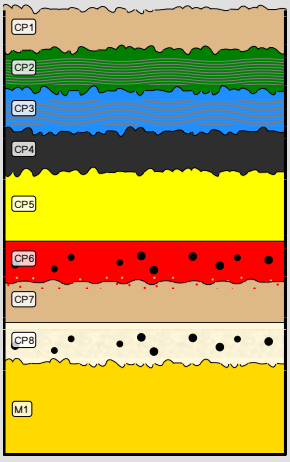
Fig. 6: Stratigraphic representation of the corrosion structure of the tang observed macroscopically under binocular microscope using the MiCorr application with reference to the whole Fig. 5. The characteristics of the strata, such as discontinuity, are accessible by clicking on the drawing that redirects you to the search tool by stratigraphy representation, Credit HE-Arc CR, N.Gutknecht,

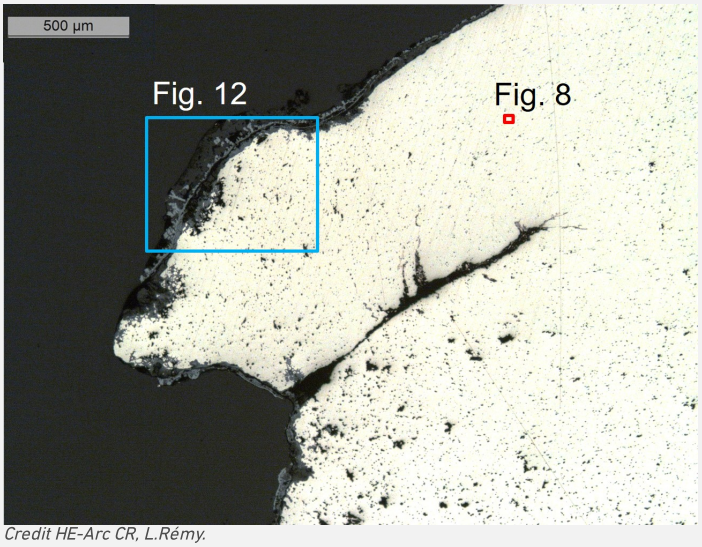
Fig. 7: Micrograph from an area of the cross-section of the sample taken from the tang fragment with location of Fig. 8 (red square) and Fig. 12 (blue square), unetched, bright field,

Description of sample	The cross-section corresponds to a lateral cut (Fig. 3). The surface is covered with a thick corrosion layer but part of it has gone (Fig. 7).
Alloy	Tin Bronze
Technology	Cold worked with partial annealing
Lab number of sample	MAH 87-197
Sample location	Musées d'art et d'histoire, Genève, Geneva
Responsible institution	Musées d'art et d'histoire, Genève, Geneva
Date and aim of sampling	1987, metallography and corrosion characterisation

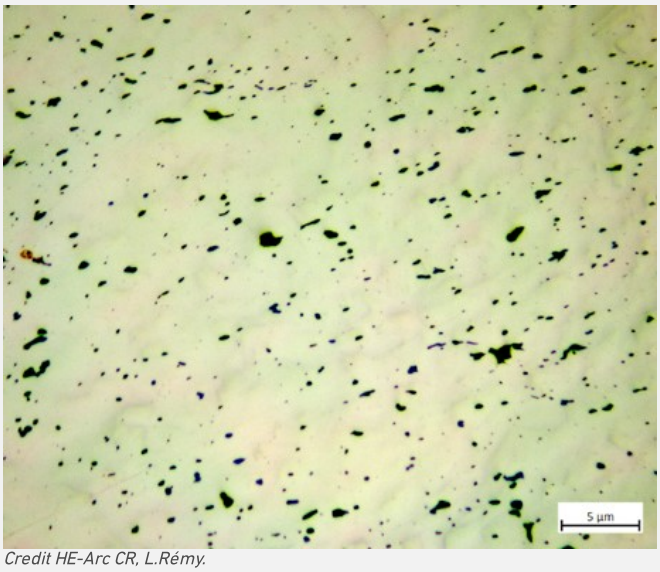
Fig. 8: Detail of the metal from Fig. 7, unetched, bright field,

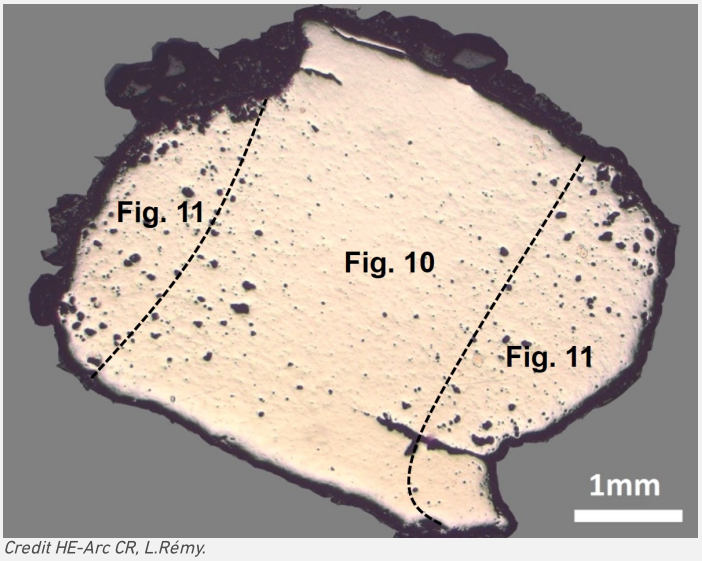
The remaining metal is a tin bronze (Table 3) with high porosity (Figs. 7-9) and large cracks both on the left and right edges of the sample (Fig. 9). The metal contains small, elongated copper sulphide (Table 4) and Pb inclusions. The etched metal shows three zones with a core where elongated grains and slip lines are visible indicating cold working without annealing (Figs. 9-10), while annealing appears on both external sides (Fig. 9-11). The average hardness of the metal is HV1 145, but significant variations are observed, depending on where the measurements are taken.

Fig. 9: Micrograph of the cross section of the tang of a knife with three distinct zones: metal core with elongated grains and slip lines (Fig. 10) and external sides with polygonal grains and twin lines (Fig. 11), unetched, bright field,

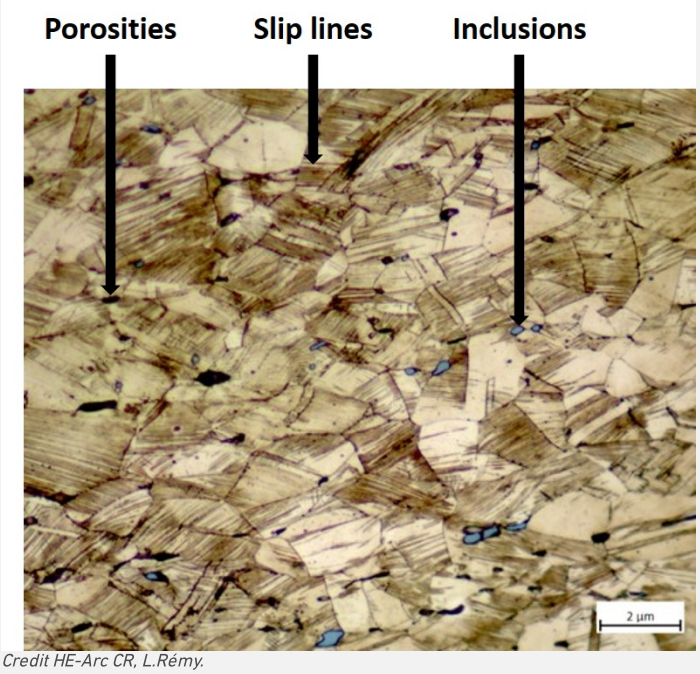
Fig. 10: Micrograph of the metal sample from Fig. 9 (detail), etched, bright field. Elongated grains with slip lines are observed, as well as grey copper sulphide inclusions and dark porosities,

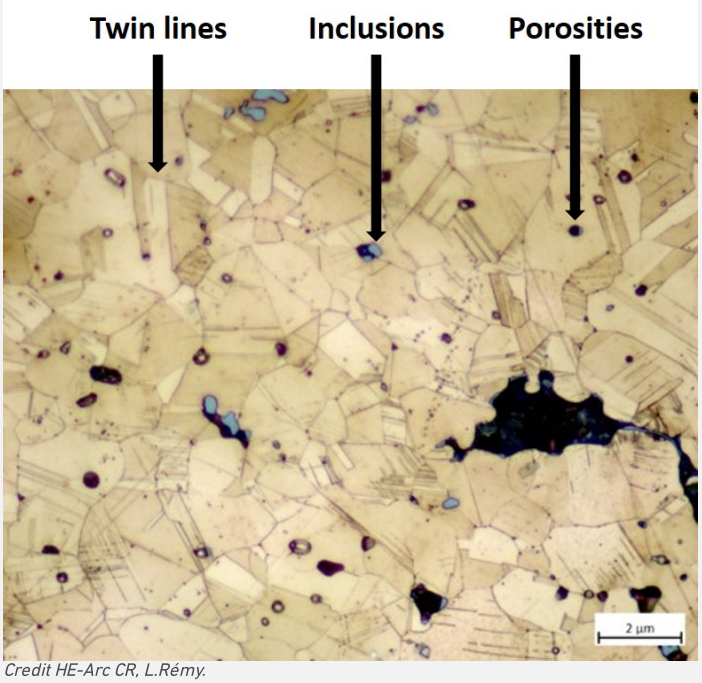
Fig. 11: Micrograph of the metal sample from Fig. 9 (detail), etched, bright field. Twin lines, grey copper sulphide inclusions and dark porosity are observed,

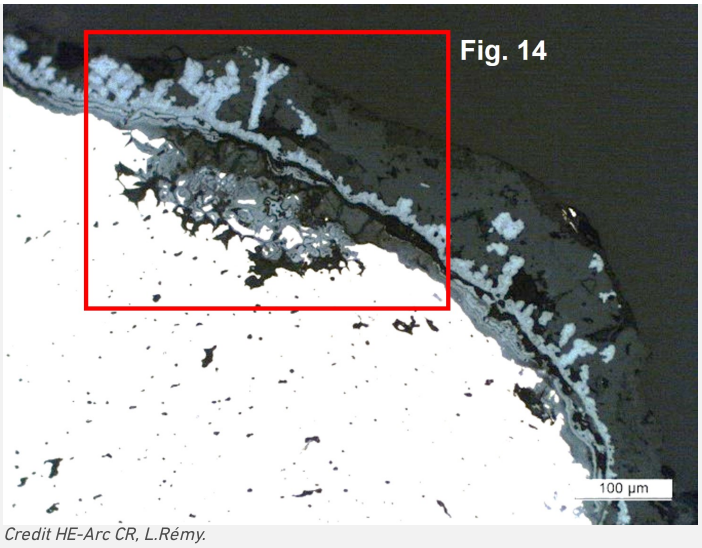
The corrosion layer has a thickness between 130µm and 70µm (Fig. 12). The observation of the sample in cross-section (Figs. 12-13) shows the presence of a succession of layers : S1 sediment, at the very top surface; CP1 thick continuous layer, dark grey in bright field, dark turquoise in dark field; CP2 thin continuous layer which might expand through the whole CP1, extra light grey in bright field, black in dark field; CP3 thin continuous layer, extra light grey in bright field, light brown in dark field; CP4 medium discontinuous layer, dark grey in bright field, light green in dark field; CP5 medium continuous layer, light grey in bright field, dark orange in dark field; CP6 thin discontinuous layer, black in bright field, light brown in dark field; CM1 medium discontinuous layer;

Fig. 12: Micrograph of the metal sample from Fig. 7 (detail, rotated of 90°), unetched, bright field.

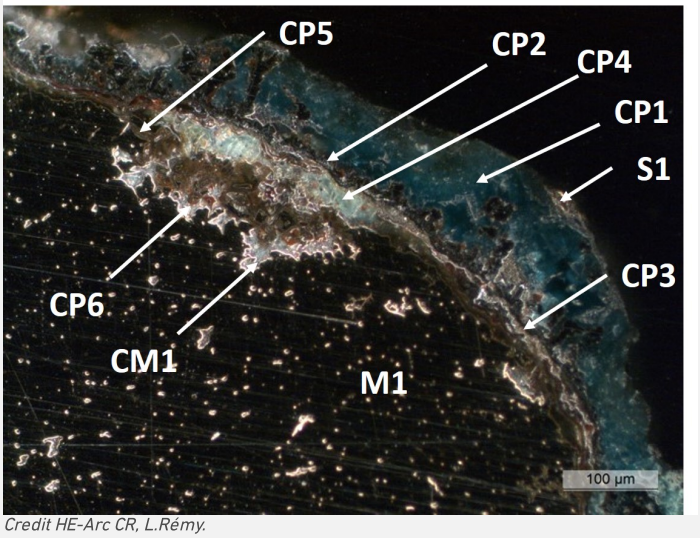
Fig. 13: Micrograph similar to Fig. 12, unetched, dark field and corresponding to the stratigraphy of Fig. 16,

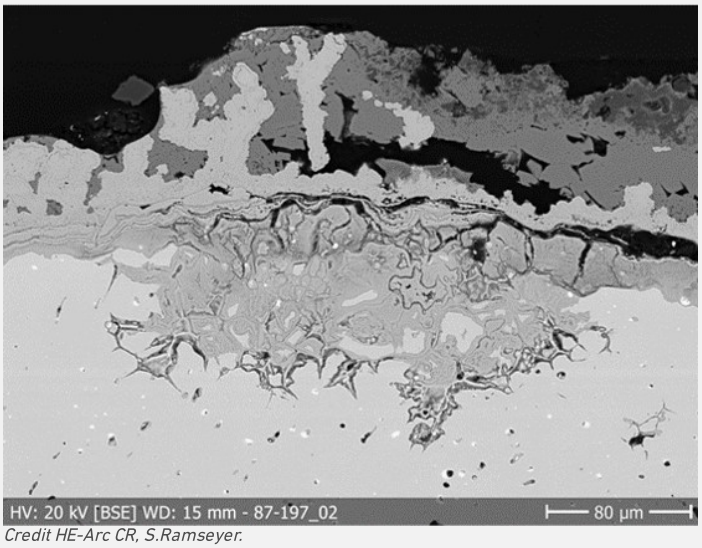
Fig. 14: SEM image, BSE-mode (detail of Fig. 12),

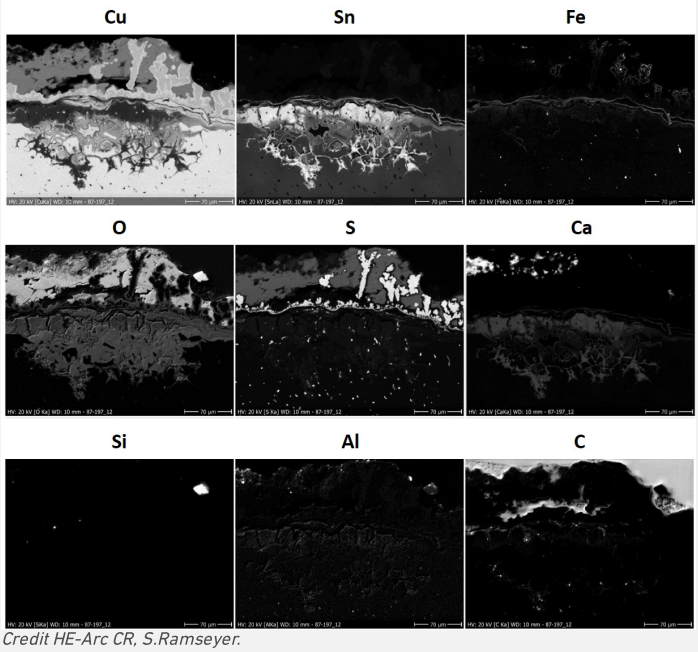
The elemental chemical distribution (Fig. 15) of the SEM image (Fig. 14) of the visually identified strata by cross-sectional observation shows that :
S1 has Ca, Al, Si and O elements;
CP1 stratum contains Cu, O and S;
CP2 stratum contains Cu, S and Fe;
CP3 stratum contains Sn, Fe and S;
CP4 stratum contains Sn and O;
CP5 stratum contains Cu, O and S;
CP6 stratum contains Sn and O, similar to CP4;

Fig. 15: Elemental chemical distribution of Fig. 14 (reversed). Method of examination: SEM/EDS, Microcity,

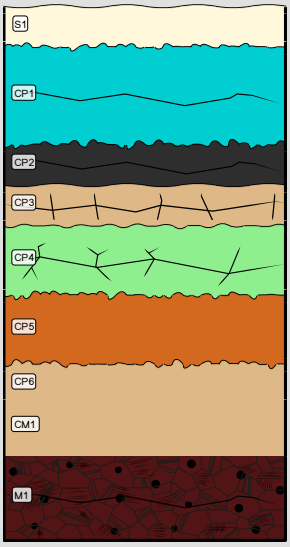
Fig. 16: Stratigraphic representation of the sample taken from the tang fragment in cross-section (dark field) using the MiCorr application. The characteristics of the strata are only accessible by clicking on the drawing that redirects you to the search tool by stratigraphy representation. This representation can be compared to Fig. 13, Credit HE-Arc CR, L.Rémy.

The following correspondence can be found: CP1 in binocular mode as sediment (S1) in cross-section mode. CP2 and CP3 in binocular mode are differentiated by their color. They match CP1 in cross-section mode. CP4 in binocular mode matches CP2 in cross-section mode. CP5 in binocular mode seems to match CP3 in cross-section mode. CP6 and CP7 in binocular mode match CP4 in cross-section mode. CP8 in binocular mode matches CP5, CP6 and CM1 in cross-section mode.

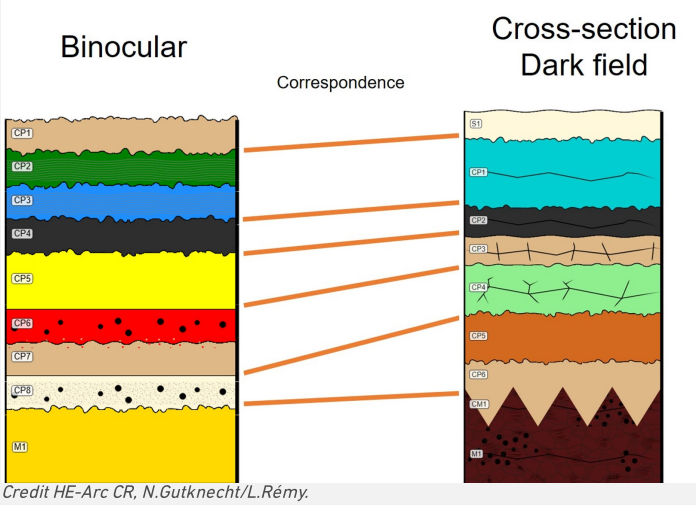
Fig. 17: Stratigraphic representation side by side of binocular view and cross-section (dark field),
