TANG FRAGMENT OF A KNIFE HR-6246 - TIN BRONZE - LATE BRONZE AGE - SWITZERLAND

Artefact name	Tang fragment of a knife HR-6246
Authors	Marianne. Senn (Empa, Dübendorf, Zurich, Switzerland) & Christian. Degrigny (HE-Arc CR, Neuchâtel, Neuchâtel, Switzerland) & Naima. Gutknecht (HE-Arc CR, Neuchâtel, Neuchâtel, Switzerland) & Rémy. Léopold (HE-Arc CR, Neuchâtel, Neuchâtel, Switzerland)
Url	/artefacts/1230/

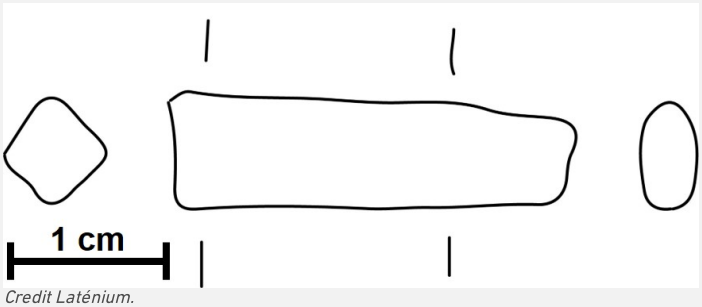
Fig. 1: Tang fragment of a knife (after Rychner-Faraggi 1983, plate 35.35),

Description of the artefact	Tang fragment of a knife with shiny yellow and green-blue corrosion products (Figs. 1 & 2). Dimensions: L = 2.7cm; Ø = around 5mm; WT = 5.8g.
Type of artefact	Household implement
Origin	Hauterive - Champréveyres, Neuchâtel, Neuchâtel, Switzerland
Recovering date	Excavation 1983-1985, object from layer 1 (layer with material from Bronze Age till 20th cent.)
Chronology category	Late Bronze Age
chronology tpq	1050 B.C.
chronology taq	800 B.C.
Chronology comment	Hallstatt A/B
Burial conditions / environment	Lake

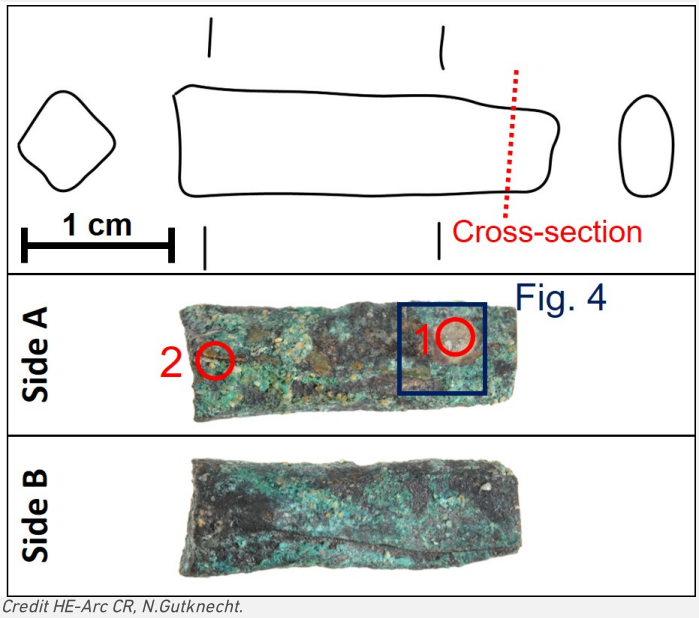
Fig. 2: Shiny yellow and green-blue corrosion products on the surface of the tang fragment of a knife,

Fig. 3: Location of the cross-section before sampling and both sides of the fragment not sampled with location of the detail of Fig. 4 (blue square) and XRF analysis areas (red circles),

XRF analyses of the tang fragment were carried out on two representative areas (Fig. 3). Point 1 was done in a lacuna of the green-blue corrosion layer, while point 2 was performed on a black corrosion layer (CP4) where all strata (soil, corrosion products, and metal) are analyzed at the same time.

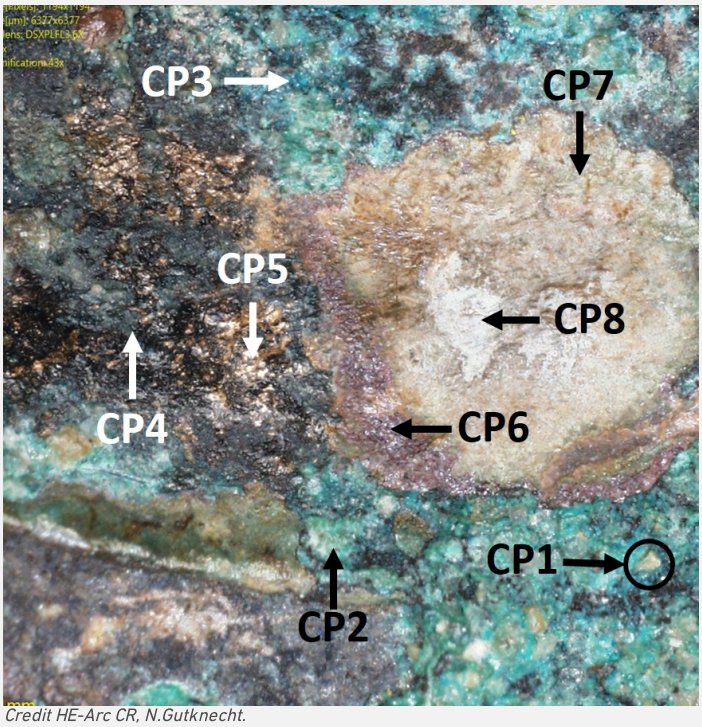
Fig. 4: Corrosion structure (detail) from Fig. 3 showing some of the documented strata,

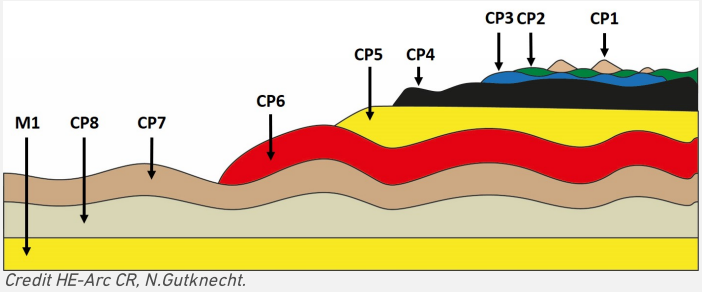
Fig. 5: Stratigraphic representation of the corrosion structure of the tang by macroscopic and binocular observation with reference to Fig. 4,

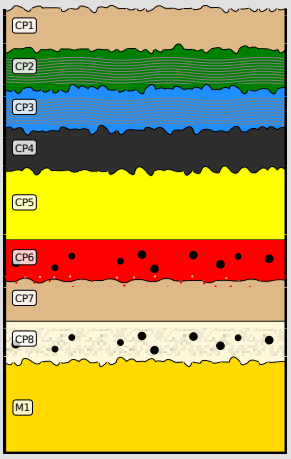
Fig. 6: Stratigraphic representation of the corrosion structure of the tang observed macroscopically under binocular microscope using the MiCorr application with reference to the whole Fig. 5. The characteristics of the strata, such as discontinuity, are accessible by clicking on the drawing that redirects you to the search tool by stratigraphy representation, Credit HE-Arc CR, N.Gutknecht,

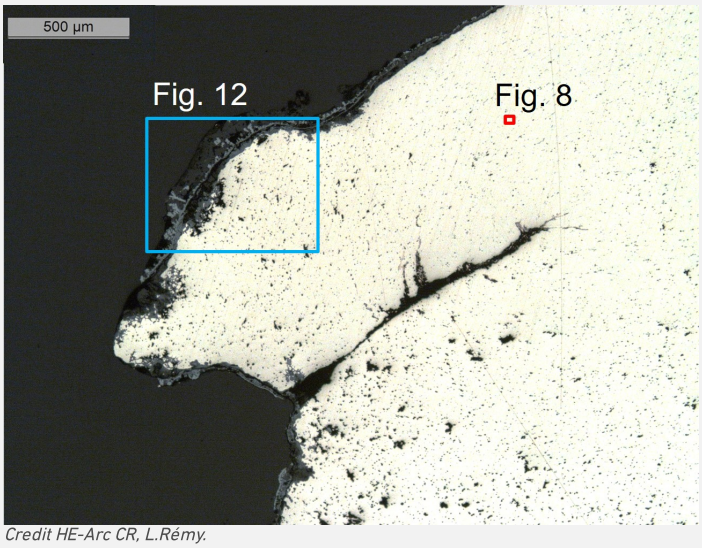
Fig. 7: Micrograph from an area of the cross-section of the sample taken from the tang fragment with location of Fig. 8 (red square) and Fig. 12 (blue square), unetched, bright field,

The cross-section corresponds to a lateral cut (Fig. 3). The surface is covered with a thick corrosion layer but part of it has gone (Fig. 7).
Alloy	Tin Bronze
Technology	Cold worked with partial annealing
Lab number of sample	MAH 87-197
Sample location	Musées d'art et d'histoire, Genève, Geneva
Responsible institution	Musées d'art et d'histoire, Genève, Geneva
Date and aim of sampling	1987, metallography and corrosion characterisation

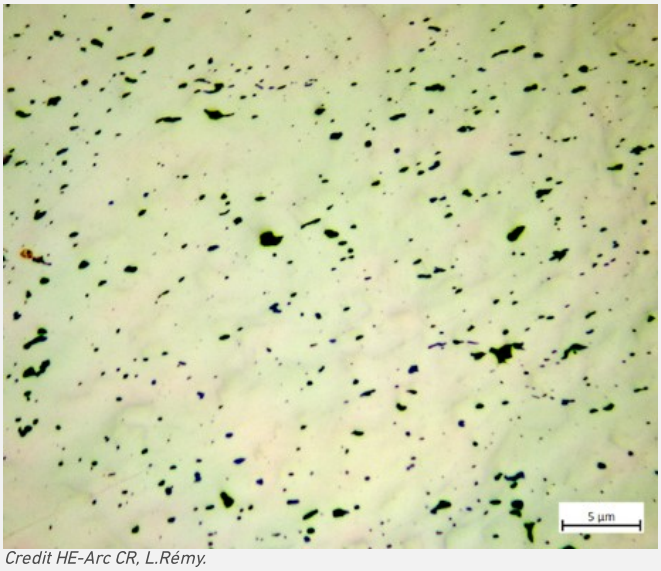
Fig. 8: Detail of the metal from Fig. 7, unetched, bright field,

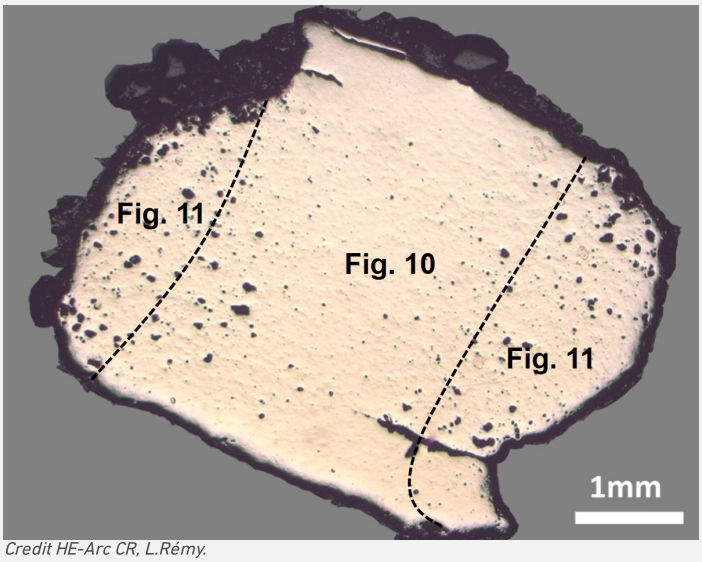
The remaining metal is a tin bronze (Table 3) with high porosity (Figs. 7-9) and large cracks both on the left and right edges of the sample (Fig. 9). The metal contains small, elongated copper sulphide (Table 4) and Pb inclusions. The etched metal shows three zones with a core where elongated grains and slip lines are visible indicating cold working without annealing (Figs. 9-10), while annealing appears on both external sides (Fig. 9-11). The average hardness of the metal is HV1 145, but significant variations are observed, depending on where the measurements are taken.

Fig. 9: Micrograph of the cross section of the tang of a knife with three distinct zones: metal core with elongated grains and slip lines (Fig. 10) and external sides with polygonal grains and twin lines (Fig. 11), unetched, bright field,

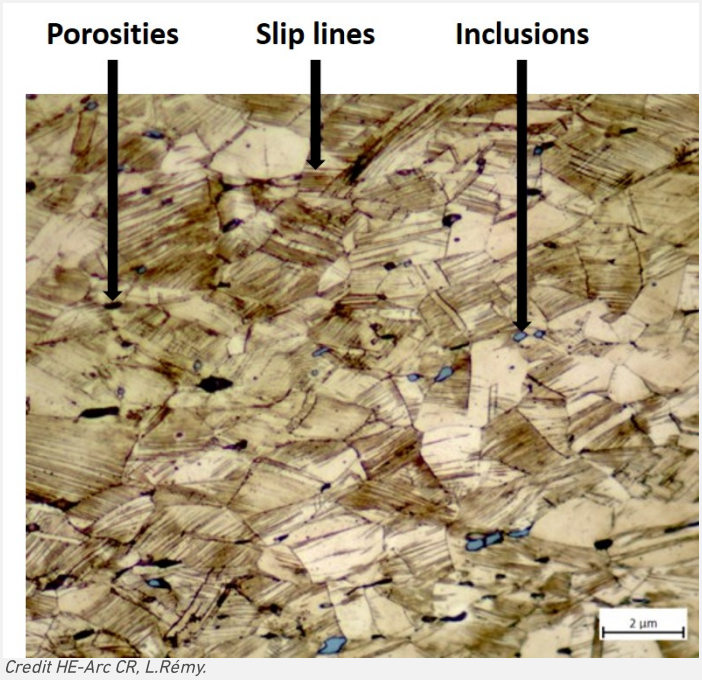
Fig. 10: Micrograph of the metal sample from Fig. 9 (detail), etched, bright field. Elongated grains with slip lines are observed, as well as grey copper sulphide inclusions and dark porosities,

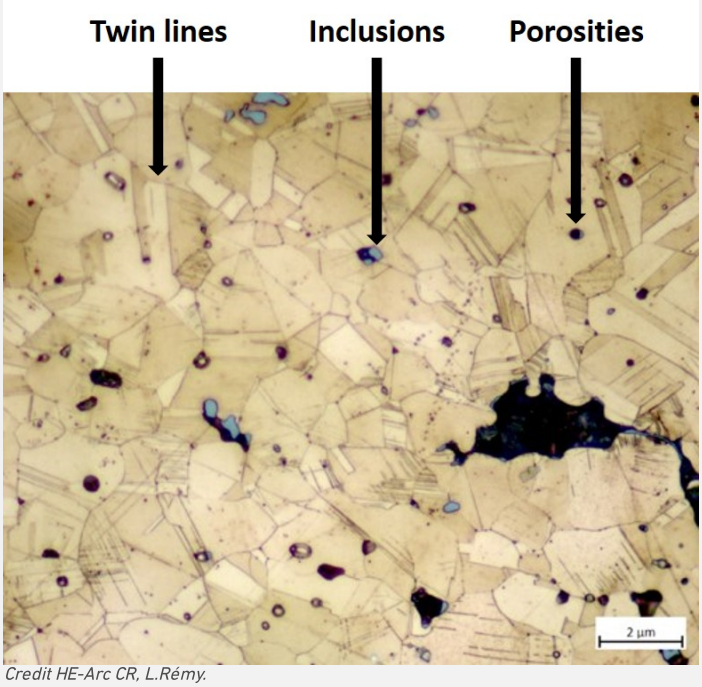
Fig. 11: Micrograph of the metal sample from Fig. 9 (detail), etched, bright field. Twin lines, grey copper sulphide inclusions and dark porosity are observed,

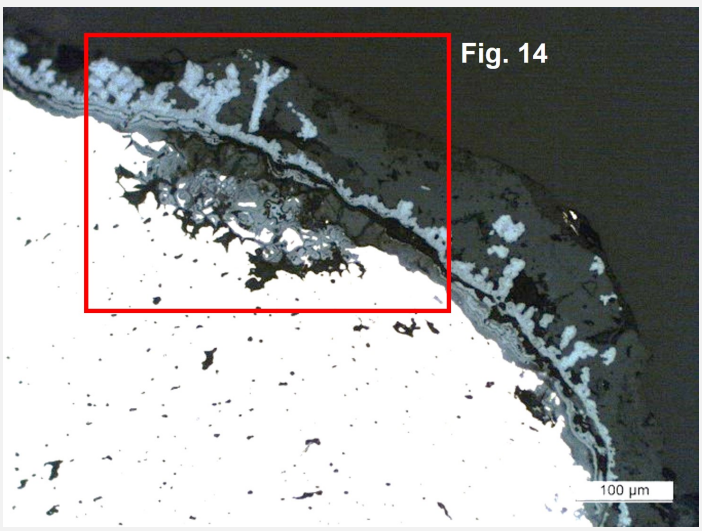
The corrosion layer has a thickness between 130µm and 70µm (Fig. 12). The observation of the sample in cross-section (Figs. 12-13) shows the presence of a succession of layers : S1 sediment, at the very top surface; CP1 thick continuous layer, dark grey in bright field, dark turquoise in dark field; CP2 thin continuous layer which might expand through the whole CP1, extra light grey in bright field, black in dark field; CP3 thin continuous layer, extra light grey in bright field, light brown in dark field; CP4 medium discontinuous layer, dark grey in bright field, light green in dark field; CP5 medium continuous layer, light grey in bright field, dark orange in dark field; CP6 thin discontinuous layer, black in bright field, light brown in dark field; CM1 medium discontinuous layer;

Fig. 12: Micrograph of the metal sample from Fig. 7 (detail, rotated of 90°), unetched, bright field.

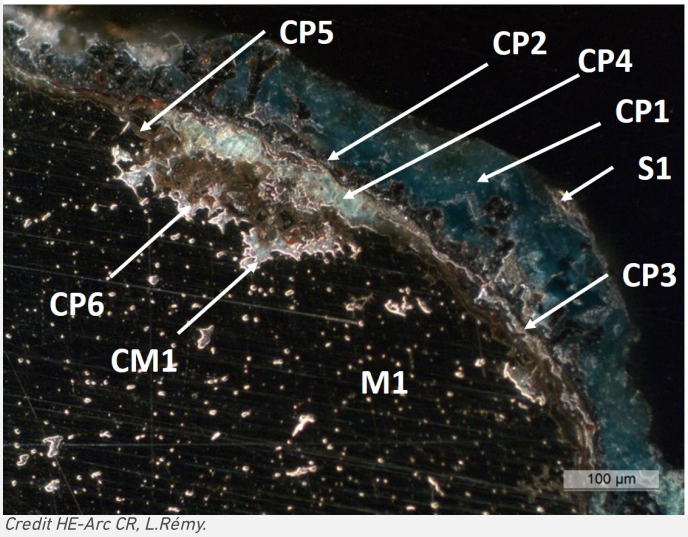
Fig. 13: Micrograph similar to Fig. 12, unetched, dark field and corresponding to the stratigraphy of Fig. 16,

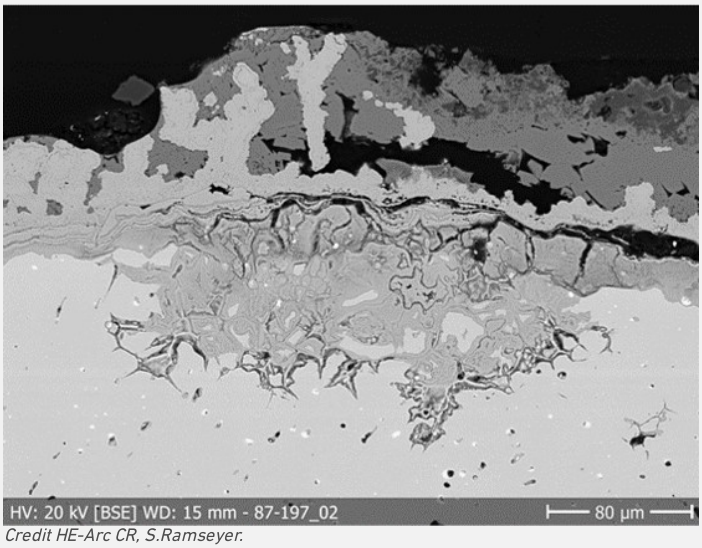
Fig. 14: SEM image, BSE-mode (detail of Fig. 12),

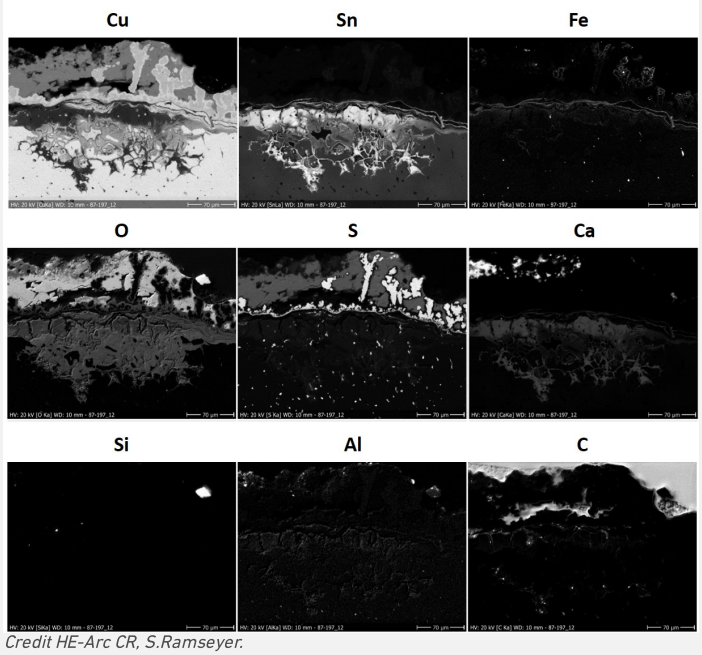
The elemental chemical distribution (Fig. 15) of the SEM image (Fig. 14) of the visually identified strata by cross-sectional observation shows that :
S1 has Ca, Al, Si and O elements;
CP1 stratum contains Cu, O and S;
CP2 stratum contains Cu, S and Fe;
CP3 stratum contains Sn, Fe and S;
CP4 stratum contains Sn and O;
CP5 stratum contains Cu, O and S;
CP6 stratum contains Sn and O, similar to CP4;

Fig. 15: Elemental chemical distribution of Fig. 14 (reversed). Method of examination: SEM/EDS, Microcity,

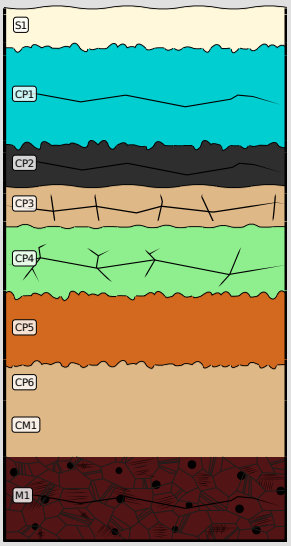
Fig. 16: Stratigraphic representation of the sample taken from the tang fragment in cross-section (dark field) using the MiCorr application. The characteristics of the strata are only accessible by clicking on the drawing that redirects you to the search tool by stratigraphy representation. This representation can be compared to Fig. 13, Credit HE-Arc CR, L.Rémy.

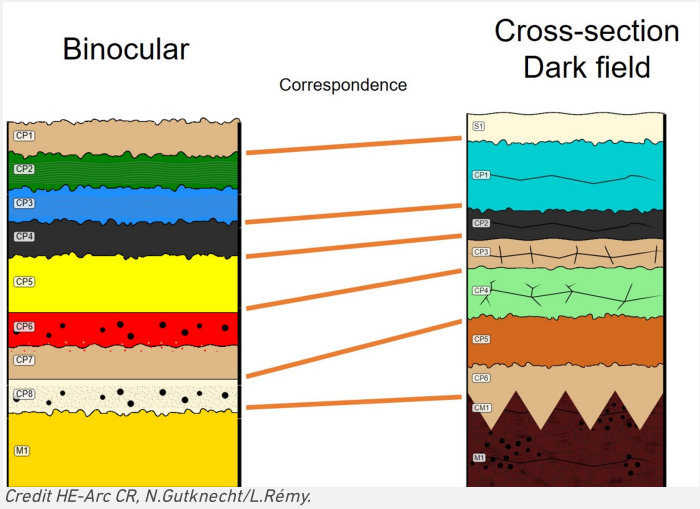
The following correspondence can be found: CP1 in binocular mode as sediment (S1) in cross-section mode. CP2 and CP3 in binocular mode are differentiated by their color. They match CP1 in cross-section mode. CP4 in binocular mode matches CP2 in cross-section mode. CP5 in binocular mode seems to match CP3 in cross-section mode. CP6 and CP7 in binocular mode match CP4 in cross-section mode. CP8 in binocular mode matches CP5, CP6 and CM1 in cross-section mode.

Fig. 17: Stratigraphic representation side by side of binocular view and cross-section (dark field),
