PIN OR NEEDLE FRAGMENT HR-3031 - TIN BRONZE - LATE BRONZE AGE - SWITZERLAND

Artefact name	Pin or needle fragment HR-3031
Authors	Marianne. Senn (EMPA, Dübendorf, Zurich, Switzerland) & Christian. Degrigny (HE-Arc CR, Neuchâtel, Neuchâtel, Switzerland) & Naima. Gutknecht (HE-Arc CR, Neuchâtel, Neuchâtel, Switzerland) & Rémy. Léopold (HE-Arc CR, Neuchâtel, Neuchâtel, Switzerland)
Url	/artefacts/1232/

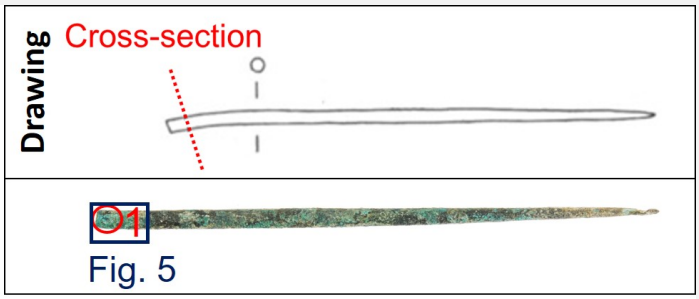
Fig. 4: Location of cross-section on drawing and indication of XRF analysis (red circle) and Fig. 5 (blue square),

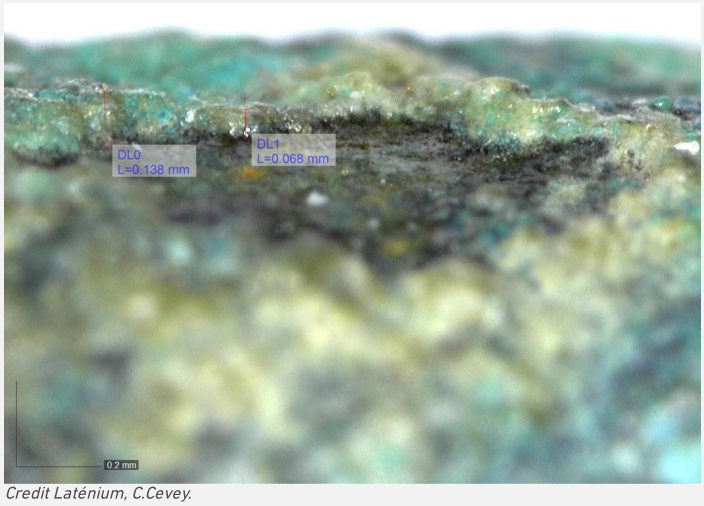
Fig. 6: Side view of the lacuna of Fig. 5,

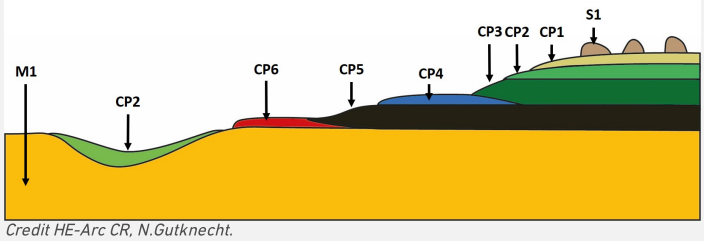
Strata	Type of stratum	Principal characteristics
S1	Sediments	Nodule, light brown, thin, scattered, non compact, friable, very soft
CP1	Corrosion product	Layer, light brown, thin, discontinuous, compact, powdery, soft
CP2	Corrosion product	Layer, light green, thin, discontinuous, compact, powdery, soft
CP3	Corrosion product	Layer, dark green, thin, discontinuous, compact, tough, soft
CP4	Corrosion product	Layer, blue, thin, discontinuous, compact, tough, soft
CP5	Corrosion product	Layer, black, thin, discontinuous, compact, tough, soft
CP6	Corrosion product	Layer, dark red, thin, scattered, non compact, friable, soft
M1	Metal	Dark yellow, thick, compact, soft

Fig. 7: Stratigraphic representation of the corrosion structure of the pin by macroscopic and binocular observation using the MiCorr application with reference to Fig. 8,

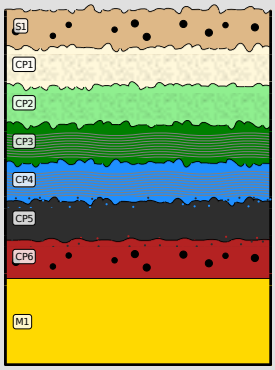
Fig. 8: Stratigraphic representation of the corrosion structure of the pin or needle observed macroscopically under binocular microscope using the MiCorr application with reference to the whole Fig. 7. The characteristics of the strata, such as discontinuity, are accessible by clicking on the drawing that redirects you to the search tool by stratigraphy representation, Credit HE-Arc CR., N.Gutknecht.

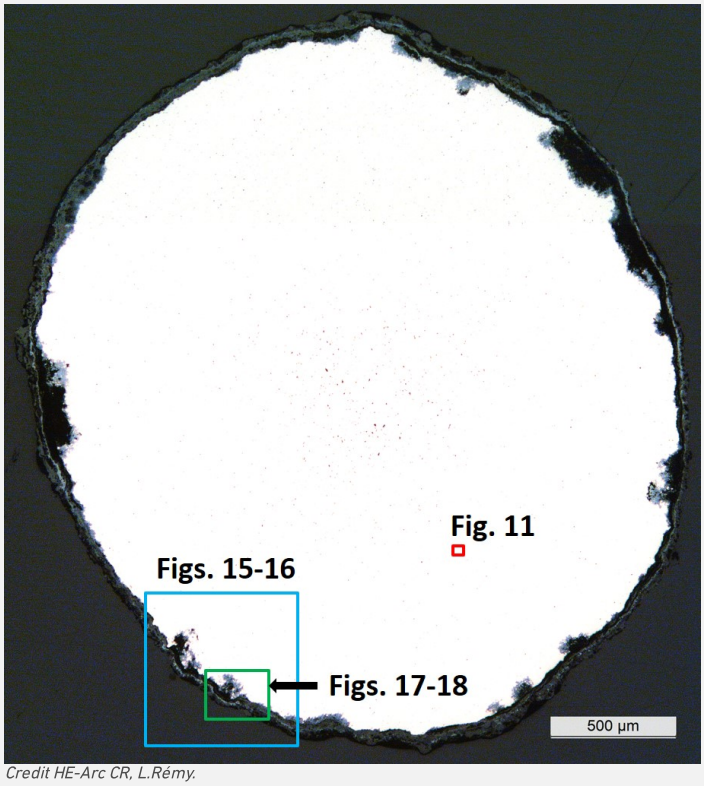
Fig. 9: Micrograph of the cross-section of the sample taken from the pin or needle fragment (Fig. 4), unetched, bright field with location of Fig. 11 (red square), Figs. 15 to 16 (blue square) and Figs. 17 to 18 (green square),

Description of sample	The cross-section is circular and is a complete section through the pin (Fig. 9). The surface is completely covered with a rather thin corrosion layer of irregular thickness (Fig. 10). At the center of the cross-section, the metal seems to have more porosities and/or inclusions.
Alloy	Tin Bronze
Technology	Cold worked with partial annealing
Lab number of sample	MAH 87-195
Sample location	Musées d'art et d'histoire, Genève, Geneva
Responsible institution	Musées d'art et d'histoire, Genève, Geneva
Date and aim of sampling	1987, metallography and corrosion characterisation

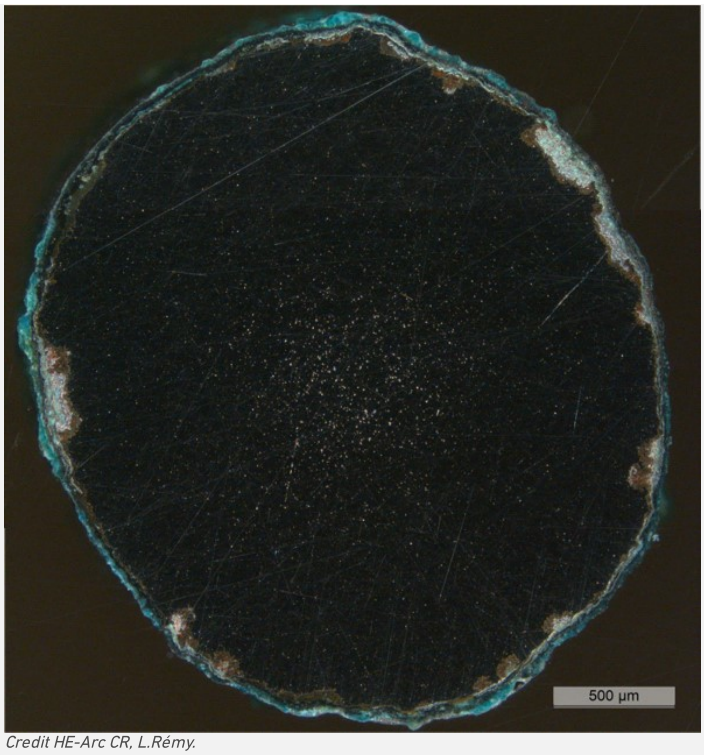
Fig. 10: Micrograph of the cross-section of the sample taken from the pin or needle fragment similar to Fig. 9, unetched, dark field,

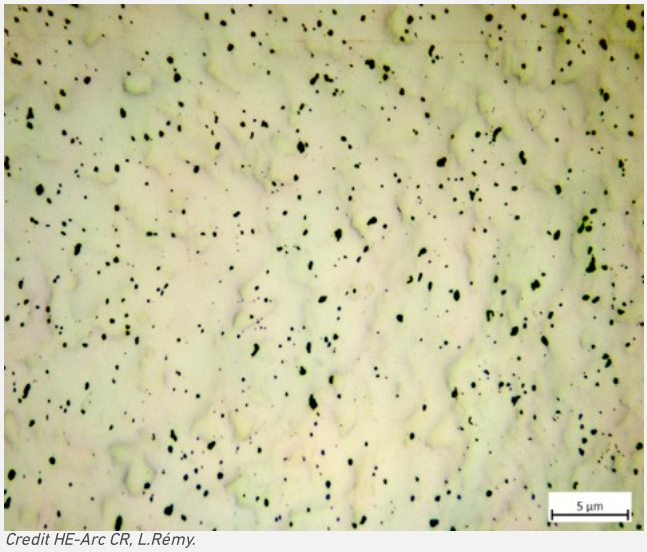
Fig. 11: Micrograph of the metal sample from Fig. 9 (detail), unetched, bright field,

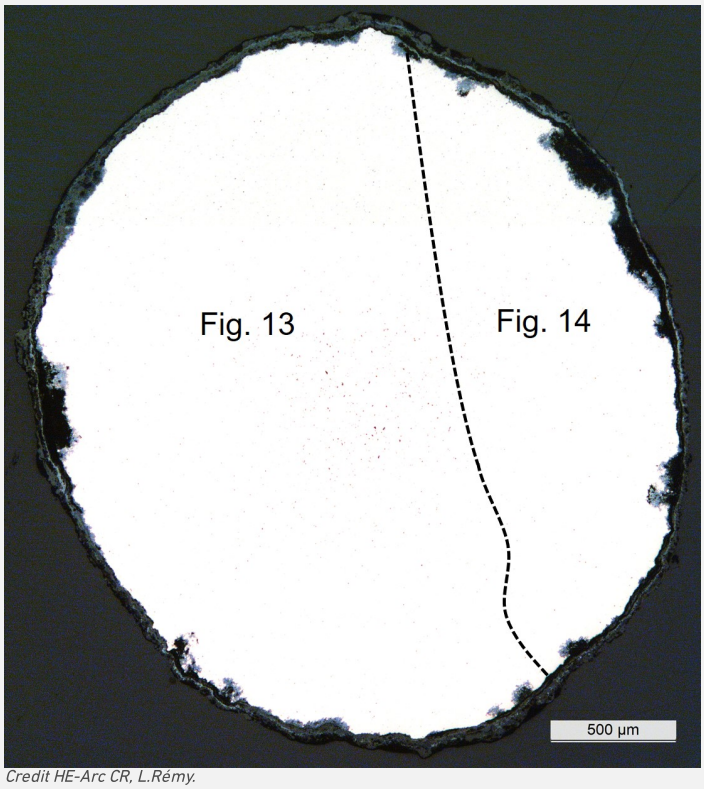
As suggested by XRF analysis, the remaining metal is a tin bronze with some Sb (Table 3), porosities and small copper sulphide inclusions (Table 4). The etched structure of the tin bronze shows two zones (Fig. 12): more than one half of the section is constituted of re-crystallised and angular grains, some of them with twins (Fig. 13), while the other half shows the presence of strain or slip lines in the grains (Fig. 14). They indicate a final cold working without annealing. Copper sulphide inclusions are found both at the grain boundaries and inside the grains (Figs. 13 and 14). The average hardness of the metal is about HV1 120.

Fig. 12: Micrograph similar to Fig. 9 indicating two zones with characteristic microstructures: Fig. 13 where re-crystallised and angular grains with some twins are visible and Fig. 14 where slip lines are more prominent,

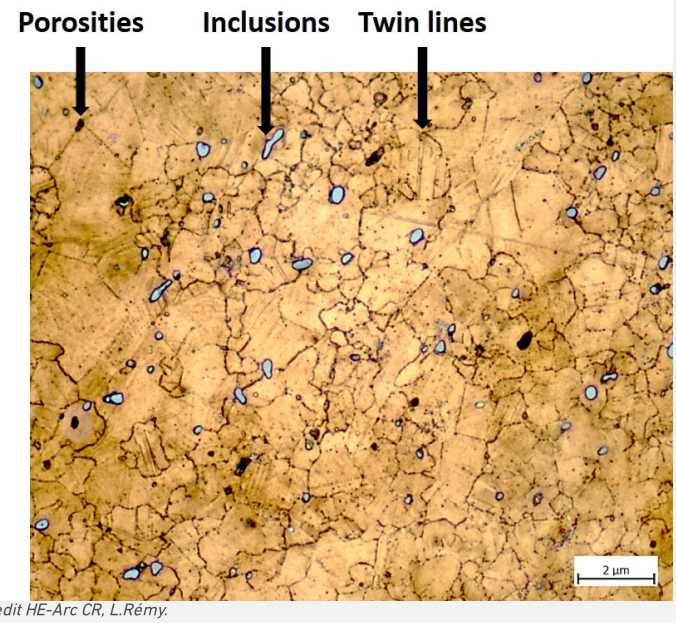
Fig. 13: Micrograph of the metal from Fig. 12 (detail), etched, bright field. Twin lines are visible. Grey copper sulphide inclusions are observed, as well as dark porosities,

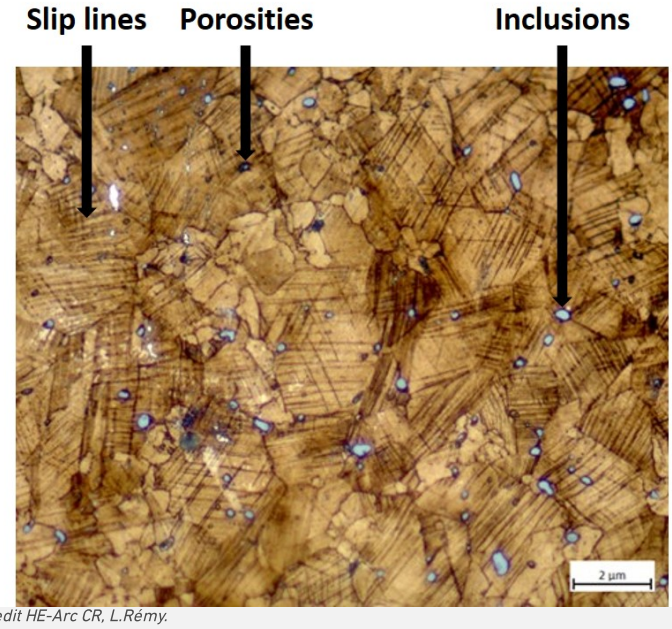
Fig. 14: Micrograph of the metal from Fig. 12 (detail), etched, bright field. Polygonal grains with slip lines are observed, as well as grey copper sulphide inclusions and dark porosities,

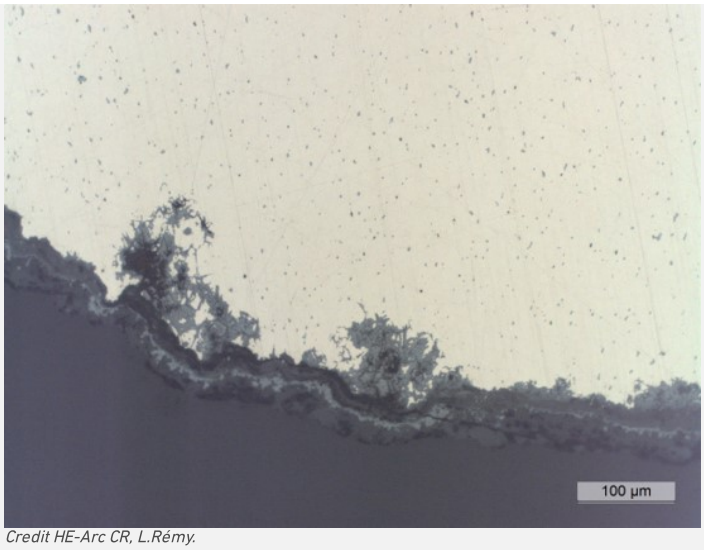
The corrosion layer has an average thickness of about 50µm (Fig. 15). The observation of the sample in cross-section (Figs. 15 and 18) shows the presence of a succession of layers (Figs. 17 and 18): S1 sediment at the top surface, discontinuous layer, black in bright field and light yellow in dark field; CP1 medium continuous layer, extra dark grey in bright field, dark turquoise in dark field; CP2 thin continuous layer, extra light grey in bright field, black in dark field; CP3 thin continuous layer, dark grey in bright field, extra light grey in dark field; CP4 thin continuous layer, extra dark grey in bright field, black in dark field; CP5 thin discontinuous layer, black in bright field, light green in dark field; CP6 medium continuous layer, light grey in bright field, dark orange in dark field; CM1 thin continuous layer;

Fig. 15: Micrograph of the metal sample from Fig. 9 (detail), unetched, bright field,

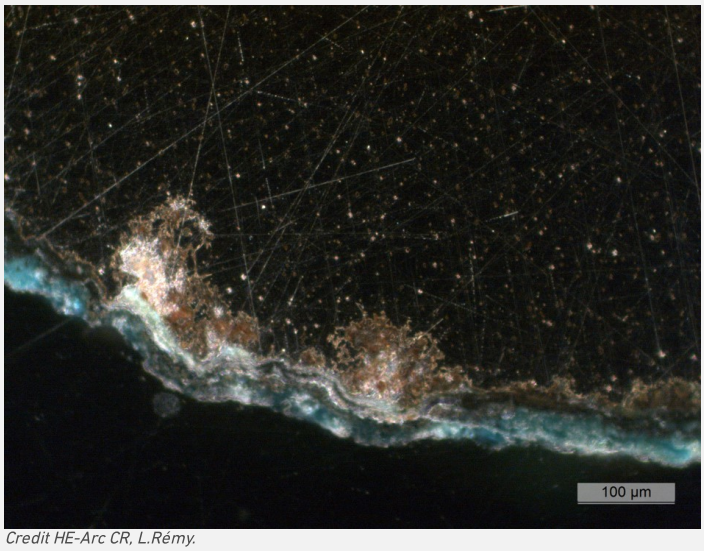
Fig. 16: Micrograph of the metal sample similar to Fig. 15, unetched, dark field,

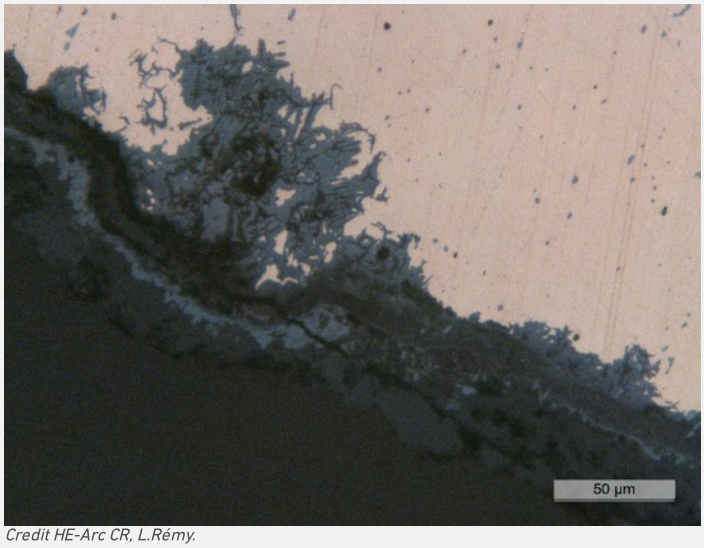
Fig. 17: Micrograph of the metal sample from Fig. 9 (detail), unetched, bright field,

Fig. 18: Micrograph of the metal sample similar to Fig.17 (detail), unetched, dark field, and corresponding to the stratigraphy of Fig. 21,

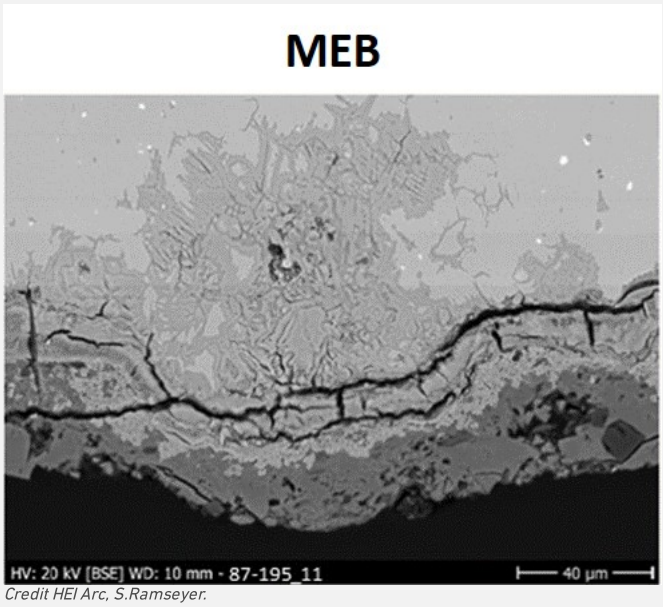
The EDX elemental mapping (Fig. 20) of SEM image (Fig. 19) of the visually identified strata in cross-section shows the following chemical distribution :
S1 has Al, Ca, Si, and O elements;
CP1 stratum contains Cu, O and S;
CP2 stratum contains Cu, S and Fe;
CP3 stratum contains Sn, O, Fe and S;
CP4 stratum contains Cu, Sn, O, Fe and S;
CP5 stratum contains Cu, Sn, O, Fe and S;
CP6 stratum contains Cu, Sn, O and S.

Fig 20: Elemental chemical distribution of Fig. 19. Method of examination: SEM/EDS, Microcity,

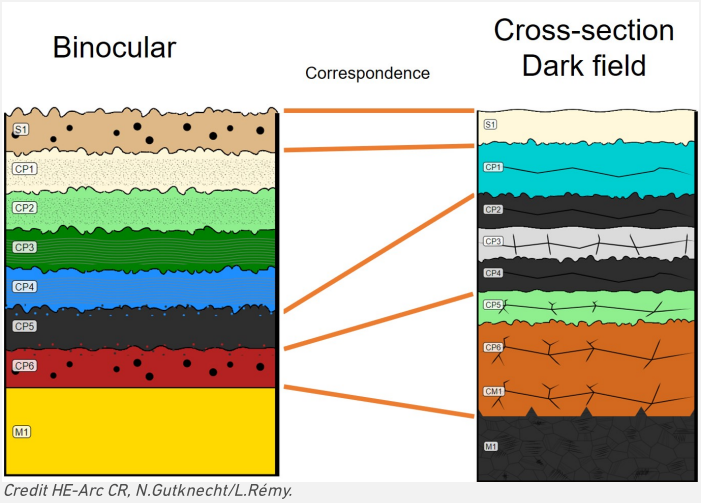
Sediment (S1) in binocular mode is documented as sediment (S1) in cross-section mode.
CP1, CP2, CP3 and CP4 in binocular mode are differentiated by their color. They match CP1 in cross-section mode.
CP5 in binocular mode matches CP2, CP3 and CP4 in cross-section mode.
CP6 in binocular mode seems to match CP5, CP6 and CM1 in cross-section mode.
On cross-section, it was possible to describe and analyze the microstructure of the metal.

Fig. 22: Stratigraphic representation side by side of binocular view and cross-section (dark field),
