BUST OF AN APPLIQUE 2005.054.F00265.1 - QUARTERNARY BRONZE ALLOY - ROMAN TIMES - SWITZERLAND

Artefact name Bust of an applique 2005.054.F00265.1

Authors Christian. Degrigny (HE-Arc CR, Neuchâtel, Neuchâtel, Switzerland) & Marie. Arnautou (HE-Arc CR, Neuchâtel, Neuchâtel, Switzerland) & Valentin. Boissonnas (HE-Arc CR, Neuchâtel, Neuchâtel, Switzerland)

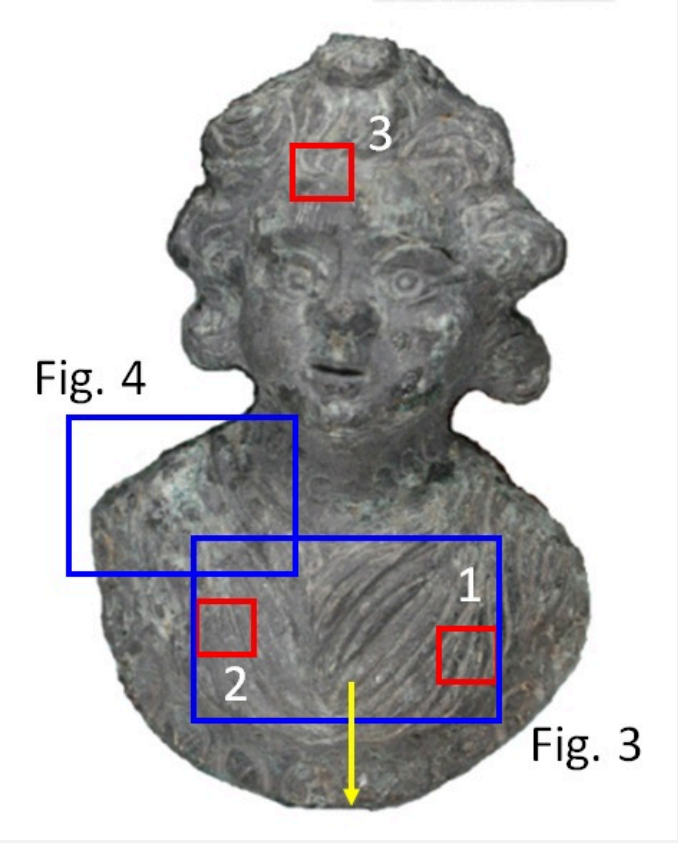
Fig. 1: Bust of an applique as found (left picture) and the bust (right picture),

Description of the artefact Bust representing a love figure from a bronze applique (Fig. 1), covered by a thin dark-grey patina and scattered green corrosion products. Dimensions: L = 6 cm; W = 3.5 cm; T = 3 cm.

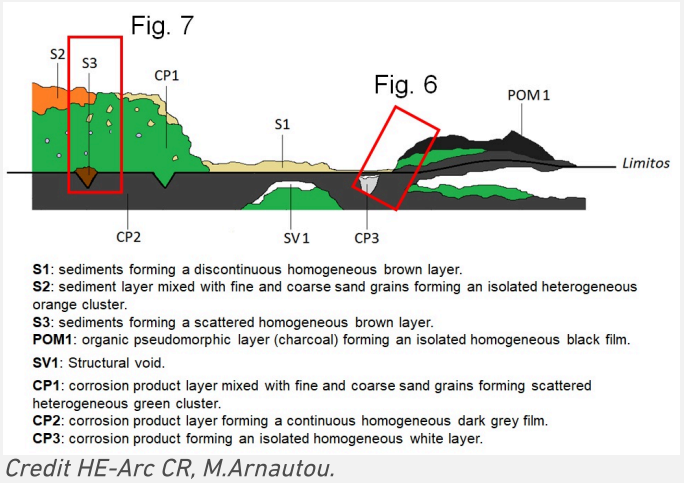
S1: sediments forming a discontinuous homogeneous brown layer.
S2: sediment layer mixed with fine and coarse sand grains forming an isolated heterogeneous orange cluster.
S3: sediments forming a scattered homogeneous brown layer.
POM1: organic pseudomorphic layer (charcoal) forming an isolated homogeneous black film.
SV1: Structural void.
CP1: corrosion product layer mixed with fine and coarse sand grains forming scattered heterogeneous green cluster.
CP2: corrosion product layer forming a continuous homogeneous dark grey film.
CP3: corrosion product forming an isolated homogeneous white layer.

Fig. 5: Stratigraphic representation based on visual observation and visualization of the stratigraphies of Figs. 6 and 7.

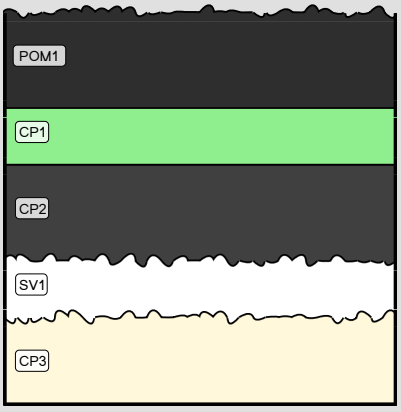
Fig. 6: Stratigraphic representation of the corrosion structure of the bust observed macroscopically under binocular microscope using the MiCorr application. The characteristics of the strata are only accessible by clicking on the drawing that redirects you to the search tool by stratigraphy representation. This representation can be compared to Fig. 5, Credit HE-Arc CR, C.Degrigny.

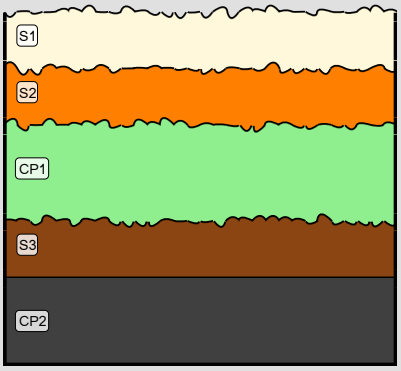
Fig. 7: Stratigraphic representation of the corrosion structure of the bust observed macroscopically under binocular microscope using the MiCorr application. The characteristics of the strata are only accessible by clicking on the drawing that redirects you to the search tool by stratigraphy representation. This representation can be compared to Fig. 5, Credit HE-Arc CR, C.Degrigny.

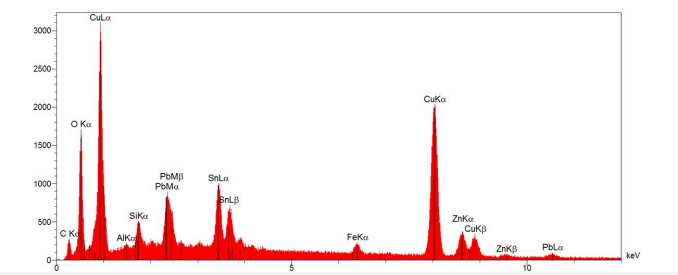
The qualitative analysis carried out on the dark patina by SEM/EDS (Fig. 8) confirms the XRF results (Table 1), showing the same elements and the presence of O, which probably correspond to copper oxide (cuprite Cu2O or tenorite CuO). The dark patina is covered by an adherent green corrosion layer (CP1) which has developed in scattered clusters (probably copper carbonate). The clusters have a surface area of 2 mm2 to 2 cm2, and have a thickness of 0.5 to 5 millimeters. In some places, the green corrosion layer has formed in the porous blisters of the dark layer (Fig. 5). Charcoal might be found locally (POM1) as well as different sediments: S1 (discontinuous and brown), S2 (mixed with fine and coarse sand grains) and S3 (scattered homogeneous brown layer).

Fig. 8: EDS spectrum of the scale of the dark-grey patina taken from the bottom part of the bust (yellow arrow of Fig. 2),
