BUST OF AN APPLIQUE 2005.054.F00265.1 - QUARTERNARY BRONZE ALLOY - ROMAN TIMES - SWITZERLAND

Artefact name Bust of an applique 2005.054.F00265.1

Authors Christian. Degrigny (HE-Arc CR, Neuchâtel, Neuchâtel, Switzerland) & Marie. Arnautou (HE-Arc CR, Neuchâtel, Neuchâtel, Switzerland) & Valentin. Boissonnas (HE-Arc CR, Neuchâtel, Neuchâtel, Switzerland)

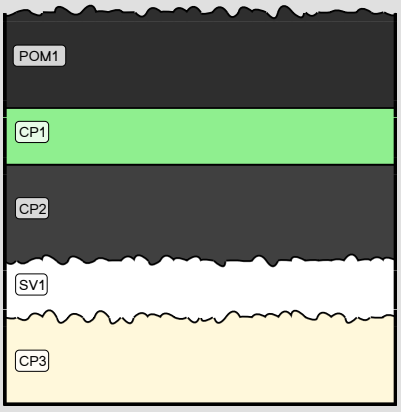
Fig. 6: Stratigraphic representation of the corrosion structure of the bust observed macroscopically under binocular microscope using the MiCorr application. The characteristics of the strata are only accessible by clicking on the drawing that redirects you to the search tool by stratigraphy representation. This representation can be compared to Fig. 5, Credit HE-Arc CR, C.Degrigny.

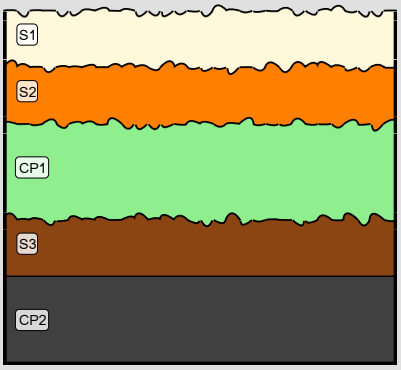
Fig. 7: Stratigraphic representation of the corrosion structure of the bust observed macroscopically under binocular microscope using the MiCorr application. The characteristics of the strata are only accessible by clicking on the drawing that redirects you to the search tool by stratigraphy representation. This representation can be compared to Fig. 5, Credit HE-Arc CR, C.Degrigny.
