FRAGMENT OF THE SUPPORT STRUCTURE OF AN ENGINE VHS-404 – GREY CAST IRON – MODERN TIMES

Artefact name	Fragment of the support structure of an engine VHS-404
Authors	Marianne. Senn (EMPA, Dübendorf, Zurich, Switzerland) & Christian. Degrigny (HE-Arc CR, Neuchâtel, Neuchâtel, Switzerland)
Url	/artefacts/1234/

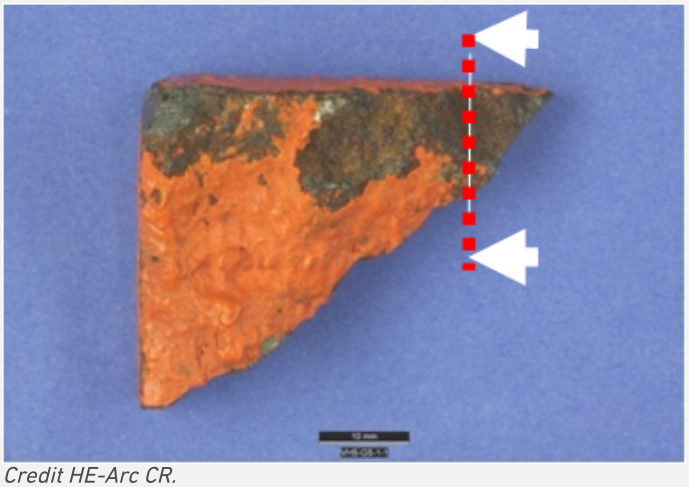
Fig. 1: Fragment (left) of the painted support structure of the engine from the SS Rigi steamer (right) (after www.verkehrshaus.ch, consulted on December 5, 2011),

Description of the artefact	Corroded fragment (Fig. 1) of the painted support structure of the engine from the SS Rigi steamer.
Type of artefact	Supporting structure
Origin	Flush-desk side-wheel paddle steamer SS Rigi
Recovering date	Removed in 1952 during the last renovation
Chronology category	Modern Times
chronology tpq	1860 A.D.
chronology taq	1896 A.D.
Chronology comment	Cast by Escher Wyss
Burial conditions / environment	Outdoor to indoor atmosphere
Artefact location	Swiss Museum of Transport, Luzern, Lucerne
Owner	Swiss Museum of Transport, Luzern, Lucerne
Inv. number	VHS-404
Recorded conservation data	Renovated in 1860 and 1880. The engine was replaced in 1894 and in 1952.

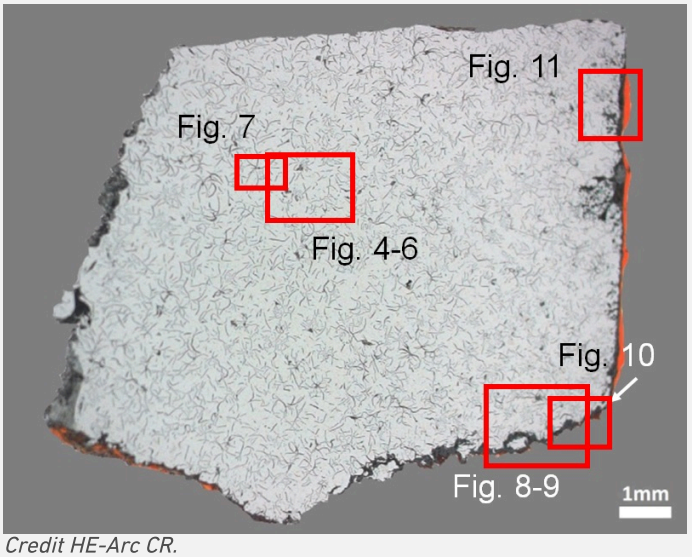
Fig. 2: Location of sampling area,

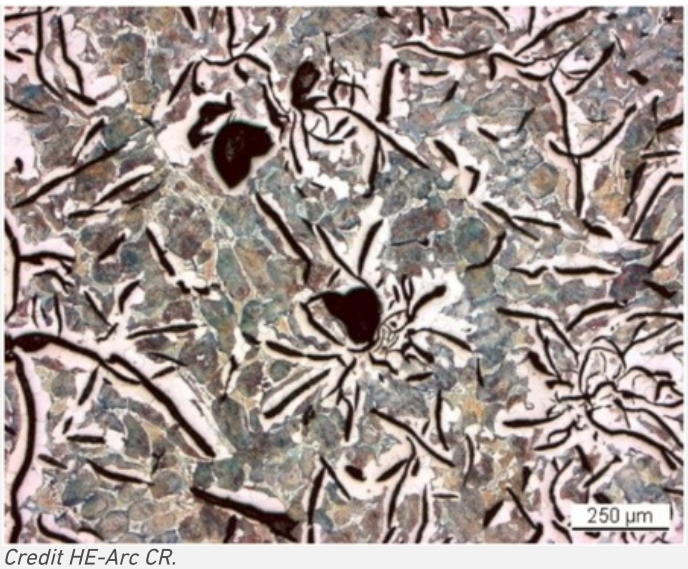
The remaining metal is a high P and Si grey cast iron with elevated Mn and V contents (Tables 1 and 2). The structure contains black graphite flakes and graphite nodules (Fig. 4) as well as angular grey manganese sulphide inclusions which can contain a dark alumina-rich centre (Fig. 4 and Table 1). The graphite flakes are irregular and vary in size. At low magnification the flakes are evenly spread over the entire surface with a tendency to form clusters. Some porosity is noticeable. Under SEM, in the BSD-mode, an additional eutectic phase is visible (Fig. 5). After etching one can see how the graphite is surrounded by alpha-iron in a pearlite matrix (Figs. 6 and 7). The lamellar pearlite includes steadite (Fe_3P) and manganese sulphide (MnS) inclusions. According to the cast iron diagram after Maurer (Bargel and Schulze 2008, 257), the structure is typical for a hypoeutectic pearlitic grey cast iron (C content <4.3 mass%, Si content ca. 2.0 mass%) including pearlite, steadite and graphite. The slow cooling rate and the higher Si level have favoured the formation of graphite. The high P content favours the growth of interconnected networks of steadite. The average hardness of the metal is HV1 160. This hardness is only approximate. Normally cast iron hardness is determined with a Brinell test, but due to the small size of the sample this could not be carried out. The calculated HB is about 150.

Fig. 4: Micrograph of the metal sample from Fig. 3 (inverted picture, detail), unetched, bright field. We observe graphite flakes and irregular nodules in black and the metal in white. The small grey spots are manganese sulphide inclusions,

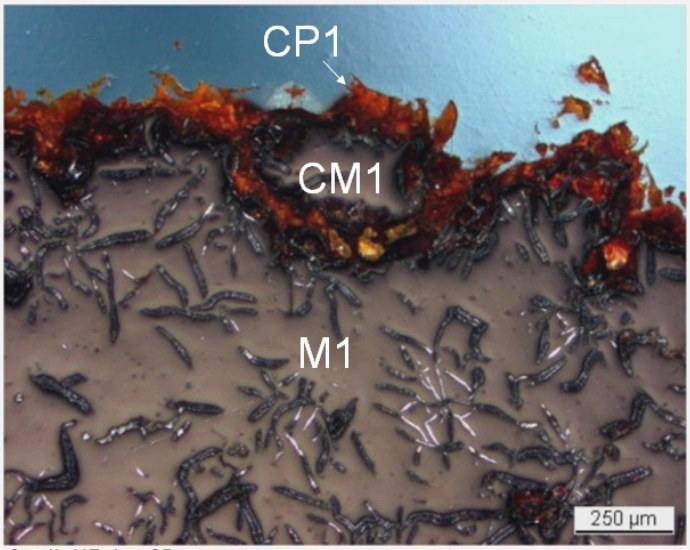
Fig. 7: Micrograph of the metal sample from Fig. 3 (detail), etched, bright field. The structure is composed of graphite (a), ferrite (b), pearlite (c), steadite (d) and MnS inclusions (e),
