AIRCRAFT REAR FASTENING PLATE VHS-497 - AL ALLOY - MODERN TIMES

Artefact name	Aircraft rear fastening plate VHS-497
Authors	Marianne. Senn (Empa, Dübendorf, Zurich, Switzerland) & Christian. Degrigny (HE-Arc CR, Neuchâtel, Neuchâtel, Switzerland)
Url	/artefacts/1235/

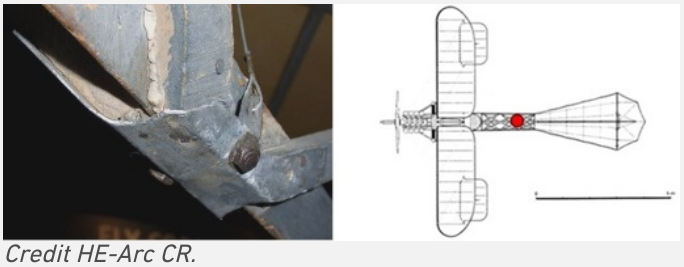
Fig. 1: Fastening plate from the back of the Dufaux IV (left) and top view of the aeroplane showing its location (red dot, right) (www.hepta.aero),

Description of the artefact	Metal fastening plate for the wooden construction of the rear of the aeroplane (Fig. 1) covered with a thin corrosion layer.
Type of artefact	Aeroplane part
Origin	Dufaux IV aeroplane
Recovering date	Biplane built by Henri and Armand Dufaux in 1909/10
Chronology category	Modern Times
chronology tpq	1909 A.D.
chronology taq	1910 A.D.
Chronology comment	
Burial conditions / environment	Outdoor to indoor atmosphere
Artefact location	Swiss Museum of Transport, Luzern, Lucerne

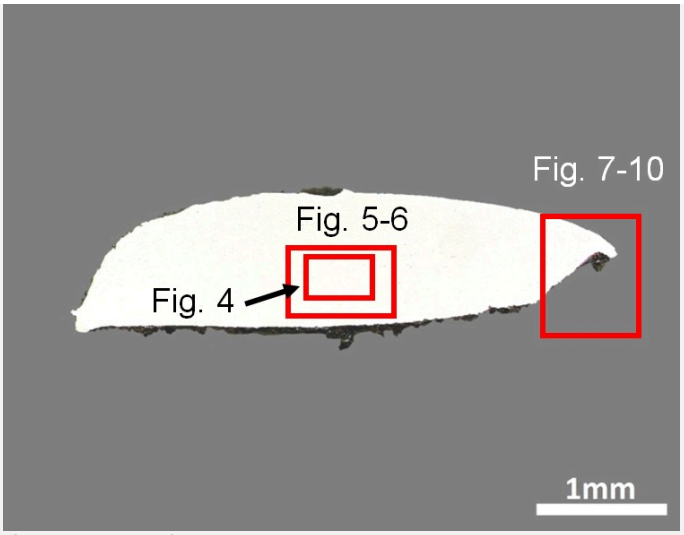
Fig. 3: Micrograph of the cross-section of the sample taken from the back fastening plate showing the location of Figs. 4 to 10,

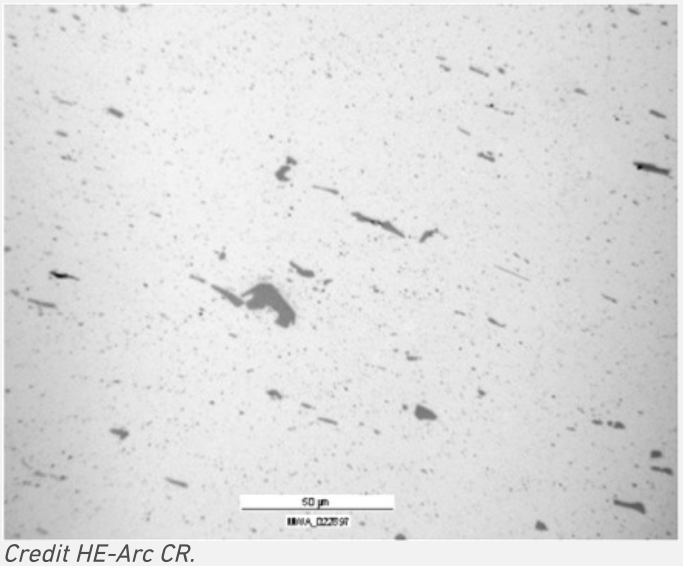
The metal is a relatively pure aluminium alloy with numerous inclusions (Table 1). From the chemical composition of the inclusions they can be interpreted as alpha-AlFeSi intermetallic compounds. In bright field we observe elongated inclusions indicating that the metal was rolled (Fig. 4). The alloy composition is similar to an unalloyed primary aluminium (Al content between 99 and 99.8 mass%). The O content reflects the immediate oxidation of the metal and is not part of the alloy. After etching the organisation of inclusions in rows is more easily seen (Fig. 5). The SEM image shows large grains formed after annealing (Fig. 6). The average hardness of the metal is HV1 40.

Fig. 4: Micrograph of the metal sample from Fig. 3 (detail), unetched, bright field. The metal matrix is in white, the elongated inclusions in grey,

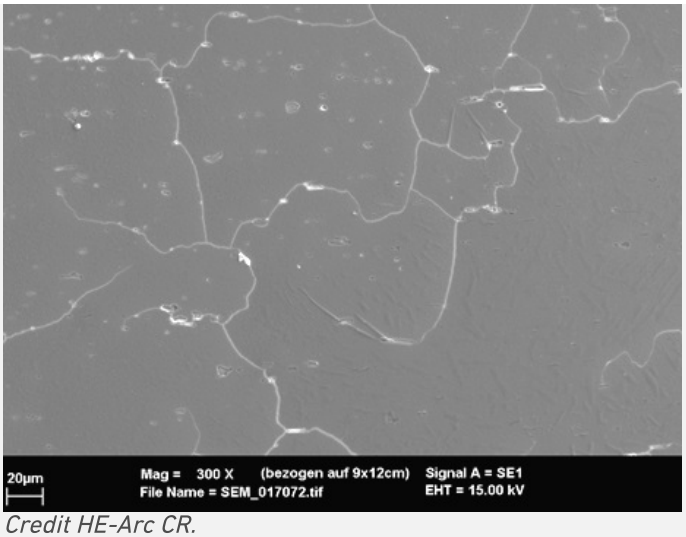
Fig. 6: SEM image of the metal sample from Fig. 3 (detail), SE-mode, etched. We observe the presence of large grains and numerous elongated inclusions,

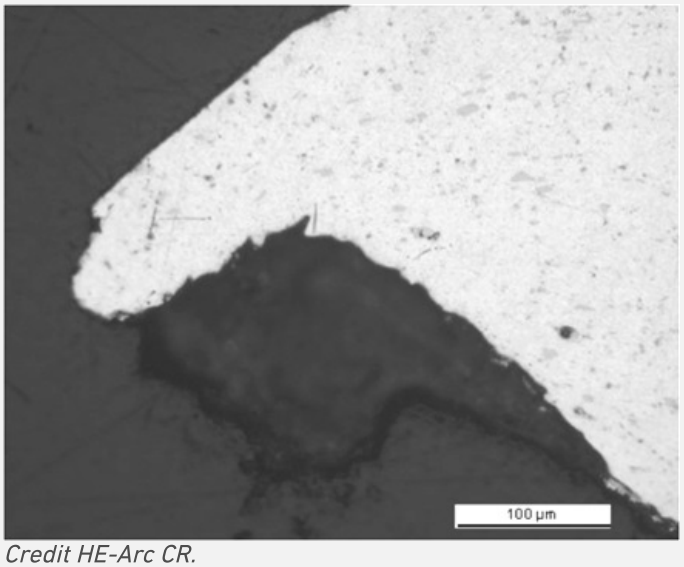
The metal is covered by a very thin corrosion layer (CP1). In addition to this, locally thicker adhering materials can be observed (NMM1, appearing as dark-grey area in Fig. 7). Under polarized light, they appear blue-brown (Fig. 8). Analysis by SEM-EDS indicates that the metal is, as expected, covered by a very thin Al and O-rich layer whereas the particles in the adherent material contain C, O, Si, Ca, Fe, Zn, S and even Ti (Figs. 9 and 10). The location of the adherent material and the presence of both Zn and Ti suggest that it is a residue of a paint coating.

Fig. 7: Micrograph showing the metal - adhering material interface from Fig. 3 (reversed picture, detail), unetched, bright field. We observe in white the metal matrix and dark-grey the adhering material,

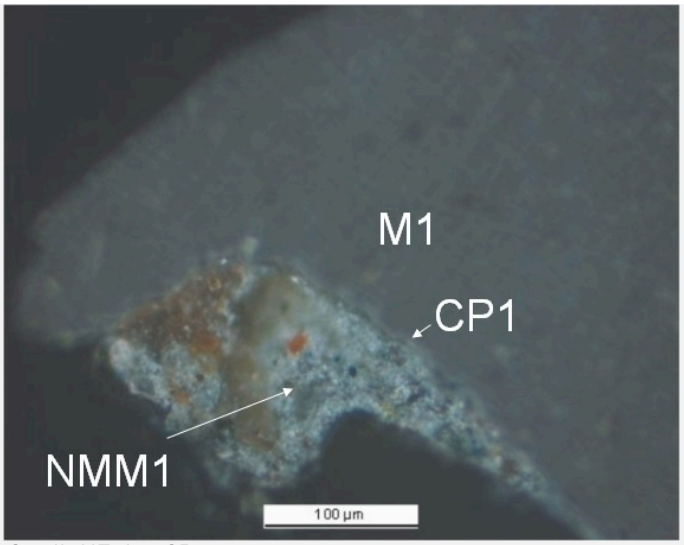
Fig. 8: Micrograph (same as Fig. 7) and corresponding to the stratigraphy of Fig. 11, unetched, polarised light. We observe in grey the metal matrix and blue-brown the adhering material,

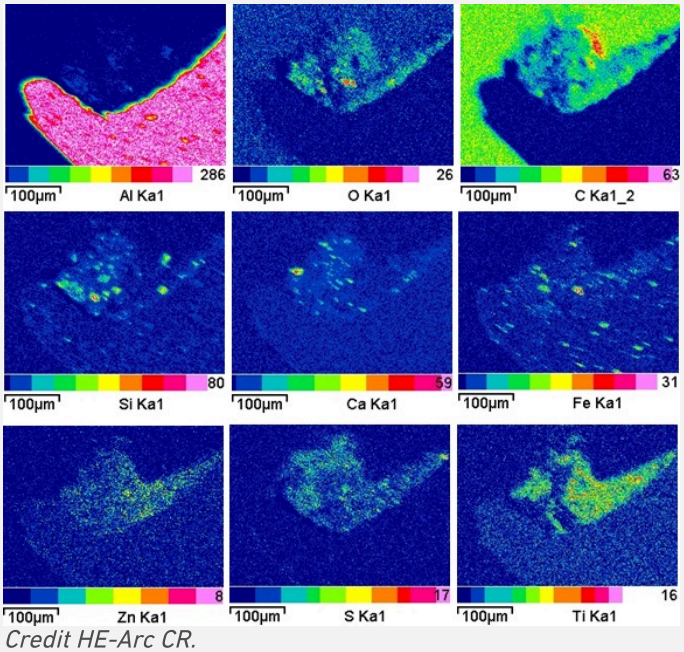
Fig. 10: Elemental chemical distribution of the selected area from Fig. 9. Method of examination: SEM/EDS, Laboratory of Analytical Chemistry, Empa,

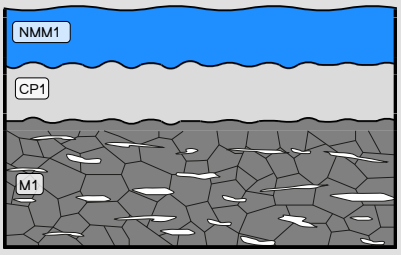
Fig. 11: Stratigraphic representation of the sample taken from the back fastening plate in cross-section (dark field) using the MiCorr application. The characteristics of the strata are only accessible by clicking on the drawing that redirects you to the search tool by stratigraphy representation. This representation can be compared to Fig. 8, Credit HE-Arc CR.

This aluminium alloy has a composition similar to a primary aluminium with an Al content between 99 and 99.8 mass%. The main impurities are Si and Fe. Because of their insolubility in the aluminium they form intermetallic (alpha-AlFeSi) inclusions. The metal was hot rolled and annealed. It is covered by a very thin corrosion layer (probably aluminium oxide) and in some areas adherent materials are present, most likely the remains of a Zn- and Ti-rich paint system mixed with environmental pollutants.
