AIRCRAFT REAR FASTENING PLATE VHS-497 - AL ALLOY - MODERN TIMES

Artefact name	Aircraft rear fastening plate VHS-497
Authors	Marianne. Senn (Empa, Dübendorf, Zurich, Switzerland) & Christian. Degrigny (HE-Arc CR, Neuchâtel, Neuchâtel, Switzerland)
Url	/artefacts/1235/

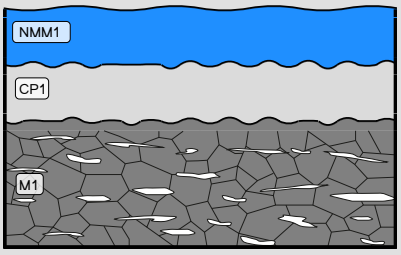
Fig. 11: Stratigraphic representation of the sample taken from the back fastening plate in cross-section (dark field) using the MiCorr application. The characteristics of the strata are only accessible by clicking on the drawing that redirects you to the search tool by stratigraphy representation. This representation can be compared to Fig. 8, Credit HE-Arc CR.

This aluminium alloy has a composition similar to a primary aluminium with an Al content between 99 and 99.8 mass%. The main impurities are Si and Fe. Because of their insolubility in the aluminium they form intermetallic (alpha-AlFeSi) inclusions. The metal was hot rolled and annealed. It is covered by a very thin corrosion layer (probably aluminium oxide) and in some areas adherent materials are present, most likely the remains of a Zn- and Ti-rich paint system mixed with environmental pollutants.
