CORRODED METAL SHEET FN 655.13.01 - FE ALLOY - MODERN TIMES - SWITZERLAND

Artefact name	Corroded metal sheet FN 655.13.01
Authors	Marianne. Senn (Empa, Dübendorf, Zurich, Switzerland) & Christian. Degrigny (HE-Arc CR, Neuchâtel, Neuchâtel, Switzerland)
Url	/artefacts/1237/

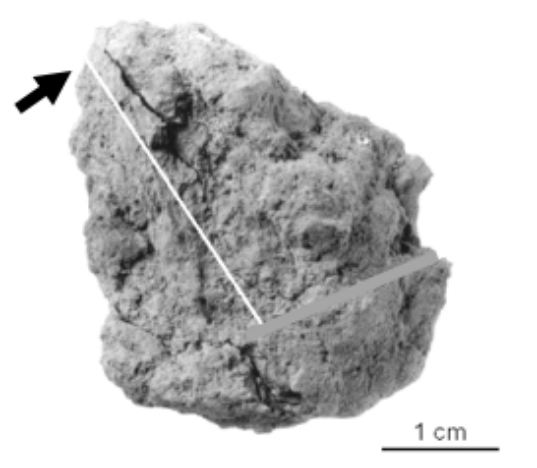
Fig. 2: Location of sampling area,

Description of sample	A longitudinal cut has been made through the sheet (Fig. 2). Large parts of the corrosion crust fell off during sampling (Fig. 3).
Alloy	Fe Alloy
Technology	Forged with final cold work
Lab number of sample	NEF 655
Sample location	HE-Arc CR, Neuchâtel, Neuchâtel
Responsible institution	Kantonsarchäologie, Dübendorf, Zurich
Date and aim of sampling	2000, metallography

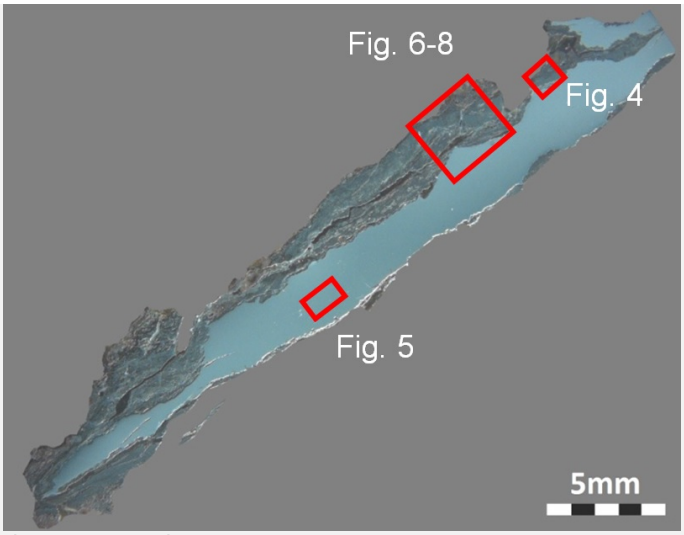
Fig. 3: Micrograph of the cross-section of the metal sheet showing the location of Figs. 4 to 8,

The corrosion is massive and large parts of the outer corrosion layers have been lost during the sample preparation. The heavily cracked corrosion crust represents about one third of the thickness of the sample (Fig. 3) and is located on one side of the metal (the rest having been lost during the cutting process). It does not show well defined layers. Despite this, three areas can be distinguished (Figs. 6 and 7). Adhering to the metal (area 1), we find an orange-red-brown layer enriched in Cl (CP3 in Fig. 9, Fig. 8 and Table 3). The dark or violet middle area 2 is richer in Fe (CP2 in Fig. 9). The outer area 3 is red-brown (CP1 in Fig. 9) and strongly contaminated by soil material (rock fragment inclusion and elements like Si, Al, P etc.). This layer is enriched in O (Fig. 9).

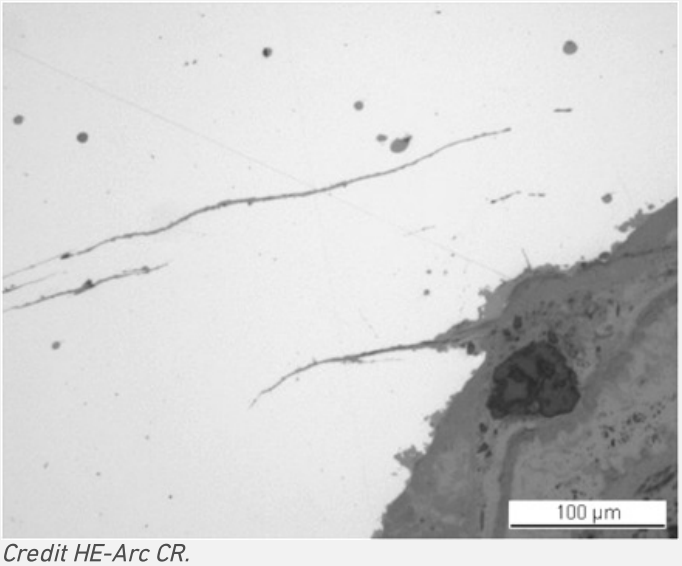
The remaining metal is an iron containing elevated (more than 1g/kg) concentrations of Co and Ni (Table 1), small round slag inclusions and cracks resulting from corrosion and deformation (Fig. 4). The composition of the round, elongated slag inclusions is similar to wüstite-FeO (Table 2). Iron reduced in the direct smelting process never contains such pure compounds and only FeO inclusions. In modern steels FeO occurs in low carbon alloys and Armco-iron (Schumann 1991, 474). After etching, the cross-section shows a heavily deformed ferritic microstructure from cold working (Fig. 6). The cracks have the same orientation as the deformation. The average hardness of the metal is HV1 195.

Fig. 4: Micrograph of metal sample from Fig. 3 (inverted picture, detail), unetched, bright field. In white the metal with round slag inclusions as well as cracks filled with corrosion products,

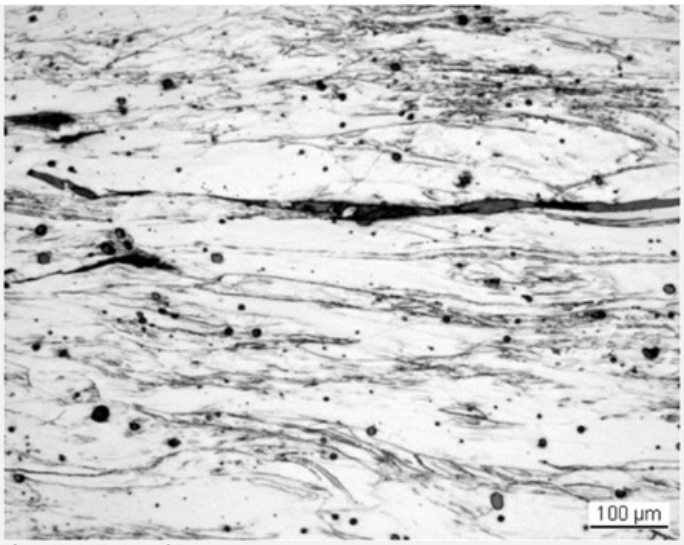
Fig. 5: Micrograph of metal sample from Fig. 3 (detail), etched, bright field. The heavily cold worked metal shows elongated grains with nearly invisible grain boundaries and cracks parallel to the grains,

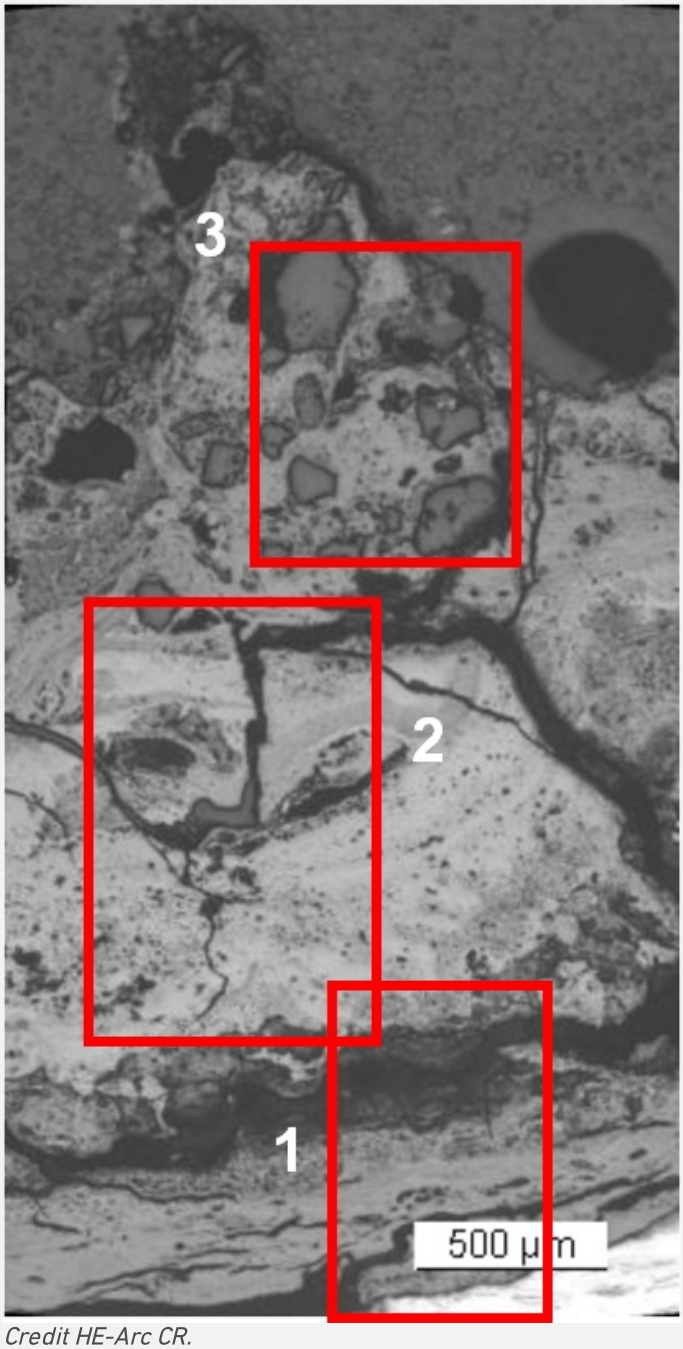
Fig. 6: Micrograph of the corrosion layer from Fig. 3 showing the metal - corrosion crust interface (detail, rotated by 45°) and corresponding to the stratigraphy of Fig. 9, unetched, bright field. The areas 1 (for CP3), 2 (for CP2) and 3 (for CP3) selected for elemental chemical distribution (Fig. 8) are marked by red rectangles,

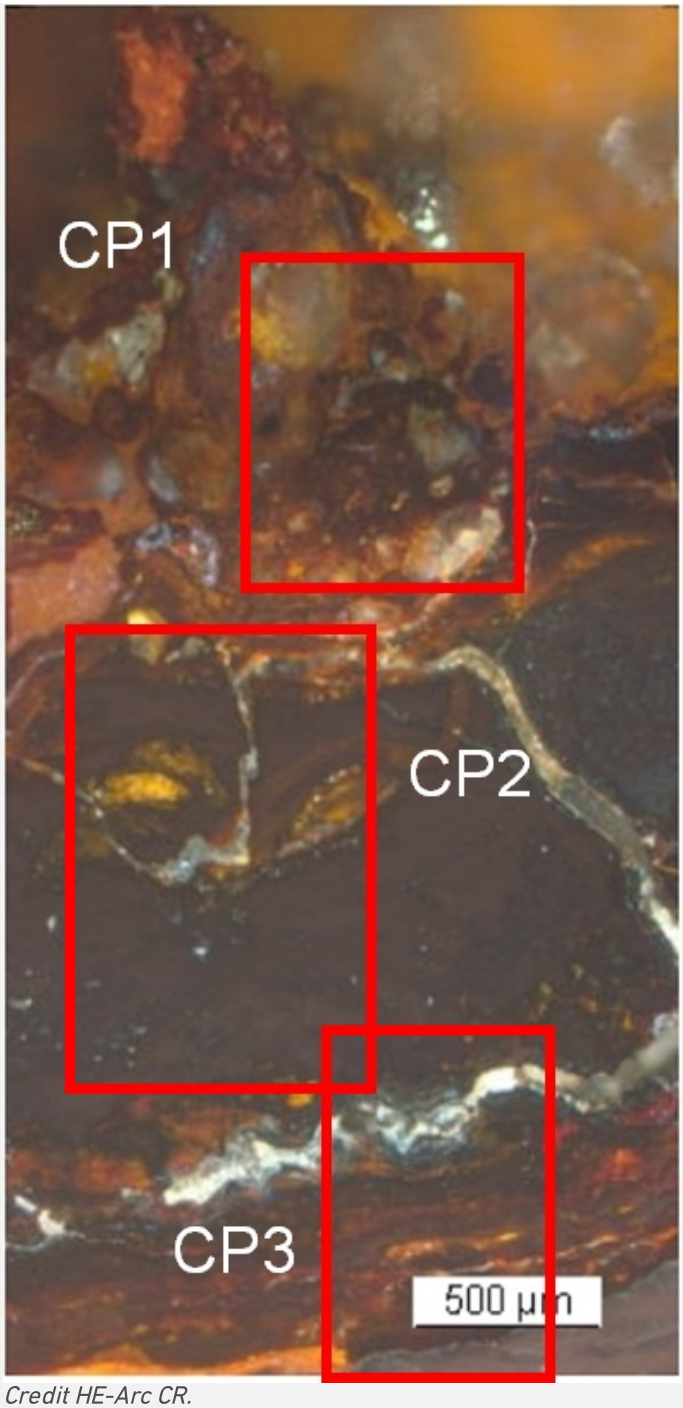
Fig. 7: Micrograph (same as Fig.6) and corresponding to the stratigraphy of Fig. 9, polarised light. The inner layer (CP3) is red-brown, area 2 is brown-violet (CP2) and the outer brown area contains rock fragment inclusions (CP1),

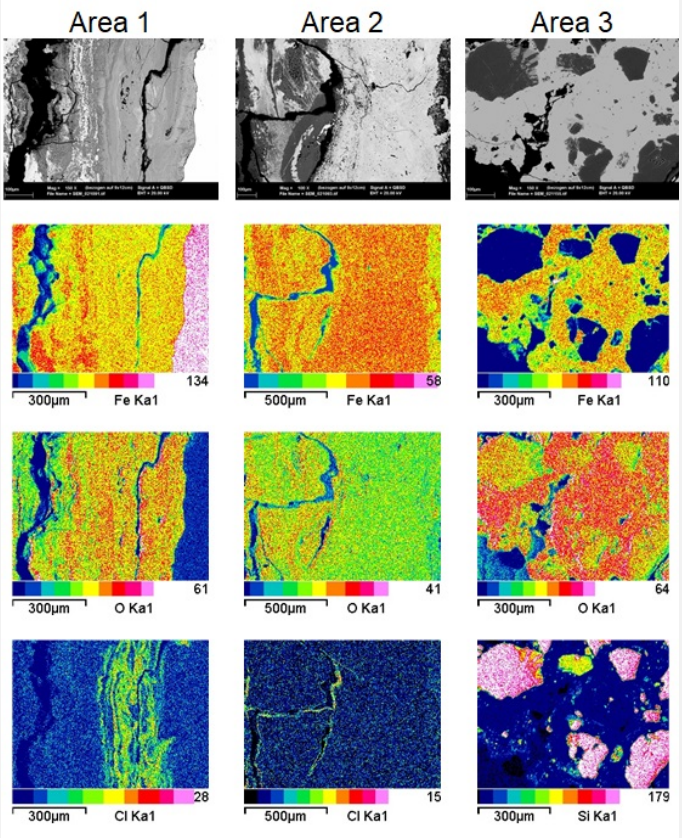
Fig. 8: SEM images, BSE-mode, and elemental chemical distribution of the selected areas from Figs. 6 and 7 (reversed picture rotated by 270°, details). First column: mapping on area 1 (CP3) where an inner layer enriched in Cl appears near the metal surface. 2nd column: area 2 (CP2) where iron oxides prevail. 3rd column: area 3 (CP1) where the outer O-rich layer includes rock fragments rich in Si. Method of examination: SEM/EDS, Lab. Anal. Chem. Empa,

This iron-based sheet is entirely cold worked and hard compared to an annealed metal. The corrosion is massive and masks the shape of the object. The presence of Cl adjacent to the metal surface indicates that the corrosion front is potentially active. The very thick top corrosion layers may have slowed down the corrosion. The object was mentioned as being Roman in Senn Bischofberger 2005, however the chemical composition of the slag inclusions shows that it is a product of the 20th century AD which has been accidentally introduced into a Roman layer.

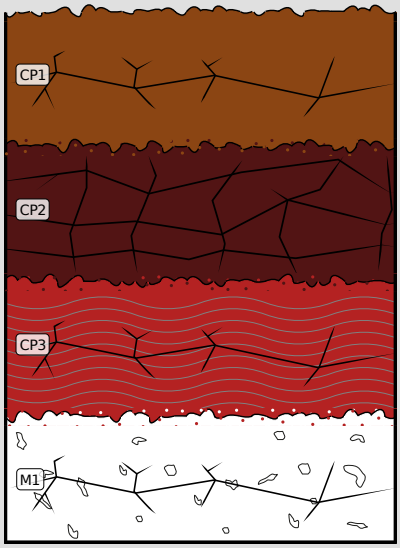
Fig. 9: Stratigraphic representation of the iron-based sheet in cross-section (dark field) using the MiCorr application. The characteristics of the strata are only accessible by clicking on the drawing that redirects you to the search tool by stratigraphy representation. This representation can be compared to Figs. 7, Credit HE-Arc CR.
