CORRODED METAL SHEET FN 655.13.01 – FE ALLOY – MODERN TIMES – SWITZERLAND

Artefact name	Corroded metal sheet FN 655.13.01
Authors	Marianne. Senn (Empa, Dübendorf, Zurich, Switzerland) & Christian. Degrigny (HE-Arc CR, Neuchâtel, Neuchâtel, Switzerland)
Url	/artefacts/1237/

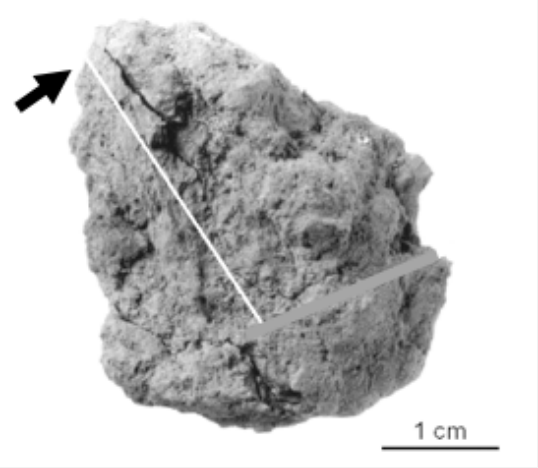
Fig. 2: Location of sampling area,

Description of sample	A longitudinal cut has been made through the sheet (Fig. 2). Large parts of the corrosion crust fell off during sampling (Fig. 3).
Alloy	Fe Alloy
Technology	Forged with final cold work
Lab number of sample	NEF 655
Sample location	HE-Arc CR, Neuchâtel, Neuchâtel
Responsible institution	Kantonsarchäologie, Dübendorf, Zurich
Date and aim of sampling	2000, metallography

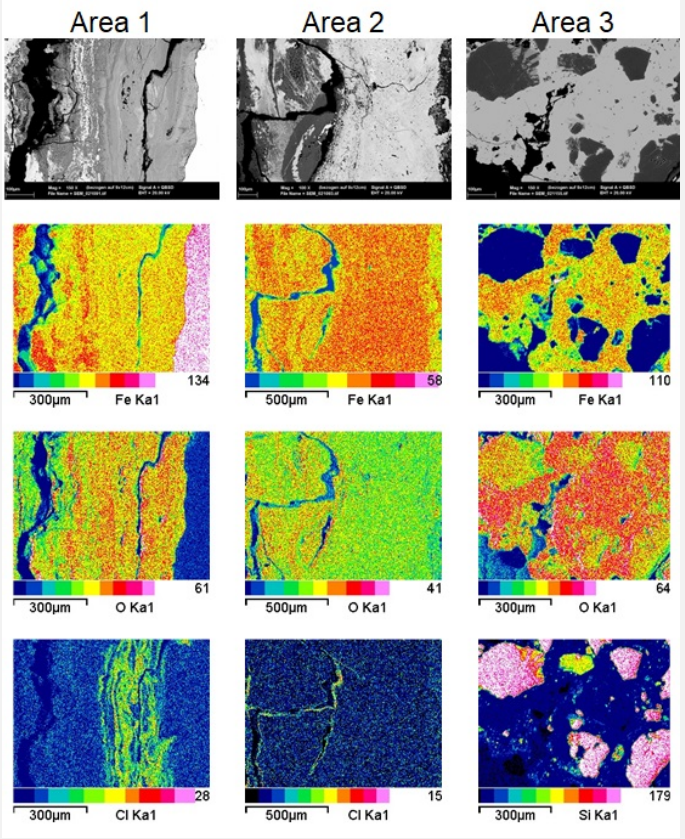
Fig. 8: SEM images, BSE-mode, and elemental chemical distribution of the selected areas from Figs. 6 and 7 (reversed picture rotated by 270°, details). First column: mapping on area 1 (CP3) where an inner layer enriched in Cl appears near the metal surface. 2nd column: area 2 (CP2) where iron oxides prevail. 3rd column: area 3 (CP1) where the outer O-rich layer includes rock fragments rich in Si. Method of examination: SEM/EDS, Lab. Anal. Chem. Empa,

This iron-based sheet is entirely cold worked and hard compared to an annealed metal. The corrosion is massive and masks the shape of the object. The presence of Cl adjacent to the metal surface indicates that the corrosion front is potentially active. The very thick top corrosion layers may have slowed down the corrosion. The object was mentioned as being Roman in Senn Bischofberger 2005, however the chemical composition of the slag inclusions shows that it is a product of the 20th century AD which has been accidentally introduced into a Roman layer.
