CORRODED METAL SHEET FN 655.13.01 - FE ALLOY - MODERN TIMES - SWITZERLAND

Artefact name Corroded metal sheet FN 655.13.01

Authors Marianne. Senn (Empa, Dübendorf, Zurich, Switzerland) & Christian. Degrigny (HE-Arc CR, Neuchâtel, Neuchâtel, Switzerland)

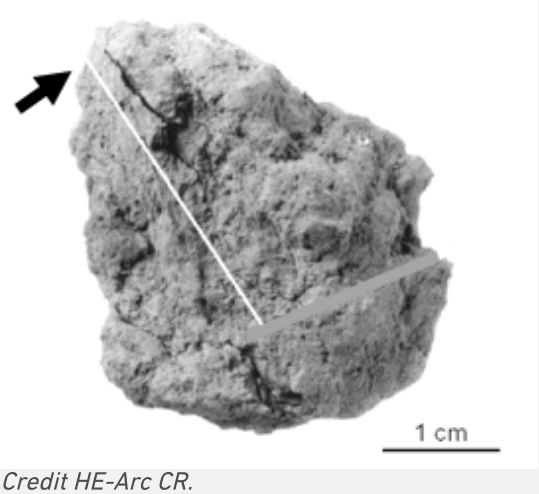
Fig. 1: Metal sheet (after Senn Bischofberger 2005, 137),

Description of the artefact Metal (iron-based) sheet with middle rib. The shape is no longer discernible (Fig. 1). The metal is covered by a thick corrosion crust. Dimensions: L = 4.5cm; WT = 35g.

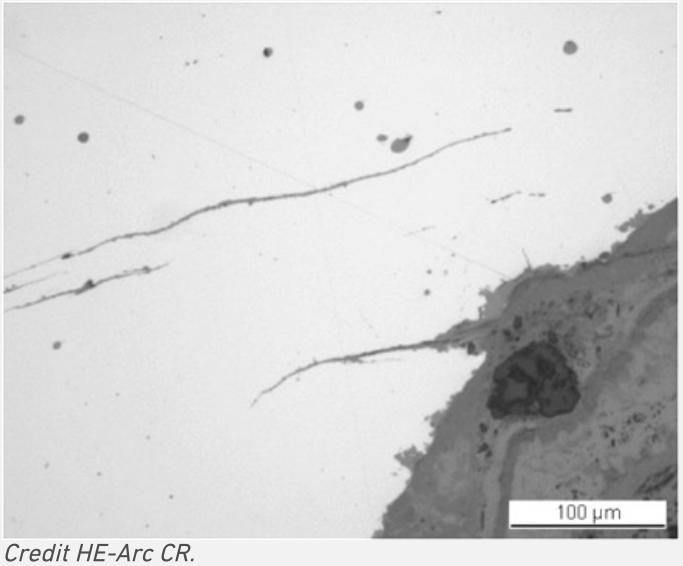
The remaining metal is an iron containing elevated (more than 1g/kg) concentrations of Co and Ni (Table 1), small round slag inclusions and cracks resulting from corrosion and deformation (Fig. 4). The composition of the round, elongated slag inclusions is similar to wüstite-FeO (Table 2). Iron reduced in the direct smelting process never contains such pure compounds and only FeO inclusions. In modern steels FeO occurs in low carbon alloys and Armco-iron (Schumann 1991, 474). After etching, the cross-section shows a heavily deformed ferritic microstructure from cold working (Fig. 6). The cracks have the same orientation as the deformation. The average hardness of the metal is HV1 195.

Fig. 4: Micrograph of metal sample from Fig. 3 (inverted picture, detail), unetched, bright field. In white the metal with round slag inclusions as well as cracks filled with corrosion products,

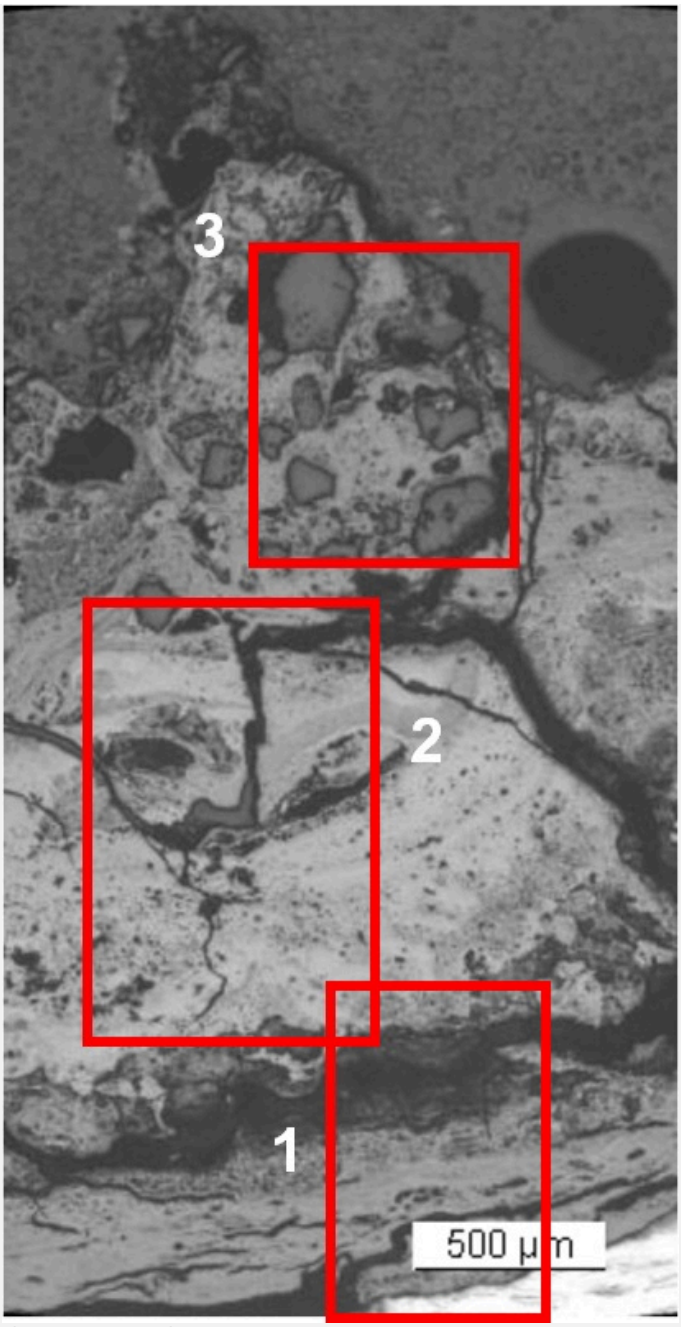
Fig. 6: Micrograph of the corrosion layer from Fig. 3 showing the metal - corrosion crust interface (detail, rotated by 45°) and corresponding to the stratigraphy of Fig. 9, unetched, bright field. The areas 1 (for CP3), 2 (for CP2) and 3 (for CP3) selected for elemental chemical distribution (Fig. 8) are marked by red rectangles,

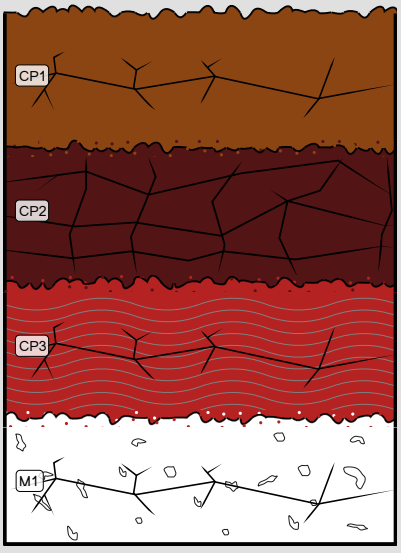
Fig. 9: Stratigraphic representation of the iron-based sheet in cross-section (dark field) using the MiCorr application. The characteristics of the strata are only accessible by clicking on the drawing that redirects you to the search tool by stratigraphy representation. This representation can be compared to Figs. 7, Credit HE-Arc CR.
