CHISEL POINT DEV 995 1069 PR – EUTECTOID TO HYPEREUTECTOID STEEL – EARLY MEDIEVAL TIMES – SWITZERLAND

Artefact name	Chisel point DEV 995 1069 PR
Authors	Marianne. Senn (Empa, Dübendorf, Zurich, Switzerland) & Christian. Degrigny (HE-Arc CR, Neuchâtel, Neuchâtel, Switzerland)
Url	/artefacts/1238/

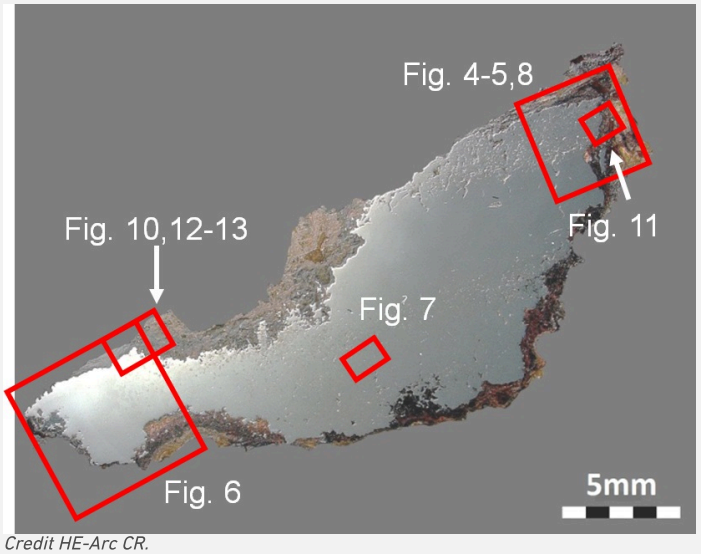
Fig. 1: Chisel point (after Eschenlohr et al. 2007, 275, 314-315),

Description of the artefact	The rectangular section of a massive moil chisel fragment with an incomplete tip and missing shaft (Fig. 1). Dimensions: L = 3.7cm; WT = 16g.
Type of artefact	Tool
Origin	Settlement Develier, Courtételle, Jura, Switzerland
Recovering date	Excavated in 1995, farm 2 and workshop area 1
Chronology category	Early medieval times
chronology tpq	550 A.D.
chronology taq	650 A.D.
Chronology comment	
Burial conditions / environment	Soil
Artefact location	Office de la Culture, Porrentruy, Jura
Owner	Office de la Culture, Porrentruy, Jura
Inv. number	DEV 995/1069 PR
Recorded conservation data	Conserved between 1995 and 2000: desiccation at 80°C, mechanical cleaning, passivation with tannic acid and surface protection with Paraloid B72® (Eschenlohr et al. 2007, 75).

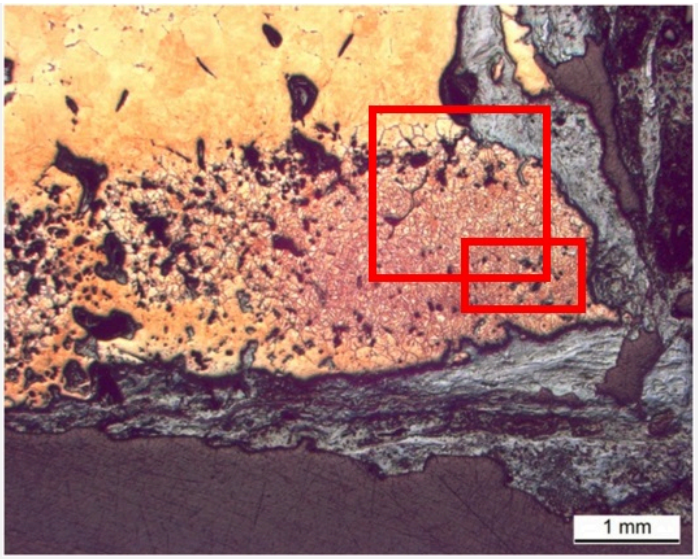
Fig. 3: Micrograph of the cross-section of the chisel point showing the location of Figs. 4 to 8 and 10 to 13,

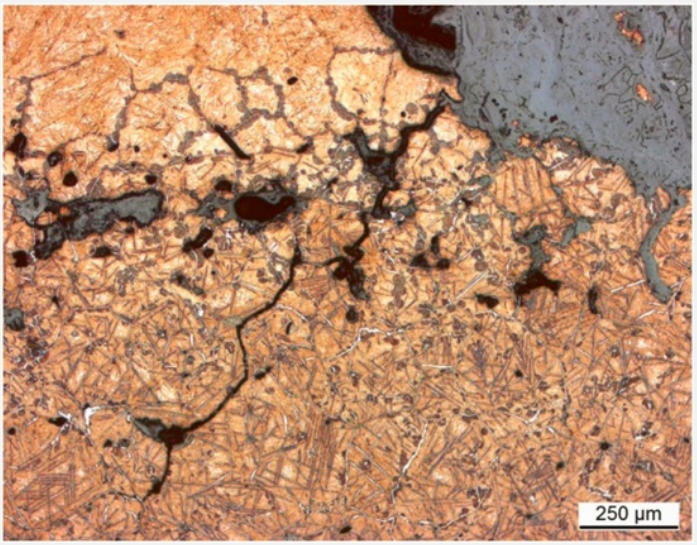
The remaining metal is a eutectoid to hypereutectoid steel (C 0.8-1 mass%) with cracks and porosity (Figs. 4 and 5). Its composition is given in Table 1 (except Fe). Of the trace elements, only Ni reaches a medium concentration (Ni 0.07 mass%). The composition and the high Ni/Co ratio are atypical for iron worked in smithies of the settlement at Develier-Courtételle JU, CH. The few slag inclusions and their chemical composition confirm this (Table 2). The slag is rich in CaO whereas the pisolithic or bean ore worked in the Central Jura smelting district is rich in Al_2O_3. The slag inclusions cannot be smithing slag because the artefact is formed from one piece of metal. The slag probably incorporated while refining the bloom or during the bloom smelting process. The ore from which this metal was smelted cannot yet be identified. Intergranular corrosion has developed, penetrating into the metal structure (Fig. 5). The etched metal shows a dominant martensitic structure, typical of quench hardened steel (Figs. 4, 6, 7 and 8). The characteristic forms of the martensite are non-organised needles (Fig. 7). In restricted areas bainite nodules occur (Figs. 6 and 7). In the centre of the point, hypereutectoid steel is composed of cementite in the grain boundaries and in needle like shapes within the grains (Fig. 9). Hypereutectoid regions also occur in the centre of the shaft and on its left surface (Fig. 4). Here the hypereutectoid steel is composed of martensite and cementite in the grain boundaries and in needle form within the grains (Figs. 5 and 8). Nevertheless, most of the chisel is dominated by eutectoid steel. The average hardness of the quench hardened eutectoid steel is about HV1 690. In the bainite nodules the average hardness drops to about HV1 350, the martensite has an average hardness of HV1 750.

Fig. 4: Micrograph of the metal sample from Fig. 3 (inverted picture, detail), etched, bright field. The metal contains porosity and cracks (in black). The micrographs of Figs. 5 and 8 are marked by the top and bottom rectangles respectively,

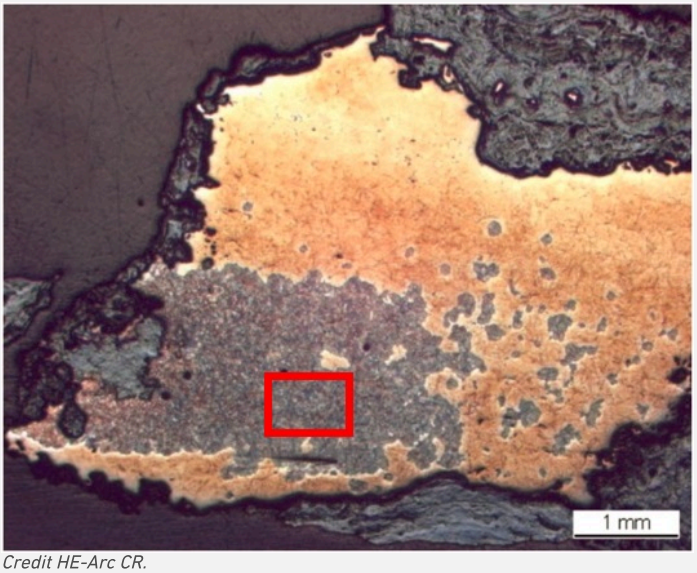
Fig. 5: Micrograph of the metal sample, detail from Fig. 4, etched, bright field. We observe martensite (in orange), cementite (in grey), porosity and intergranular cracks (in black) and corrosion,

The tool is made of hard, eutectoid to hypereutectoid steel and was, as a last manufacturing step, entirely quenched. In this state it is too hard and brittle to be used. It is likely that the quenched hypereutectoid structure provoked the breakage of the tool when it was first used. The absence of a tempering process at the end is unclear. The chemical composition of the metal and the slag inclusions indicate that the artefact was imported to the hamlet of Develier-Courtételle JU. The corrosion has, in areas, replaced the metal structure retaining a ghost structure; the outer layer has been mostly removed during surface cleaning. Extensive pitting corrosion has occurred, typical for steel with an elevated C content. The presence of S in the inner layer can be explained by putrefaction processes in the soil. Chlorides are still present at the metal-corrosion interface as no desalination process was attempted. Iron carbonates are present in the centre of a corrosion pit. The corrosion is of terrestrial type.

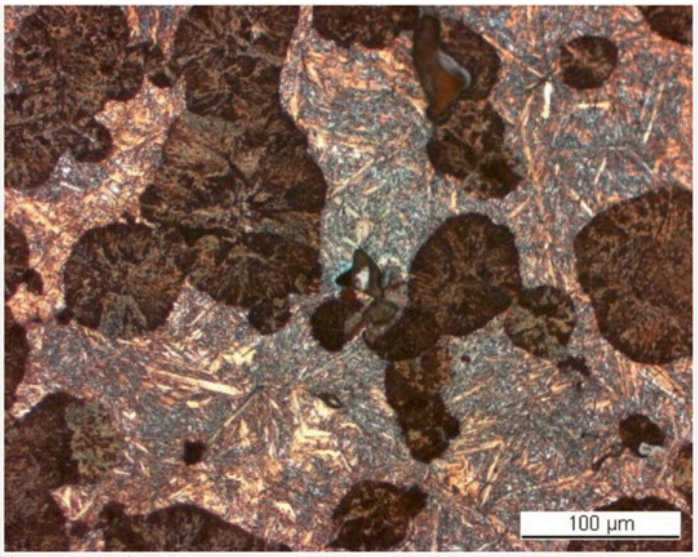
Fig. 6: Micrograph of the metal sample from Fig. 3 (inverted picture, detail), etched, bright field. We observe the metal with martensite (orange) and bainite nodules (blue). The micrograph of Fig. 9 is marked by a rectangle,

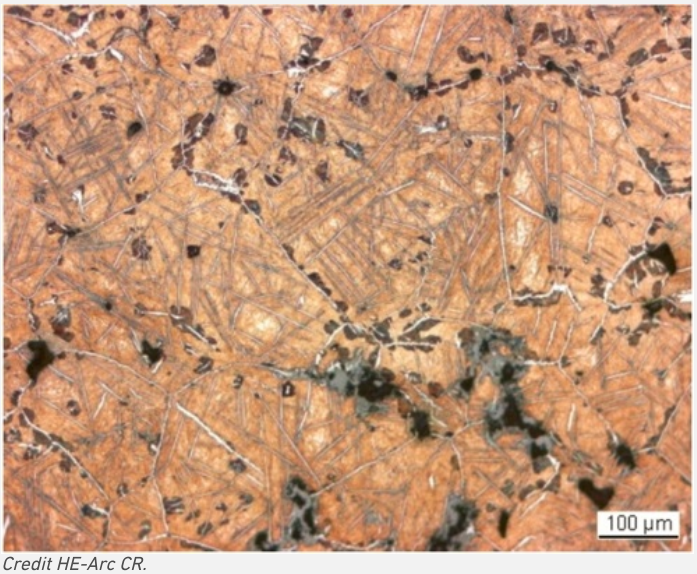
Fig. 7: Micrograph of the metal sample from Fig. 3 (detail), etched, bright field. We observe dark bainite nodules combined with martensite needles,

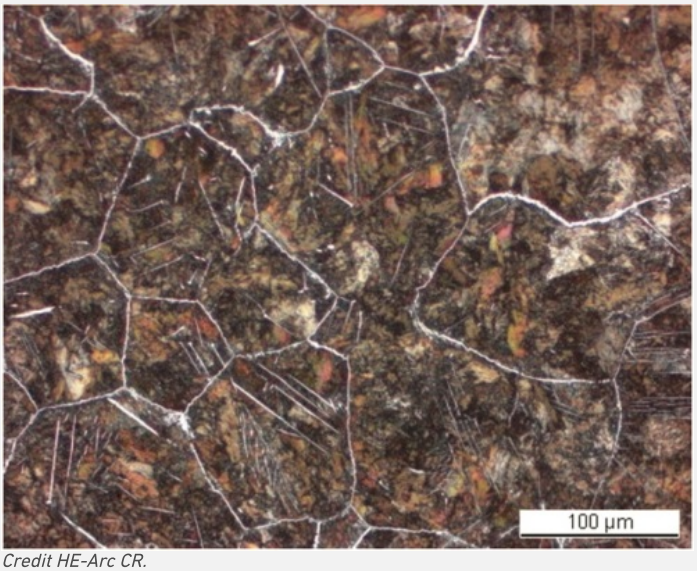
Fig. 8: Micrograph of the metal sample, detail from Fig. 4, etched, bright field. Hypereutectoid steel with a structure of cementite in white in the grain boundaries and in needle form combined with martensite (pink). Some bainite occurs around the grain boundaries,

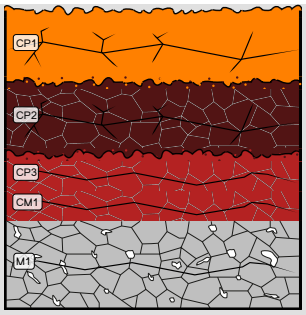
Fig. 14: Stratigraphic representation of the chisel point in cross-section (dark field) using the MiCorr application. The characteristics of the strata are only accessible by clicking on the drawing that redirects you to the search tool by stratigraphy representation. This representation can be compared to Fig. 10, Credit HE-Arc CR.
