SWORD M-SCH-B2735 - P-RICH IRON - IRON AGE - SWITZERLAND

Artefact name	Sword M-Sch-B2735
Authors	Marianne. Senn (Empa, Dübendorf, Zurich, Switzerland) & Christian. Degrigny (HE-Arc CR, Neuchâtel, Neuchâtel, Switzerland)
Url	/artefacts/1239/

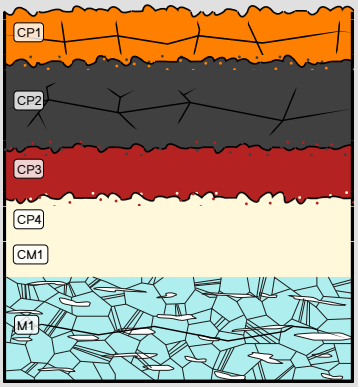
Fig. 10: Stratigraphic representation of the sample taken from the sword in cross-section (dark field) using the MiCorr application. The characteristics of the strata are only accessible by clicking on the drawing that redirects you to the search tool by stratigraphy representation. This representation can be compared to Fig. 8, Credit HE-Arc CR.
