WEDGE PART OF AN ALTAR CROWN SUSPENSION – P-RICH IRON AND HYPOEUTECTOID STEEL – MODERN TIMES – SWITZERLAND

Artefact name	Wedge part of an altar crown suspension
Authors	Marianne. Senn (Empa, Dübendorf, Zurich, Switzerland) & Christian. Degrigny (HE-Arc CR, Neuchâtel, Neuchâtel, Switzerland)
Url	/artefacts/1240/

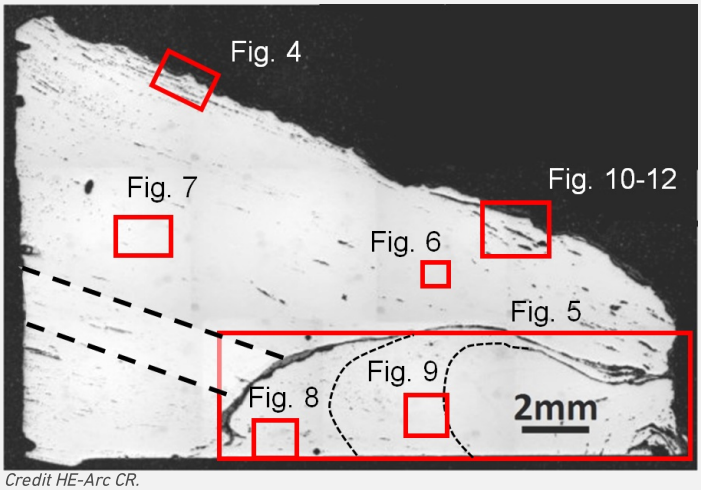
Fig. 3: Micrograph of the cross-section of the sample taken from the wedge part showing the location of Figs. 4 to 12. Steel areas are delimited by black dotted lines,

Description of sample	This sample is a section from the end of the wedge part (Fig. 2). The corrosion crust appears on the top side on Fig. 3.
Alloy	P-rich iron and hypoeutectoid steel
Technology	Annealed after (hot) rolling
Lab number of sample	RHE1-NR
Sample location	Haute École Arc Neuchâtel, Neuchâtel
Responsible institution	IWT (Naila Hadzic), Wallisellen, Zurich
Date and aim of sampling	January 2008, material testing and security report

The remaining metal (M1) is a P-rich iron (0.3-0.45 mass%) with two zones (M3) consisting of soft, hypoeutectoid steel (C content 0.2 mass%) (Fig. 3 and Table 1). The P-rich iron contains many elongated slag inclusions of various sizes forming parallel rows (Figs. 3 and 4). The number of slag inclusions is higher than in bloomery iron and their distribution is typical for rolled metal. A crack, partially filled by hammer scale and corrosion products, indicates a poor quality welding seam (Fig. 3). Below the inclusions the curve produced by forging is highlighted. In good quality wrought iron slag inclusions are small, uniformly distributed and have identical compositions (Boesenberg 2006, 622). This is not the case in this sample, but can be explained by the rudimentary rolling process of the 18th century. The chemical composition of the slag inclusions shows that iron oxides dominate, beside phosphorus oxide, calcium oxide and silica (Table 2). The composition is typical for slag formed by hearth refining of pig iron (Dillmann and L'Héritier 2007). During this process, the pig iron is oxidised. The oxidising elements are Si, P, Mn, V and Cr. The analyzed slag inclusions contain more Fe than most published ones. The high P content is similar to published examples from the 18th century (Dillmann and L'Héritier 2007, 1820). The high calcium oxide content, which is often combined with high silica content, could originate from the addition of both materials while refining the pig iron to better eliminate the P. In one of our measurements, only the silica concentration is high (Table 2). This can be interpreted as resulting from the addition of sand during forging. Etching with Oberhoffer's reagent outlines the thick welding seam (M2, Fig. 5), the rolling direction and the P segregation. Etching with nital mainly shows a ferritic structure (Fig. 6). The grains vary in size (between ASTM grain sizes of 4 to 8) and are recrystallized. The ferrite shows local ghost structures, and includes Neumann bands and some needles (Figs. 7 and 8). These are typical structures of P-rich iron. The ghost structure is formed by a fast recrystallization of P-rich iron after heating above 1000°C. The Neumann bands indicate cold working. The hypoeutectoid steel consists of ferrite with lamellar pearlite (Fig. 9). The average hardness of the metal is HV1 185 (in the Empa test report a mean of HV10 175 was determined). The areas close to the welding seam are harder (ca. HV1 210). The calculated tensile strength based on HV1 175 is about 544N/mm^2.

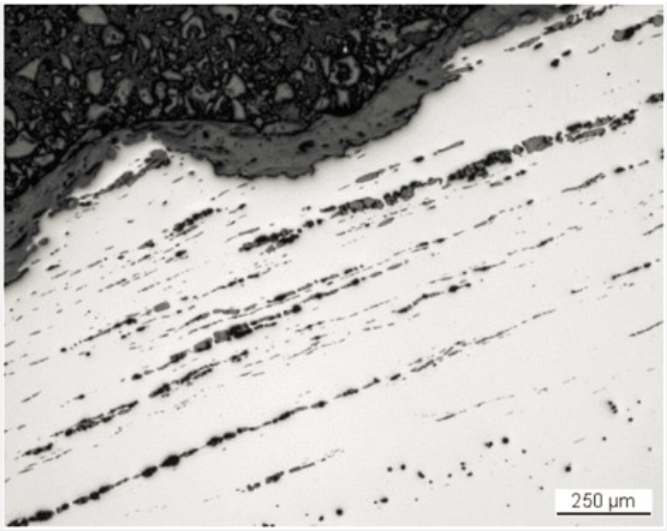
Fig. 4: Micrograph of the metal sample from Fig. 3 (reversed picture, detail), unetched, bright field. In white the metal, in grey the corrosion layer. There are numerous slag inclusions in the metal all orientated to form rows. Some inclusions are empty, probably due to sample preparation,

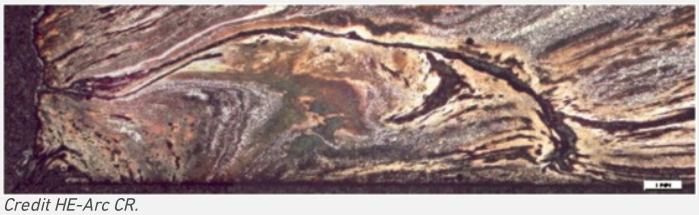
Fig. 5: Micrograph of the metal sample from Fig. 3 (reversed picture, detail), etched with Oberhoffer's reagent, bright field. The etching shows the P segregation near the welding line and outlines the irregular P distribution in the metal (white P-rich areas, dark P-poor areas),

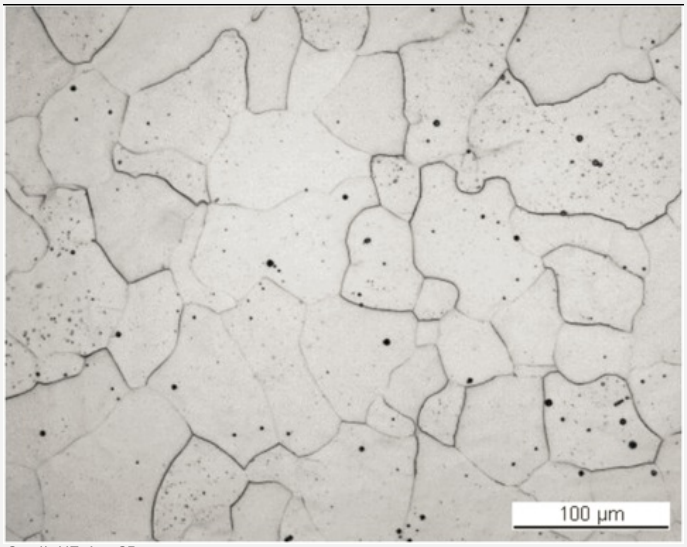
Fig. 6: Micrograph of the metal sample from Fig. 3 (detail), nital etched, bright field. The metal presents a ferritic structure,

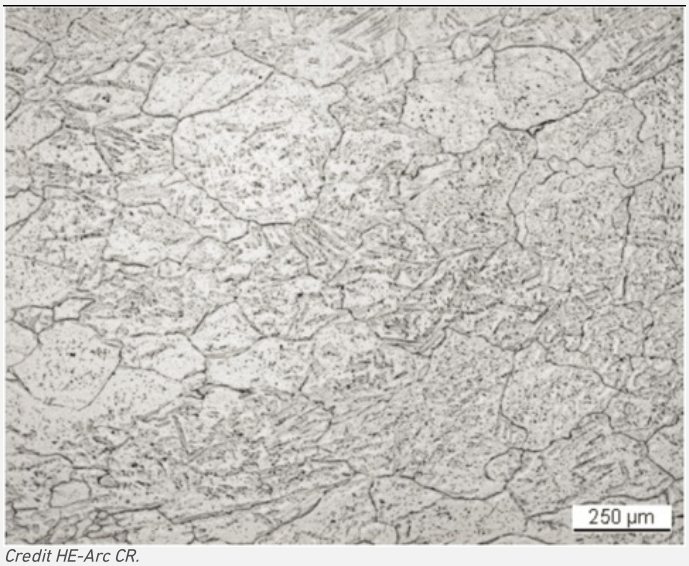
Fig. 7: Micrograph of the metal sample from Fig. 3 (detail), nital etched, bright field. The ferrite shows a ghost structure with needles,

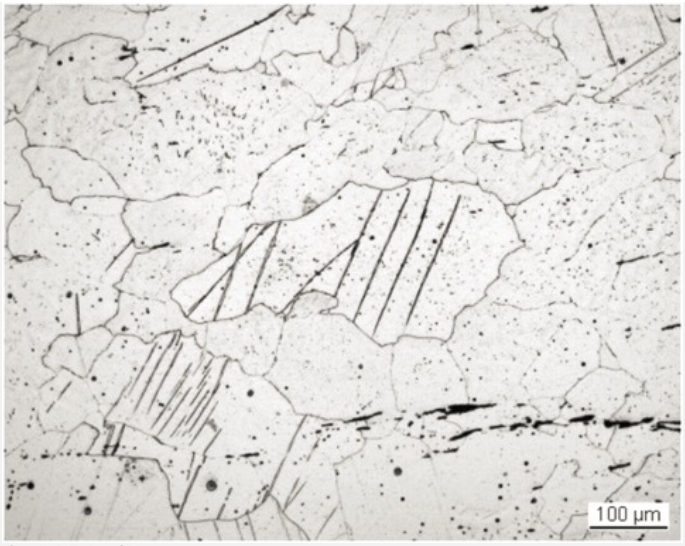
Fig. 8: Micrograph of the metal sample from Fig. 3 (detail), nital etched, bright field. The ferrite grains include Neumann bands,

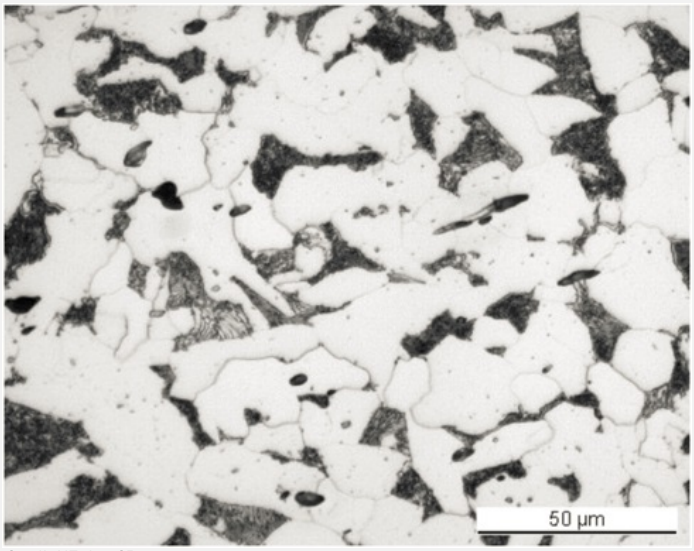
Fig. 9: Micrograph of the metal sample from Fig. 3 (detail), nital etched, bright field. The hypoeutectoid steel is constituted of ferrite in white and lamellar pearlite (in black),

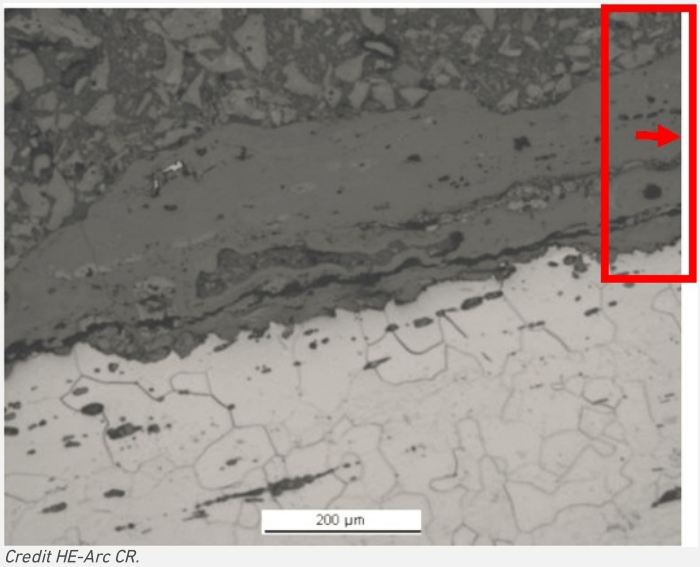
The corrosion crust is thin and irregular. It is restricted to one of the three surfaces. In bright field, the corrosion layer seems homogeneous and appears medium-grey with a fissure parallel to the metal surface (Fig. 10). Under polarised light the corrosion products near the metal surface are mostly red-orange (CP3), whereas in the outer layer they appear orange-brown (CP1) (Fig. 11). A dark-brown zone is visible between them (CP2) and contains bright inclusions with a chemical composition similar to wüstite (Table 3). This corresponds to corroded slag inclusions (internal markers). Chemical analysis (Table 3) and elemental mapping (Fig. 12) do not highlight a difference in composition of the corrosion layers, except for the corroded slag inclusions.

Fig. 10: Micrograph showing the metal - corrosion layer interface from Fig. 3 (reversed picture, detail), unetched, bright field. The grey corrosion layer contains bright inclusion rows. The area selected for elemental chemical distribution (Fig. 12) is marked by the red rectangle which expends beyond the micrograph,

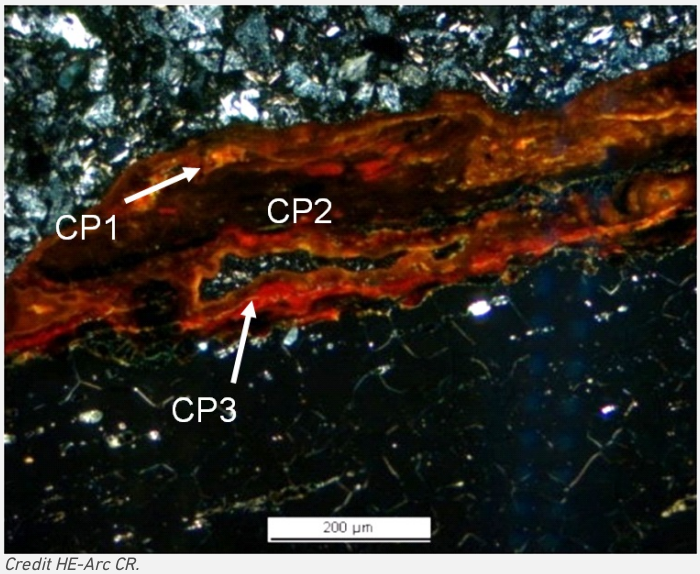
Fig. 11: Micrograph (same as Fig. 10) corresponding to the stratigraphy of Fig. 13, unetched, polarised light. We observe from bottom to top: a red-orange inner corrosion layer (CP3), followed by a dark-brown intermediate layer (CP2) and an orange-brown outer layer (CP1),

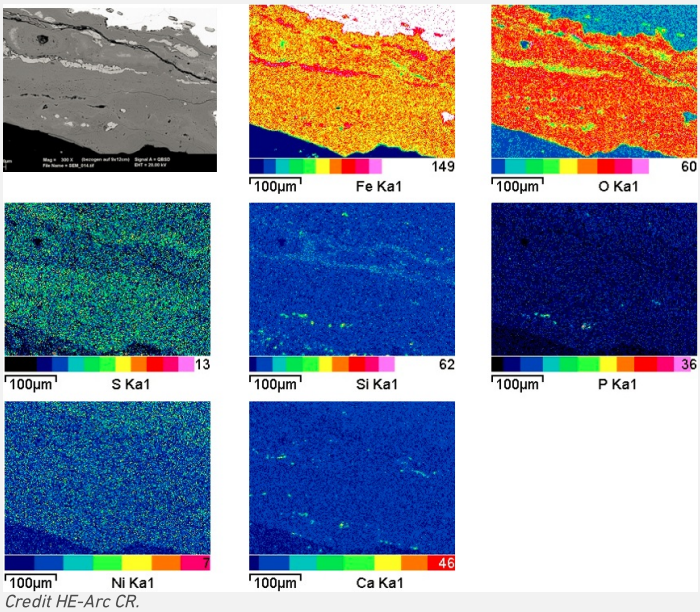
Table 3: Chemical composition (mass %, <: below the detection limit) of the corrosion crust (from Fig. 12). Method of analysis: SEM/EDS, Laboratory of Analytical Chemistry, Empa.

Fig. 12: SEM image, BSE-mode, and elemental chemical distribution of the selected area from Fig. 10 (inversed, detail). Method of examination: SEM/EDS, Laboratory of Analytical Chemistry, Empa,

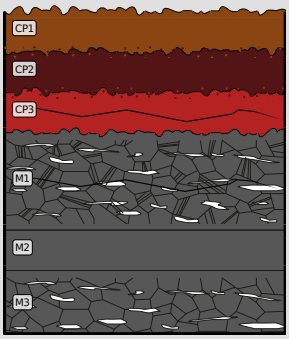
Fig. 13: Stratigraphic representation of the sample taken from the wedge part in cross-section (dark field) using the MiCorr application. The characteristics of the strata are only accessible by clicking on the drawing that redirects you to the search tool by stratigraphy representation. This representation can be compared to Fig. 11, Credit HE-Arc CR.
