WEDGE PART OF AN ALTAR CROWN SUSPENSION – P-RICH IRON AND HYPOEUTECTOID STEEL – MODERN TIMES – SWITZERLAND

Artefact name	Wedge part of an altar crown suspension
Authors	Marianne. Senn (Empa, Dübendorf, Zurich, Switzerland) & Christian. Degrigny (HE-Arc CR, Neuchâtel, Neuchâtel, Switzerland)
Url	/artefacts/1240/

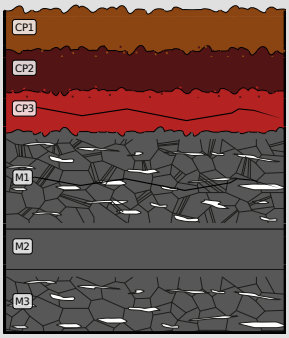
Fig. 13: Stratigraphic representation of the sample taken from the wedge part in cross-section (dark field) using the MiCorr application. The characteristics of the strata are only accessible by clicking on the drawing that redirects you to the search tool by stratigraphy representation. This representation can be compared to Fig. 11, Credit HE-Arc CR.
