MOIL CHISEL DEV 995 762 PR – STEEL – EARLY MEDIEVAL TIMES – SWITZERLAND

Artefact name Moil chisel DEV 995 762 PR

Authors Marianne. Senn (Empa, Dübendorf, Zurich, Switzerland) & Christian. Degrigny (HE-Arc CR, Neuchâtel, Neuchâtel, Switzerland)

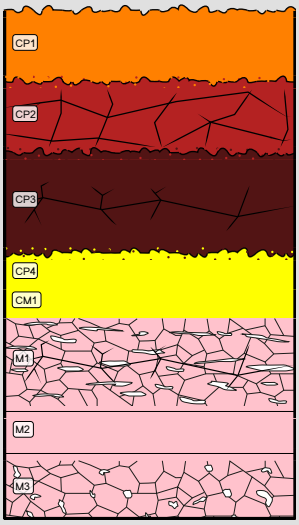
Fig. 14: Stratigraphic representation of sample 2 from the moil chisel in cross-section (dark field) using the MiCorr application. The characteristics of the strata are only accessible by clicking on the drawing that redirects you to the search tool by stratigraphy representation. This representation can be compared to Fig. 11, Credit HE-Arc CR.
