FITTING ON BACK PANEL OF A MILITARY CARRIAGE – THOMAS STEEL – MODERN TIMES – SWITZERLAND

Artefact name	Fitting on back panel of a military carriage
Authors	Marianne. Senn (Empa, Dübendorf, Zurich, Switzerland) & Christian. Degrigny (HE-Arc CR, Neuchâtel, Neuchâtel, Switzerland)
Url	/artefacts/1243/

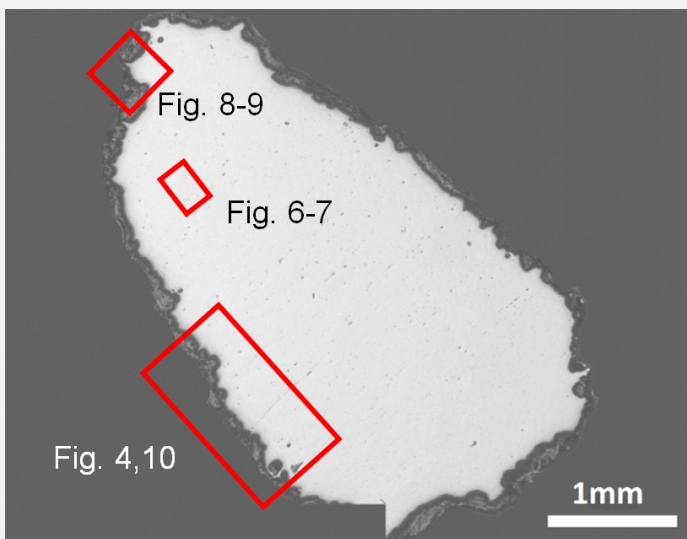
Fig. 3: Micrograph of the cross-section of the sample taken from the fitting showing the location of Figs. 4 and 6 to 10,

|	
Description of sample	This sample is a cut from the corner of one of the two fittings on the back panel (Fig. 2). The metal is covered by a thin corrosion layer (Fig. 3).
Alloy	Thomas steel
Technology	Piled from several strips, hot rolled and annealed

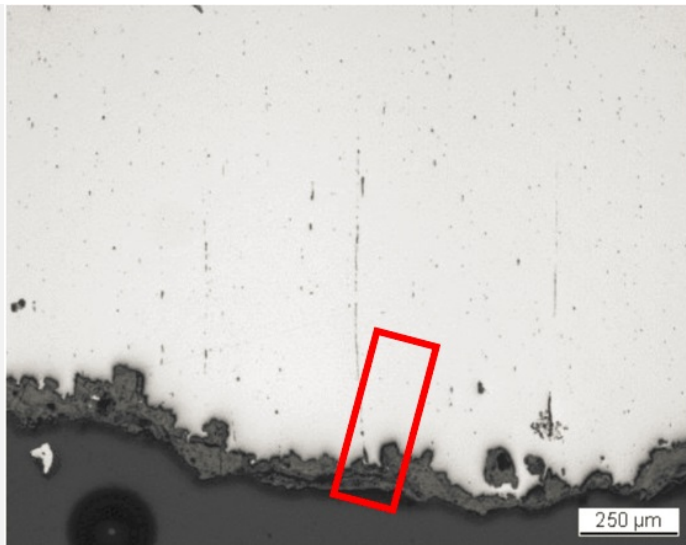
The remaining metal is a Mn-rich soft steel (C content around 0.1 mass%) containing manganese sulphide inclusions with a varying Fe content (Tables 1 and 2). The numerous inclusions form parallel rows (Fig. 4). This orientation is typical for hot rolled metal. After etching with Oberhoffer's reagent, three main welding seams (P-rich) become visible (Fig. 5). Near the surface they are also outlined by corrosion (Figs. 4 and 10). After nital etching, the metal shows a ferritic structure with tertiary cementite and lamellar pearlite at the grain boundaries (Figs. 6 and 7). The grains are small with an ASTM grain size of 10 and are recrystallized due to annealing after hot rolling. The average hardness of the metal is HV1 165. The hardness is slightly high for such a structure and this is due to the Mn content of the metal. The chemical composition, especially the Mn content and the presence of carbo-nitrides (not analysed here), is typical for Thomas steel.

Fig. 4: Micrograph of the metal sample from Fig. 3 (rotated by 270°, detail), unetched, bright field. We observe the metal including welding seams outlined by corrosion products and MnS inclusions. The area selected for elemental chemical distribution (Fig. 10) is marked by a red rectangle,

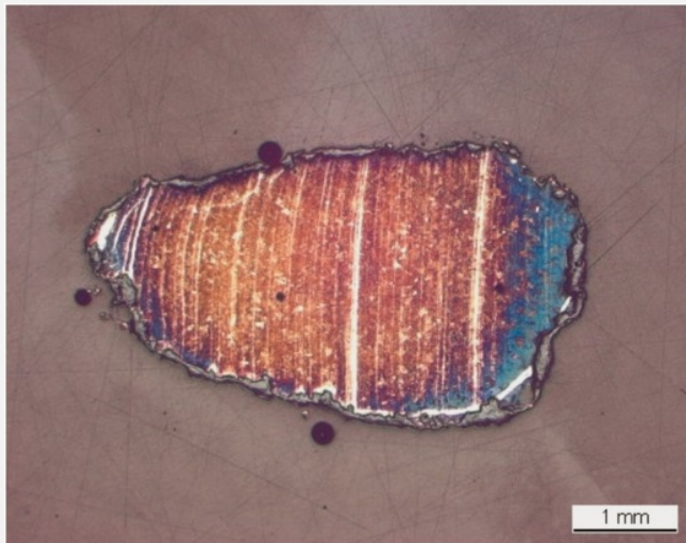
Fig. 5: Micrograph of the metal sample from Fig. 3, etched with Oberhoffer's reagent, bright field. We observe three P-rich welding seams in white,

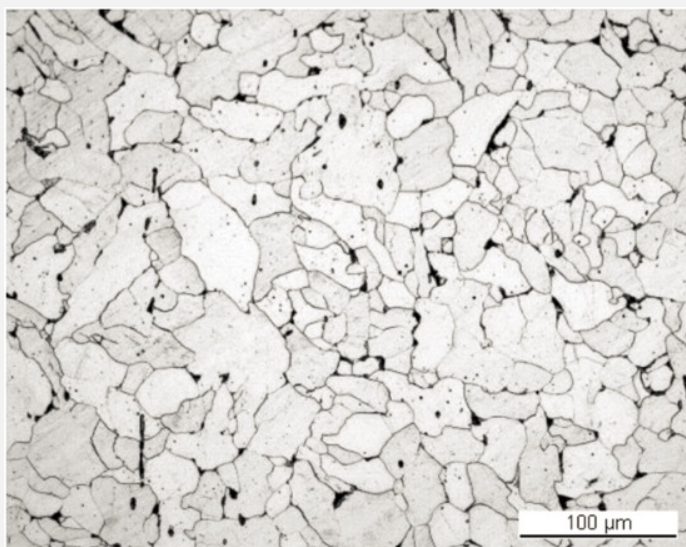
Fig. 6: Micrograph of the metal sample, nital etched, bright field. We observe tertiary cementite (black) on the grain boundaries,

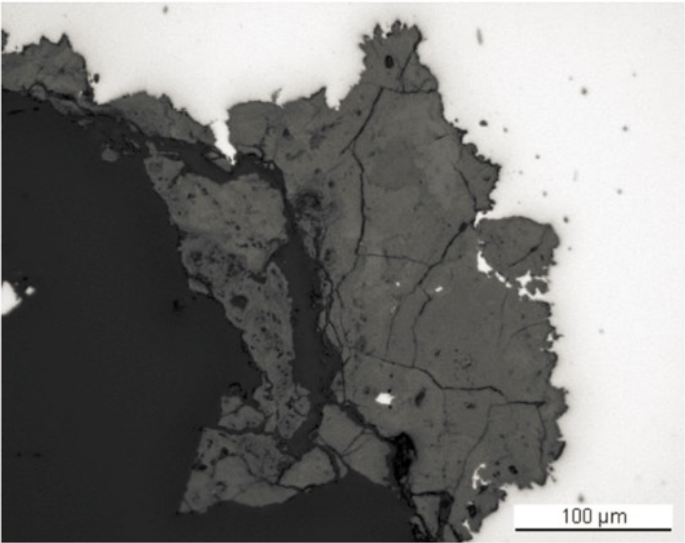
The average thickness of the corrosion products is about 80µm (Figs. 4 and 8). In bright field they appear grey, marbled and heavily cracked (Fig. 8). Under polarised light, the corrosion products appear orange to dark-brown (Fig. 9). At the metal - corrosion products interface they are dark-brown (CP3). The middle part (CP2) is dark-red and the outer part is bright orange (CP1). The elemental mapping of the corrosion layers shows no distinctive stratification, but areas near the metal - corrosion crust interface (CP3) as well as the top surface of the corrosion layer (CP1) seem to have a lower O content (Fig. 10). The O content indicates the presence of iron hydroxides (Table 3). Soil materials (such as rock fragments and dust) are found in the welding seams near the surface.

Fig. 8: Micrograph showing the metal - corrosion crust interface from Fig. 3 (rotated by 270°, detail), unetched, bright field. We observe in white the metal, in grey the corrosion products and in black the resin,

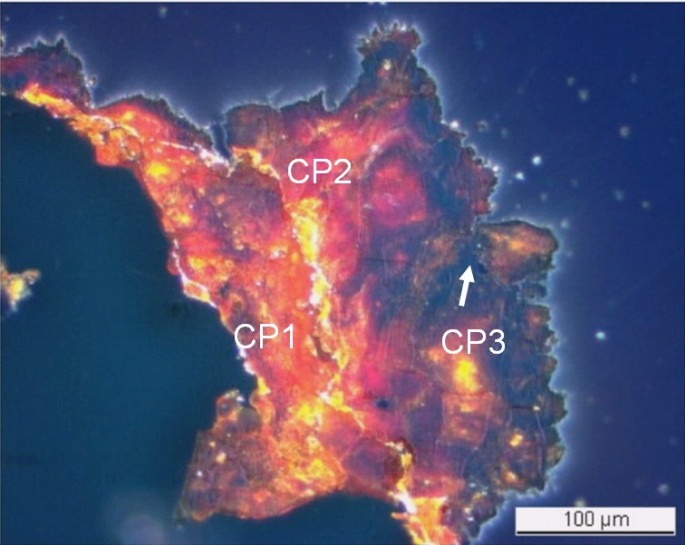
Fig. 9: Micrograph showing the metal - corrosion crust (same as Fig. 8) and corresponding to the stratigraphy of Fig. 11, unetched, polarised light. The corrosion products are dark-brown at the metal - corrosion crust interface and red-orange on the outside,

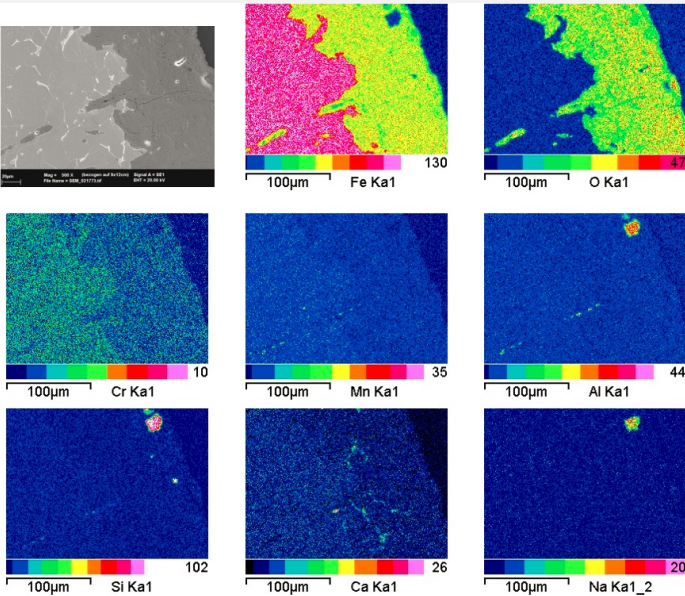
Elements Location	O	S	Mn	Fe	Total
In welding seam	34	<	<	67	102
Inner corrosion layer (CP3)	38	<1	1	66	106

Table 3: Chemical composition (mass %, <: below the detection limit) of the corrosion layer (from Fig. 10). Method of analysis: SEM/EDS, Laboratory of Analytical Chemistry, Empa.

Fig. 10: SEM image, BSE-mode, and elemental chemical distribution of the selected area from Fig. 4 (rotated by 270°, detail). Method of examination: SEM/EDS, Laboratory of Analytical Chemistry, Empa.

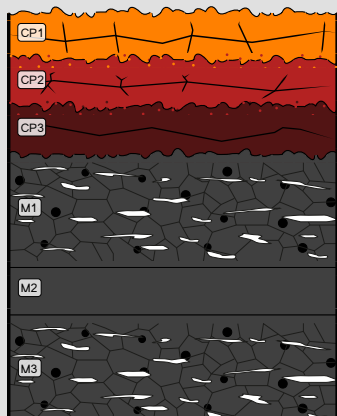
Fig. 11: Stratigraphic representation of the sample taken from the fitting in cross-section (dark field) using the MiCorr application. The characteristics of the strata are only accessible by clicking on the drawing that redirects you to the search tool by stratigraphy representation. This representation showing for the metal part a welding seam (M2) can be compared to Fig. 9, Credit HE-Arc CR.
