SHINGLE OF A ROOF – CU ALLOY – MODERN TIMES – SWITZERLAND

Artefact name	Shingle of a roof
Authors	Marianne. Senn (EMPA, Dübendorf, Zurich, Switzerland) & Christian. Degrigny (HE-Arc CR, Neuchâtel, Neuchâtel, Switzerland)
Url	/artefacts/1244/

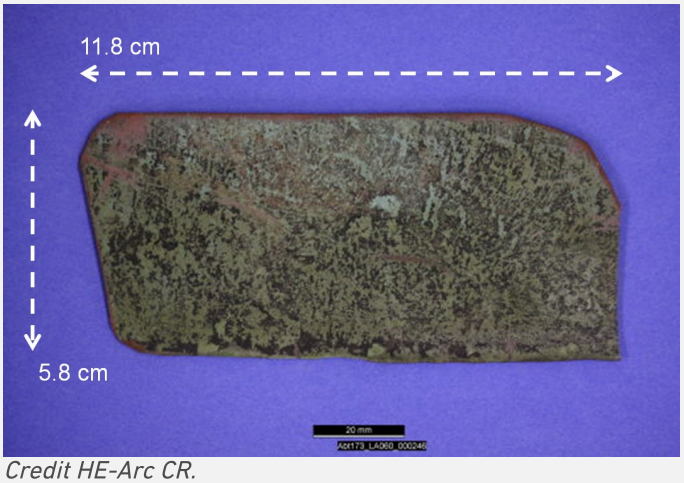
Fig. 1: Shingle of a roof, internal side,

Description of the artefact	Shingle, slightly curved, the internal side is covered with heterogeneously distributed green and black corrosion products (Fig. 1). The external side shows a regular dark green corrosion crust. Dimensions: L = 11.8cm; W = 5.8cm.
Type of artefact	Architectural element
Origin	Roof of the Abbey of St Gallen, Sankt Gallen, Saint Gallen, Switzerland
Recovering date	None
Chronology category	Modern Times
chronology tpq	1780 A.D.
chronology taq	----
Chronology comment

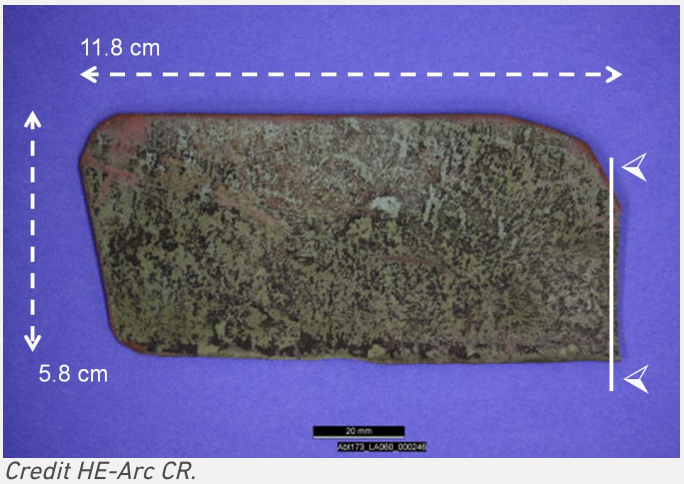
Fig. 2: Location of sampling area,

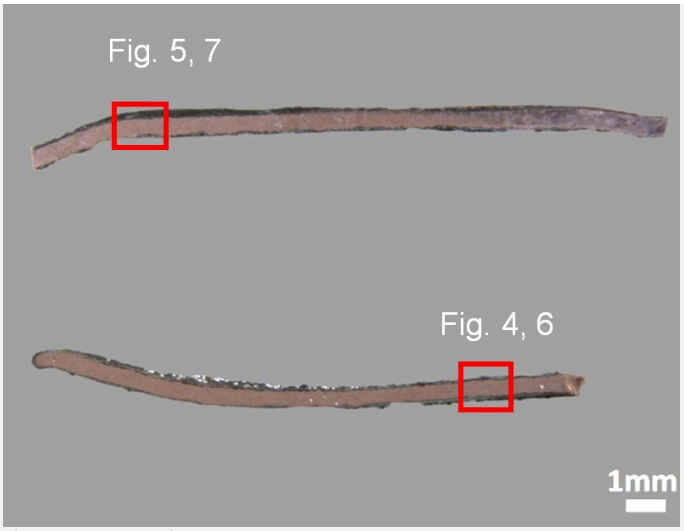
Fig. 3: Micrograph of the cross-sections of the sample taken from the shingle showing the location of Figs. 4 to 7,

Description of sample	Two samples were taken (Fig. 3). The polished samples show a well-preserved metal surface with a thin corrosion crust. T = 0.5mm.
Alloy	Cu Alloy
Technology	Rolled (probably hot rolling) and annealed
Lab number of sample	MAH-98-257
Sample location	HE-Arc CR (Degrigny Christian), Neuchâtel, Neuchâtel
Responsible institution	Conservation Department of the Musées d'art et d'histoire, Genève, Geneva
Date and aim of sampling	2009, integration of sample to the MIFAC-Metal project (Degrigny, 2016)

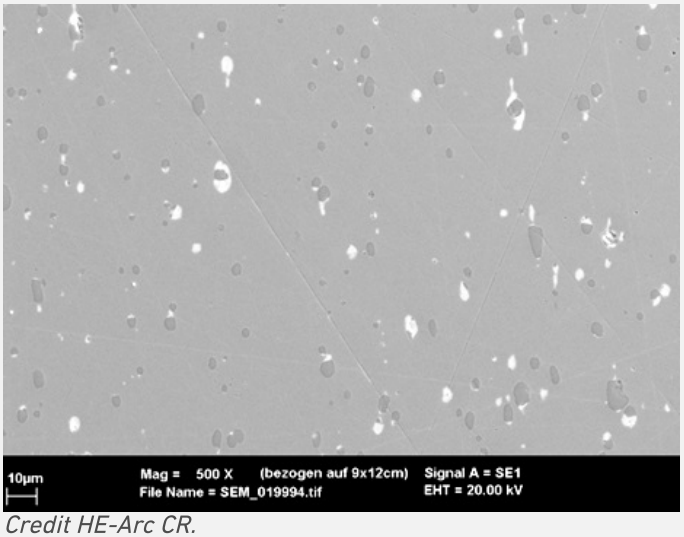
The remaining metal is a copper alloy (Table 1). The evenly distributed inclusions observed under SEM, SE-mode, are either light-grey or white (Fig. 4). The oval shape of the light-grey inclusions is due to deformation, probably by hot rolling (a common technique in the 18th century). Under polarised light they look red (Fig. 6) and their analysis reveals a composition similar to cuprite/Cu2O (Table 2). The white inclusions are rich in Pb and are remnants of the refining process (Table 2). The etched copper shows a structure of polygonal and twinned grains (Fig. 5). The grain size is variable. The average hardness of the metal is about HV1 70.

Fig. 4: SEM image, SE-mode, of the metal sample from Fig. 3 (detail). Light-grey and white inclusions are distributed evenly,

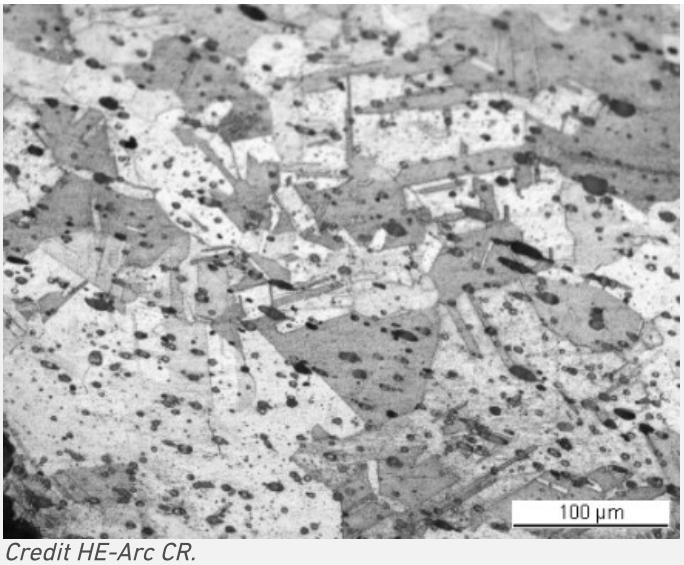
Fig. 5: Micrograph of the metal sample from Fig. 3 (detail), etched, bright field. The metal shows a structure of polygonal and twinned grains. Cuprite inclusions appear as dark spots,

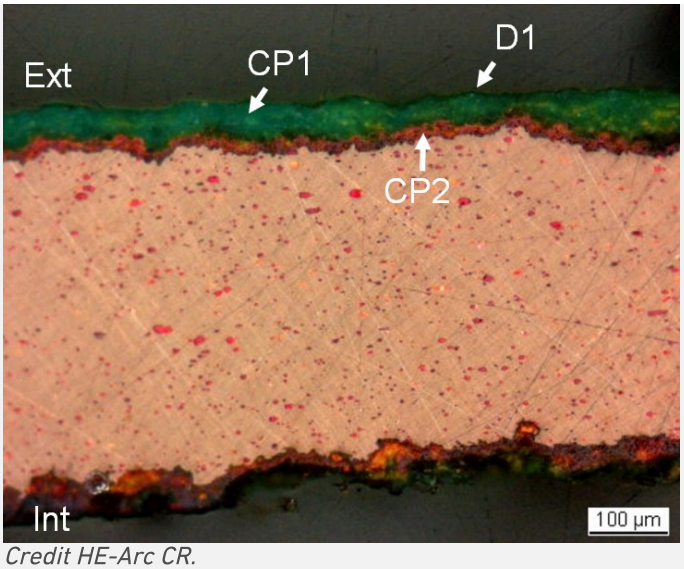
The corrosion crusts of the external and internal sides are distinctively different (Fig. 6). On the internal side an irregular reddish-orange corrosion layer has developed, and pitting corrosion has occurred. The more uniform corrosion layers on the external side consist of a reddish-orange layer, with a thicker green layer above. In some areas, dark-red corrosion products can be observed between the green and reddish-orange sub-layers. The same dark-red sub-layer can be seen in areas on the internal side covering the reddish-orange corrosion products. The reddish-orange corrosion layer on both sides (CP2) has a chemical composition similar to cuprite/Cu_2O, while the green layer on the external side (CP1) contains Cu, S and O and is enriched on its upper surface with Si (Table 3 and Fig. 7). XRD analysis of the corrosion products on the external side of another shingle fragment from the same roof identified brochantite/$Cu_4SO_4(OH)_6$ and cuprite as corrosion products (Rapport d'analyse no. MAH 98-257). These results are confirmed by Raman spectroscopy of the external side of this sample where the same compounds were clearly identified (Figs. 8 and 9).

Fig. 6: Micrograph of the metal sample from Fig. 3 and corresponding to the stratigraphy of Fig. 10, polarised light. External side: the regular corrosion crust with outer green, inner red-orange corrosion products and intermediate dark-red corrosion products. Internal side: the irregular corrosion crust with inner red-orange and outer dark-red corrosion products,

The copper shingle was rolled (probably hot rolling) and annealed to recover the ductility of the original material. The metal is covered on its external side by a typical “urban outdoor” patina consisting of copper sulphate (brochantite/Cu4(OH)6SO4) formed on top of a cuprite/Cu2O layer. The surface of the internal side, protected from the dilute sulphuric acid present in urban rainwater, has mainly developed a layer of cuprite. The silica present in the brochantite on the external side is due to airborne particle pollution. The corrosion is probably of type 1 after Robbiola et al. 1998.

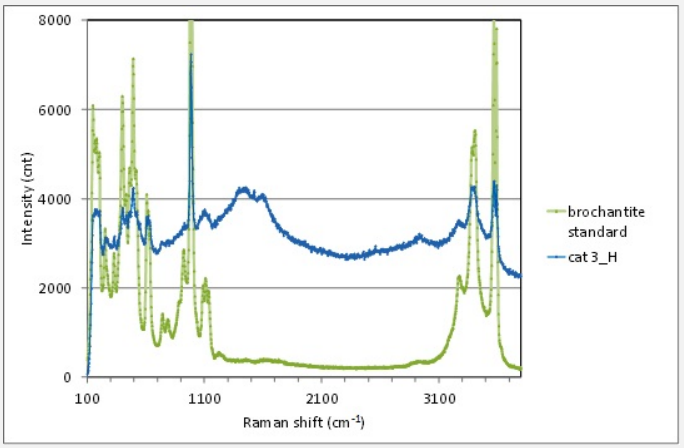
Fig. 9: Raman spectrum of the green outer corrosion layer (CP1) of the external side (cat3_H) compared to a brochantite standard spectrum. Settings: laser wavelength 532nm, acquisition time 100s, one accumulation, filter D2 (0.75-0.8 mW), hole 500, slit 80, grating 600. The peak indicated with an arrow on the cat3_H spectrum is due to fluorescence. Method of analysis: Raman spectroscopy, Lab Swiss National Museum, Affoltern a. Albis ZH,

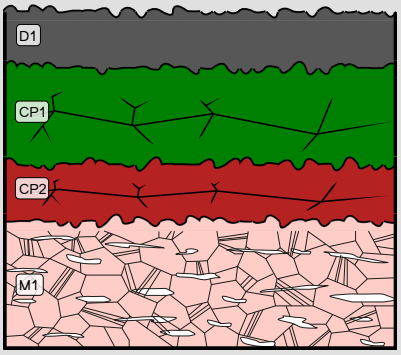
Fig. 10: Stratigraphic representation of the sample taken from the shingle in cross-section (dark field) using the MiCorr application. The characteristics of the strata are only accessible by clicking on the drawing that redirects you to the search tool by stratigraphy representation. This representation can be compared to Fig. 6, Credit HE-Arc CR.
