SHINGLE OF A ROOF – CU ALLOY – MODERN TIMES – SWITZERLAND

Artefact name	Shingle of a roof
Authors	Marianne. Senn (EMPA, Dübendorf, Zurich, Switzerland) & Christian. Degrigny (HE-Arc CR, Neuchâtel, Neuchâtel, Switzerland)
Url	/artefacts/1244/

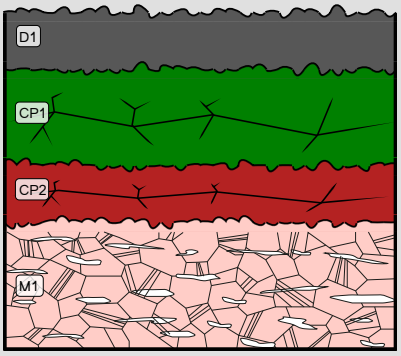
Fig. 10: Stratigraphic representation of the sample taken from the shingle in cross-section (dark field) using the MiCorr application. The characteristics of the strata are only accessible by clicking on the drawing that redirects you to the search tool by stratigraphy representation. This representation can be compared to Fig. 6, Credit HE-Arc CR.
