TANG FRAGMENT OF A KNIFE HR-6567 - LEADED BRONZE - LATE BRONZE AGE - SWITZERLAND

Artefact name Tang fragment of a knife HR-6567

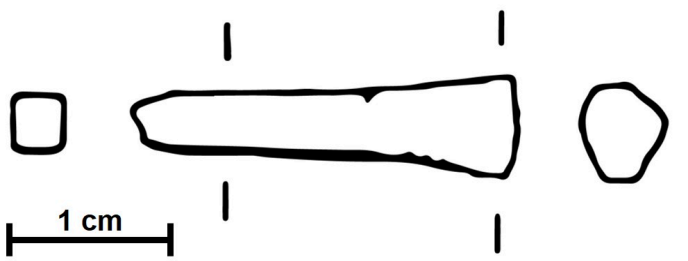
Fig. 2: Dense and brown-yellow corrosion product (detail) of the tang fragment of a knife,

Description of the artefact	Fragment de Tang avec des produits de corrosion brun-jaune brillants encore en place localement (Fig. 2). Dimensions : L = 2,9 cm ; Ømax. = 6,8 mm ; WT = 4,9 g.
Type of artefact	Household implement
Origin	Hauterive - Champréveyres, Neuchâtel, Neuchâtel, Switzerland
Recovering date	Excavation in 1983-1985, layer 3
Chronology category	Late Bronze Age
chronology tpq	1054 B.C.
chronology taq	1000 B.C.
Chronology comment	Hallstatt B1 (1054/1037BC _ 1000BC)
Burial conditions / environment	Lake
Artefact location	Laténium, Neuchâtel, Neuchâtel
Owner	Laténium, Neuchâtel, Neuchâtel
Inv. number	HR 6567
Recorded conservation data	No conservation data available, but a coating and inventory number is visible on the surface.

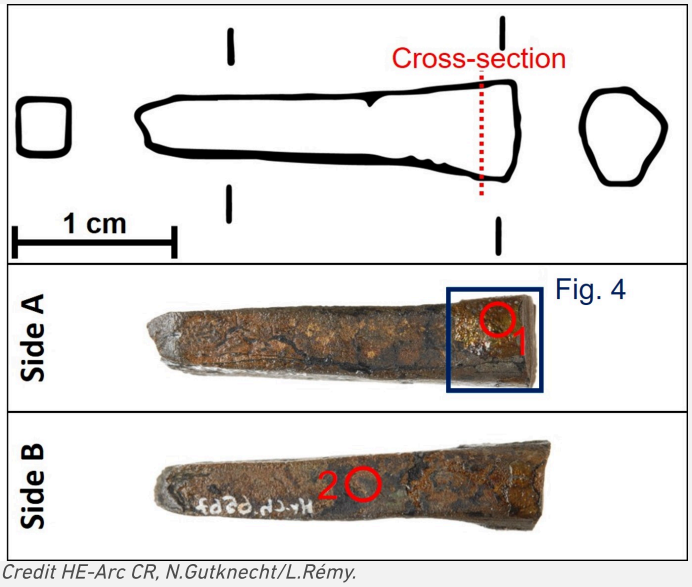
Fig. 3: Location of cross-section on drawing before sampling and both sides of fragment (after sampling) with location of the detail of Fig. 4 and XRF analysis areas (red circles),

XRF analyses of the tang fragment of a knife were carried out on two representative areas (Fig. 3). Point 1 was done on the dark yellow corrosion layer (CP2), while point 2 was performed on the remaining metal surface. For both points, soil, corrosion products and metal are analyzed at the same time.

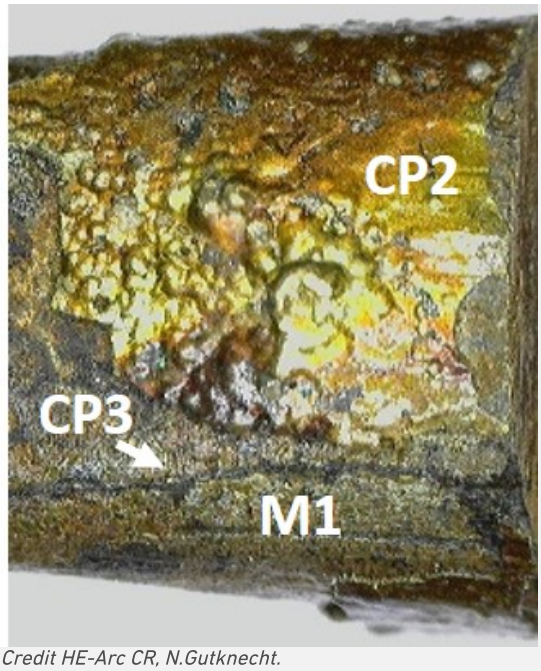
Fig. 4: Corrosion structure (detail) from Fig. 3 showing some of the documented strata in Fig. 5,

Couches	Type de strate	Principales caractéristiques
NMM1	Matériau non métallique	Film/revêtement, transparent, mince, continu
CP1	Produit corrosif	Brun, nacré, fin, discontinu, compact
CP2	Produit corrosif	Jaune foncé, épais, discontinu, compact, dur
CP3	Produit corrosif	Layer, dark grey, thin, scattered, non-compact, soft
M1	Metal	Olive, thick, metallic, soft

The NMM1 seems to be a polymer coating added after excavation of the object.

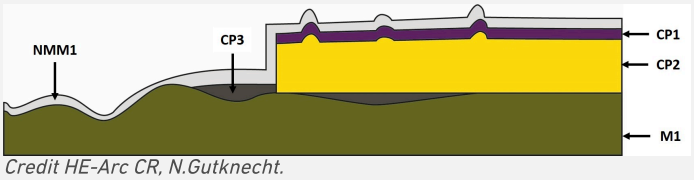
Fig. 5: Stratigraphic representation of the corrosion structure of the tang of knife by macroscopic and binocular observation with reference to Fig. 4,

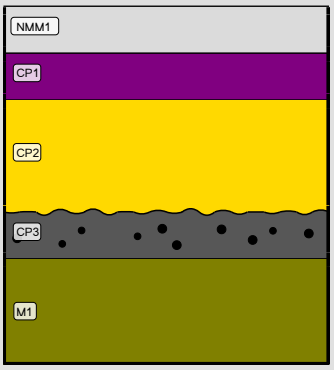
Fig. 6: Stratigraphic representation of the corrosion structure of the tang of a knife observed macroscopically under binocular microscope using the MiCorr application with reference to the whole Fig. 5. The characteristics of the strata, such as discontinuity, are accessible by clicking on the drawing that redirects you to the search tool by stratigraphy representation, Credit HE-Arc CR, N.Gutknecht.

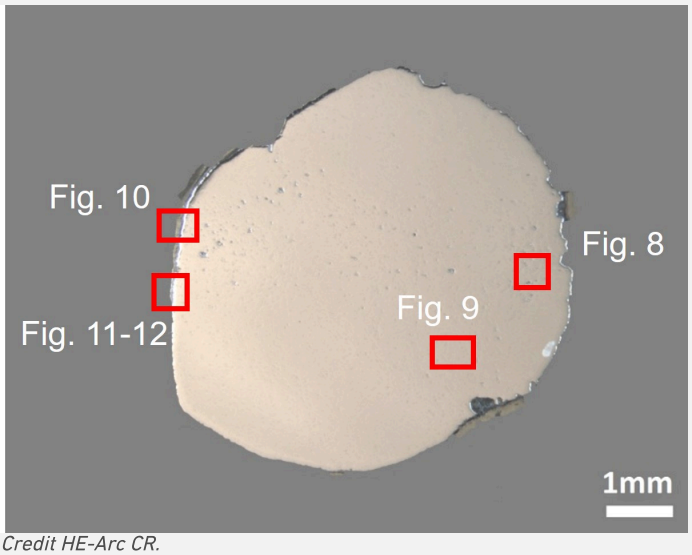
Fig. 7: Micrograph of the cross-section of the sample taken from the tang fragment of a knife showing the location of Figs. 8 to 12,

Description of sample	This cross-section shows a lateral cut through the tang (Fig. 3). Most of the corrosion structure is absent (Fig. 7).
Alloy	Leaded Bronze
Technology	Cold worked with partial annealing
Lab number of sample	MAH 87-196
Sample location	Musées d'art et d'histoire, Genève, Geneva
Responsible institution	Musées d'art et d'histoire, Genève, Geneva
Date and aim of sampling	1987, metallography and corrosion characterisation

The remaining metal is a leaded bronze (Table 2) containing numerous copper sulphide and tiny Pb inclusions (Figs. 8-10, 12 and Table 4). The porosity within the metal is high, particularly along a band through the middle of the sample (Figs. 7 and 8). The etched structure of the leaded bronze shows small, regular polygonal grains, some with twinning (Fig. 9). Slip lines appear in grains close to the metal surface (Fig. 9). The average hardness of the metal is HV1 120.

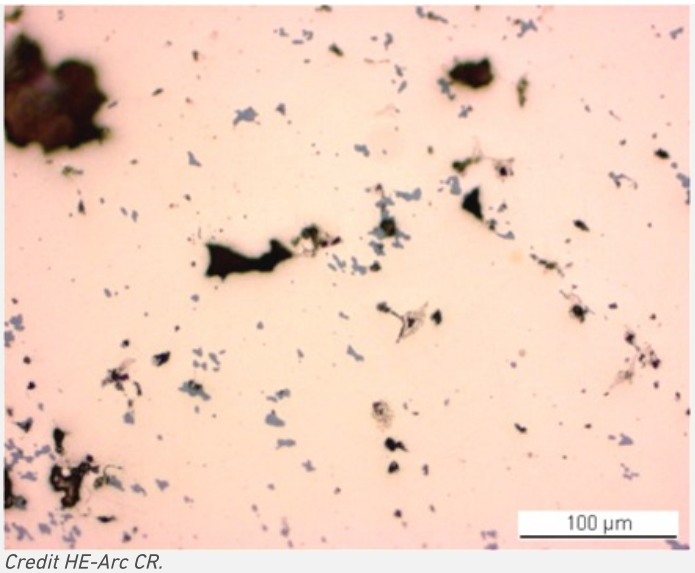
Fig. 8: Micrograph of the metal sample from Fig. 7 (detail), unetched, bright field. In pink the metal, in black the porosity and in dark-grey copper sulphide inclusions,

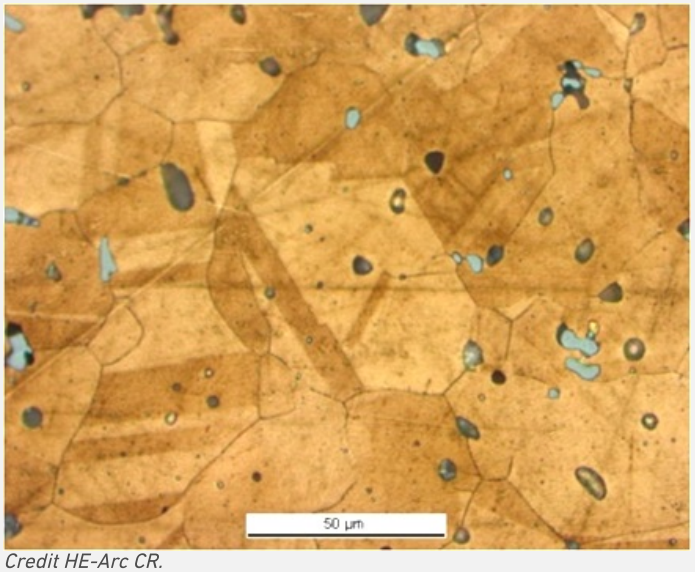
Fig. 9: Micrograph of the metal sample from Fig. 7 (detail), etched, bright field. Angular and twinned grains are revealed as well as copper sulphide inclusions in grey,

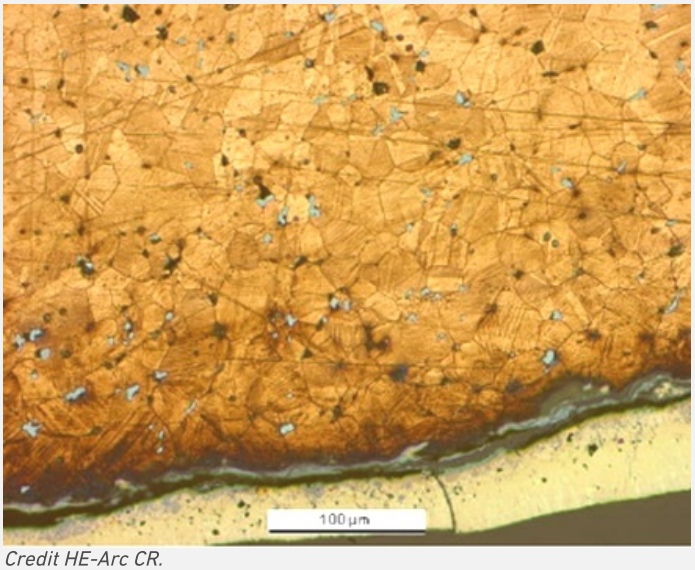
Fig. 10: Micrograph of the metal sample from Fig. 7, etched, bright field (rotated by 270°, detail). Angular grains with slip lines can be seen as well as copper sulphide inclusions in grey,

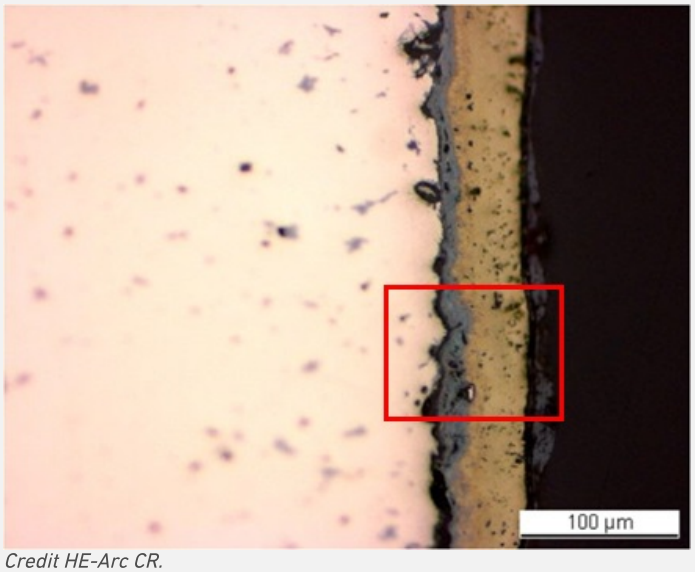
The metal has lost most of its original corrosion layer, the remainder having an average thickness between 60 and 190µm (Fig. 6). In some areas up to three corrosion strata are visible (Fig. 11). In polarised light (Fig. 12), the corrosion stratigraphy appears more clearly: it is composed of a dense black inner layer, an intermediate thick brown layer with bright spots (indicating porosity) and an outer red layer with white particles. The elemental chemical distribution of the SEM image reveals that the black inner layer (CP3) is Sn-rich, but contains Cu, O, Fe, Si, P, Pb, Ni, As, Ca and S (Table 5, Figs. 12-13). The brown layer (CP2) contains S, Fe and Cu and has a composition similar to chalcopyrite/$CuFeS_2$ (Table 5, Figs. 12-13). This was confirmed by past XRD analyses carried out by Schweizer (1994, museum report (1987)). The red layer (CP1) is an iron oxide (main elements Fe and O) and is contaminated with calcite/$CaCO_3$ particles (S1) (Table 5, Figs. 12-13).

Fig. 11: Micrograph of the metal sample from Fig. 7 (reversed picture, detail), unetched, bright field. From left to right: metal (in pink), inner light-grey layer, intermediate brown layer and top dark-grey layer. The area selected for elemental chemical distribution (Fig. 13) is marked by a red rectangle,

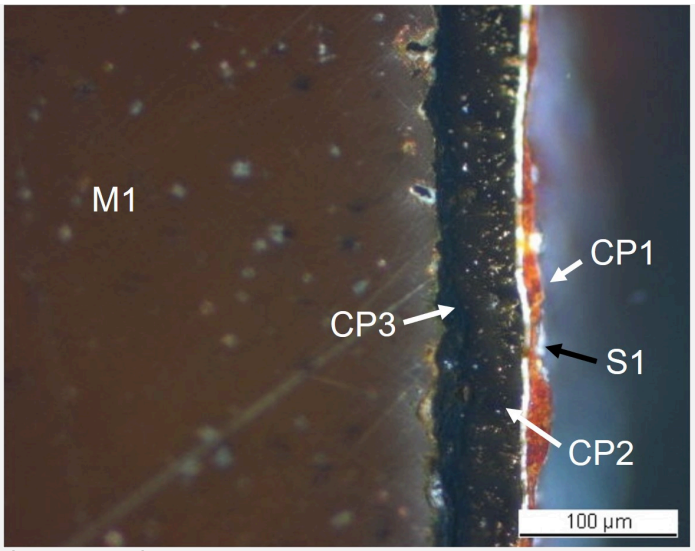
Fig. 12: Micrograph of the same area as Fig. 11 and corresponding to the stratigraphy of Fig. 14, polarized light. From left to right: metal (in brown) covered with a corrosion layer consisting of a black layer, an intermediate brown layer with bright spots, a crack (white line) and a red layer with white particles,

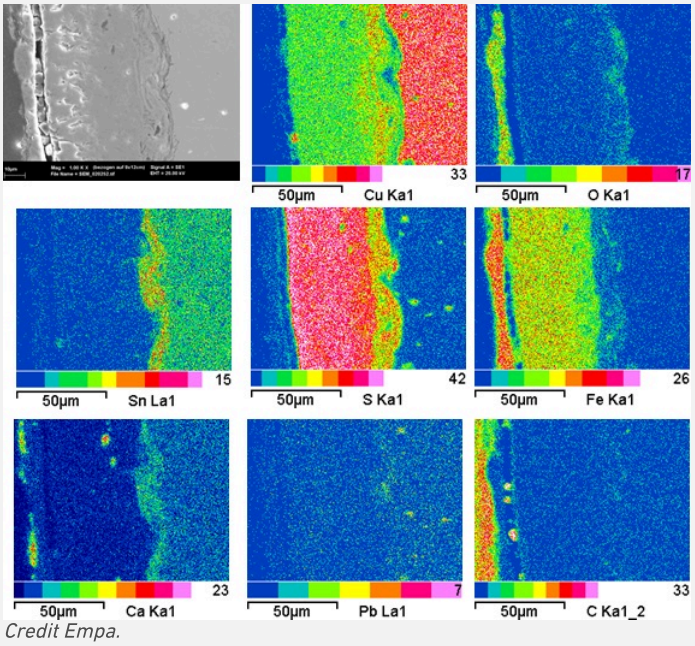
Fig. 13: SEM image, SE-mode, and elemental chemical distribution of the selected area of Fig. 11 (reversed picture). Method of examination: SEM/EDS, Laboratory of Analytical Chemistry, Empa,

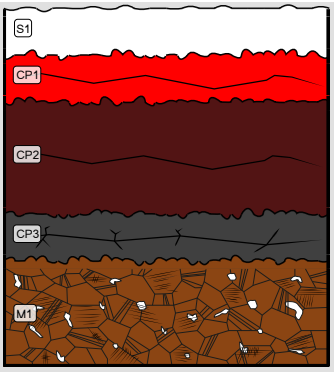
Fig. 14: Stratigraphic representation of the sample taken from the tang fragment of a knife in cross-section (dark field) using the MiCorr application. The characteristics of the strata are accessible by clicking on the drawing that redirects you to the search tool by stratigraphy representation. This representation can be compared to Fig. 12, Credit HE-Arc CR.

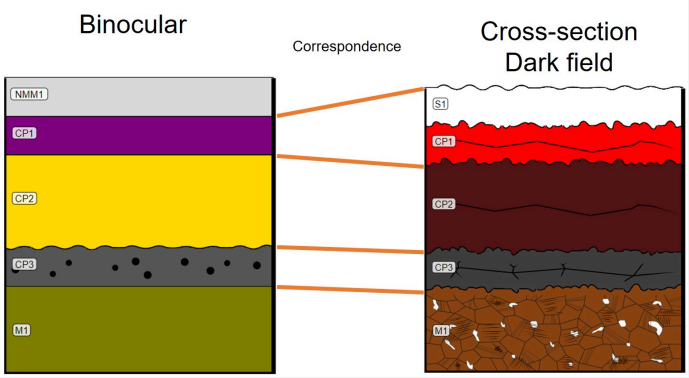
NMM1 in binocular mode is not observed in cross-section mode, as the cross-section does not show any coating.

CP1 in binocular mode is documented as sediment (S1) and CP1 in cross-section mode. But it is not clear if it matches the CP1 from cross-section, which is a Fe-rich layer, or if CP1 from binocular mode developed as an atmospheric corrosion after the excavation and is therefore not present on the embedded sample.

CP2 and CP3 in binocular mode match CP2 and CP3 in cross-section mode.

Fig. 15: Stratigraphic representation side by side of binocular view and cross-section (dark field),
