TANG FRAGMENT OF A KNIFE HR-6567 - LEADED BRONZE - LATE BRONZE AGE - SWITZERLAND

Artefact name Tang fragment of a knife HR-6567

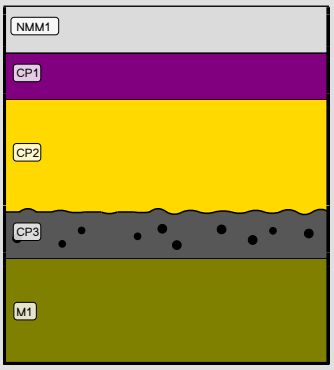
Fig. 6: Stratigraphic representation of the corrosion structure of the tang of a knife observed macroscopically under binocular microscope using the MiCorr application with reference to the whole Fig. 5. The characteristics of the strata, such as discontinuity, are accessible by clicking on the drawing that redirects you to the search tool by stratigraphy representation, Credit HE-Arc CR, N.Gutknecht.

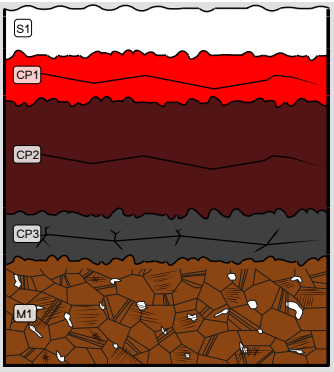
Fig. 14: Stratigraphic representation of the sample taken from the tang fragment of a knife in cross-section (dark field) using the MiCorr application. The characteristics of the strata are accessible by clicking on the drawing that redirects you to the search tool by stratigraphy representation. This representation can be compared to Fig. 12, Credit HE-Arc CR.
