SHOE NAIL 2637 1370.B. - HYPOEUTECTOID STEEL - ROMAN TIMES - SWITZERLAND

Artefact name	Shoe nail 2637 1370.B.
Authors	Christian. Degrigny (HE-Arc CR, Neuchâtel, Neuchâtel, Switzerland) & Valentin. Boissonnas (HE-Arc CR, Neuchâtel, Neuchâtel, Switzerland) & Vincent Chappuis. (HE-Arc CR, Neuchâtel, Neuchâtel, Switzerland)
Url	/artefacts/1248/

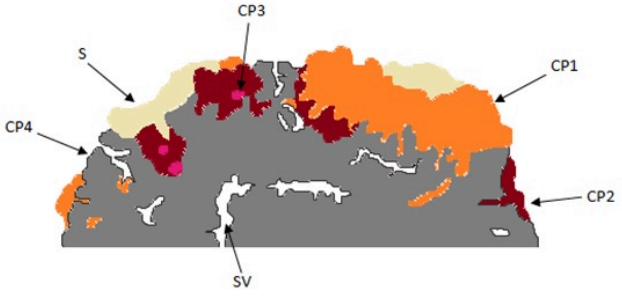
S = compact sand-clay soil.
CP1 = powdery soil, orange-coloured by corrosion products.
CP2 = dark-red corrosion crust, breaks into bits.
CP3 = vivid pink-red and globular corrosion products.
CP4 = dark grey to black and very hard corrosion products, results in an dark-orange powder when scratched.
SV = structural void near the center of the cross section, seems to draw a square shape.

Fig. 3: Preliminary stratigraphy of the corrosion layers based on the observation of a broken nail,

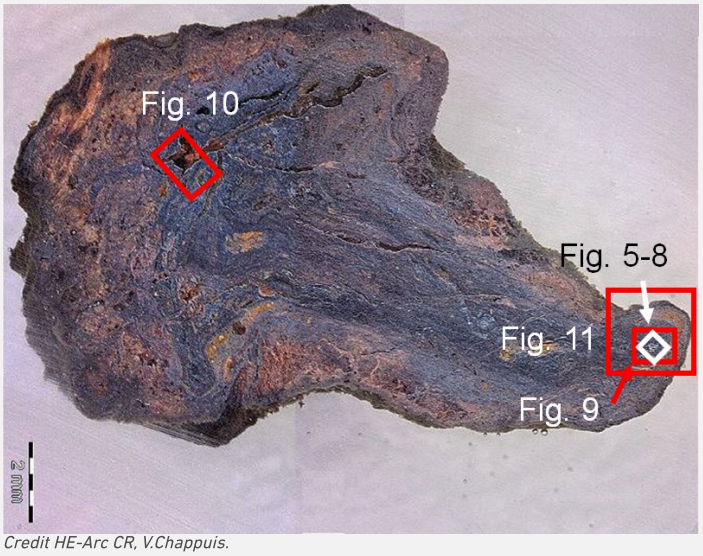
Fig. 4: Micrograph of the cross-section of the nail showing the location of figs. 5 to 11,

The metal is heavily corroded and the thickness of the corrosion crust is irregular, varying from 0.8 to 3.8mm, with an average of about 2mm. The corrosion has replaced most of the metal (Fig. 4). Between corrosion layers the limit of the original structure is visible. Some leather fibers seem to be preserved as pseudomorphic structures in voids of the metal core (POM1, Figs. 9 and 10). The carbon mapping (Fig.11) shows the presence of carbon in these areas. This can also be due to the penetration of the mounting resin in the cracks.

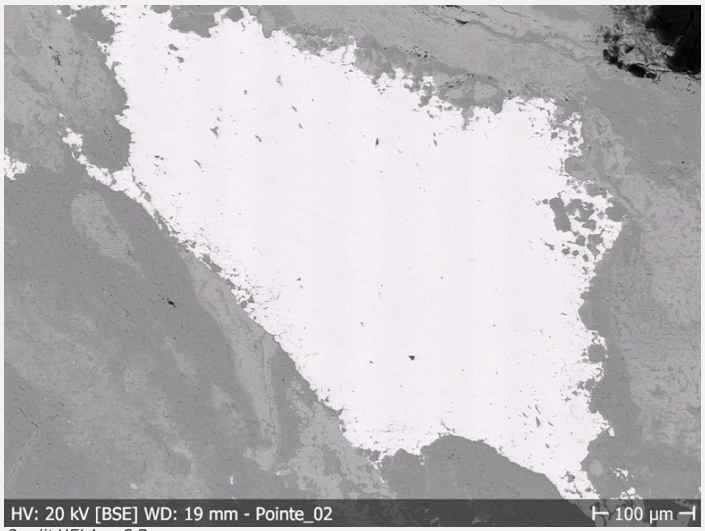
The remaining metal is an hypoeutectoid steel (Fig. 5 and 6), containing Fe, Si and O slags inclusions (possibly fayalite FeO,SiO2), and consisting of less than 1% of the total volume of the highly mineralized nail. After Nital etching, it shows intergranular corrosion on one of its sides (Figs. 7 and 8).

Fig. 5: SEM, BSE-mode picture of remaining metal from cross-section of Fig. 4,

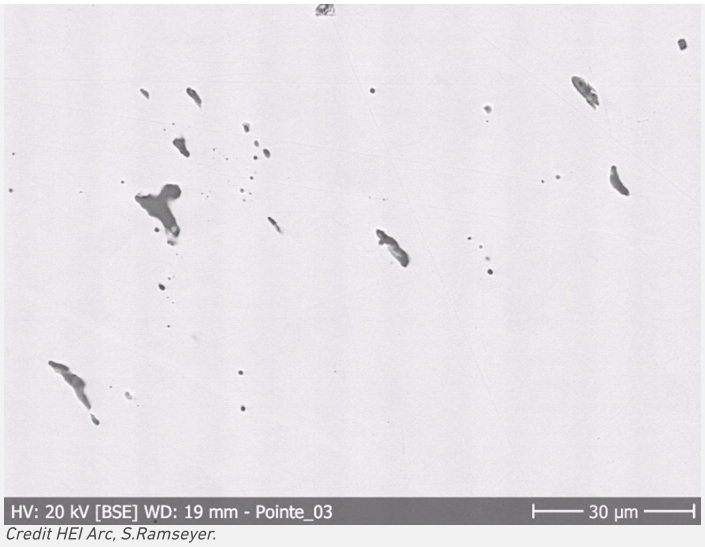
Fig. 6: SEM, BSE-mode picture of inclusions in remaining metal (detail of Fig. 5),

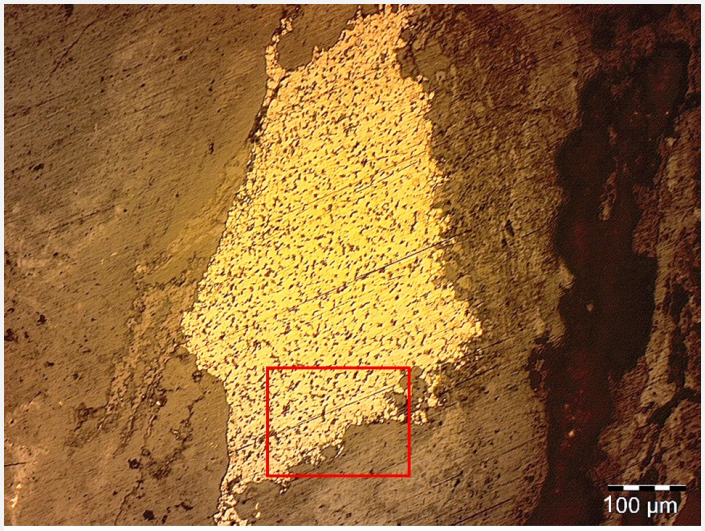
Fig. 7: Micrograph of the metal sample from Fig. 5 (detail, rotated 90°), Nital etched, bright field, with indication of Fig. 8 (red rectangle)

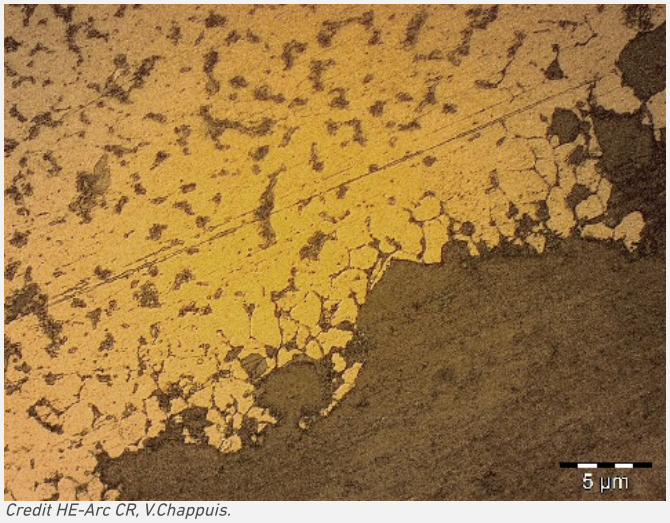
Fig. 8: Micrograph of the selected area of Fig. 7, Nital etched with no clear grain structure, bright field, Intergranular corrosion and grey phase (perlite?) are observed,

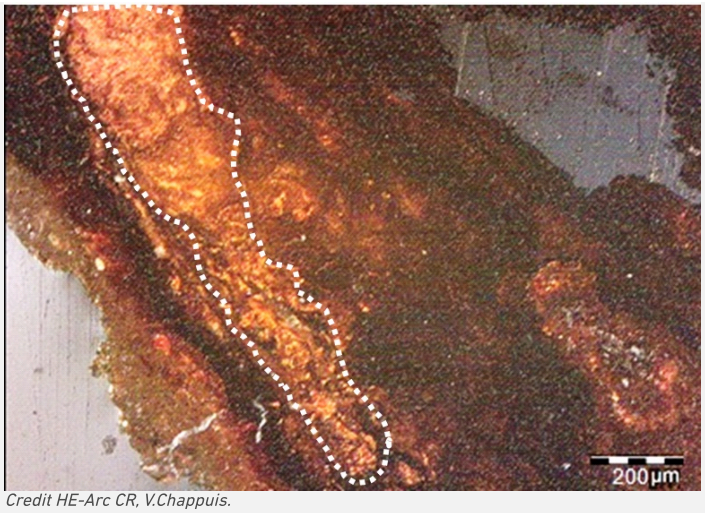
Fig. 9: Micrograph of the metal sample from Fig. 4, bright field. The deliminated zone shows what could be leather pseudomorphic fibers filling a void,

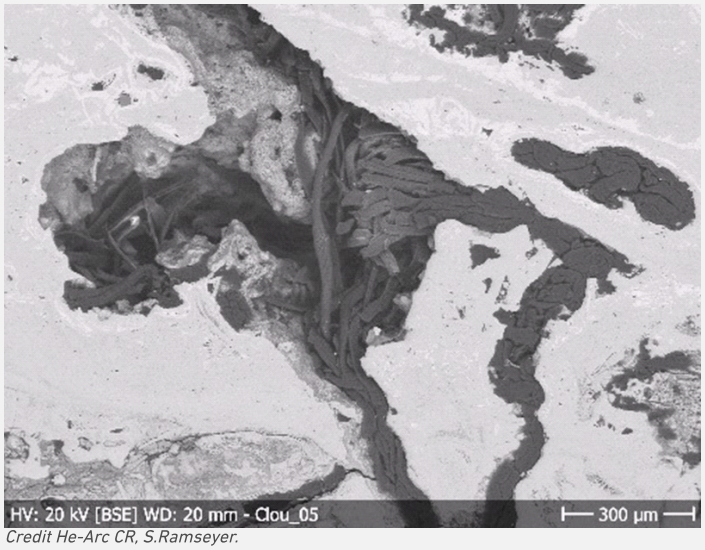
Fig. 10: SEM - BSE-mode picture of another void filled with fibers in the head of the nail (see Fig. 4),

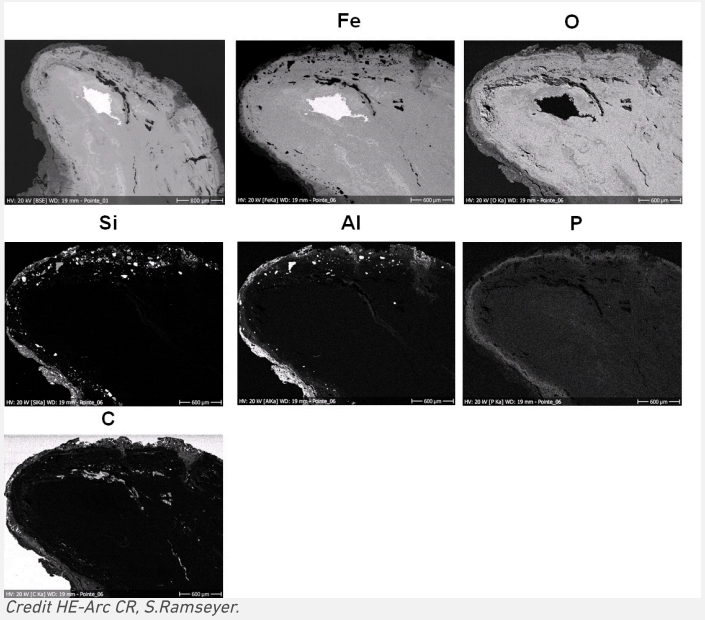
Si, Al, P and K can be considered external markers, helping to determine the limit of the original surface (Fig. 11 and Table 1). The outer layer of corrosion products (CP1-3) ranges from dark grey to orange in bright field and contains less O and Fe on its borders than the inner layer (CP4-5, Figs. 4 and 11, Table 1). The SEM pictures show a marbling appearance of the inner corrosion layer (CP5). Cl and S do not seem to be present in the sampled nail.

Fig. 11: Elemental chemical distribution of the selected area from Fig. 4 (90° counter-clockwise rotated). SEM-EDS,

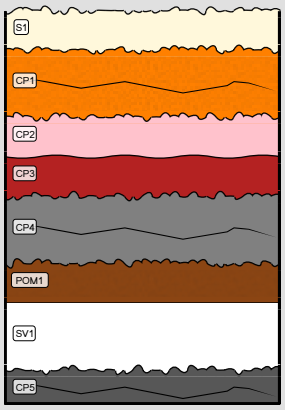
Fig. 12: Stratigraphic representation of the nail in cross-section (dark field) using the MiCorr application. The characteristics of the strata are only accessible by clicking on the drawing that redirects you to the search tool by stratigraphy representation. This representation can be compared to Fig. 14, Credit HE-Arc CR, V.Chappuis.

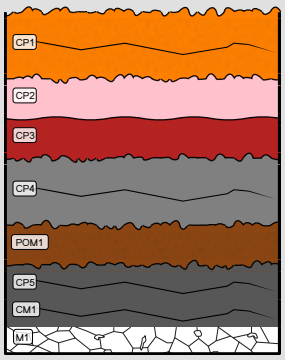
Fig. 13: Stratigraphic representation of the nail in cross-section (dark field) using the MiCorr application. The characteristics of the strata are only accessible by clicking on the drawing that redirects you to the search tool by stratigraphy representation. This representation can be compared to Fig. 14, Credit HE-Arc CR, V.Chappuis.

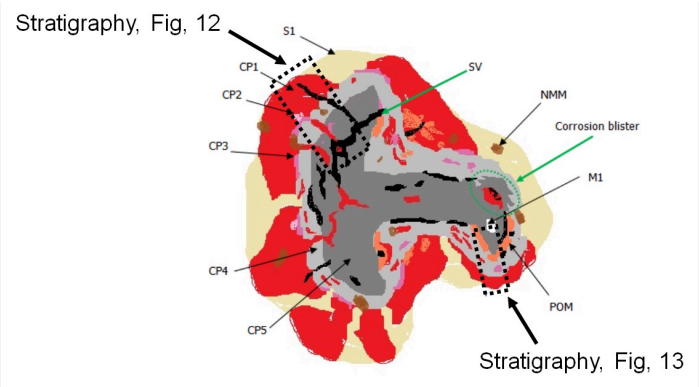
The schematic representation of corrosion layers of Fig. 3 integrating additional information based on the analyses carried out is given in Fig. 14. The following strata were identified:

SV = structural void, present as fissures that either pass through the different layers, or are present at corrosion interfaces, especially at the CP4/CP5 interface. The void is 0.1 to 0.3mm thick and partially filled with POM in the outer layers.

Fig. 14: Improved stratigraphic representation of the nail from visual observations and analyses and visualization of the two stratigraphies of Figs, 12 and 13,
