CHISEL D.2019.4.2.2 – CU ALLOY – LATE BRONZE AGE – FRANCE

Artefact name   Chisel D.2019.4.2.2

Authors   Christian. Degrigny (HE-Arc CR, Neuchâtel, Neuchâtel, Switzerland) & Naima. Gutknecht (HE-Arc CR, Neuchâtel, Neuchâtel, Switzerland) & Valentina. Valbi (Laboratoire Métallurgie et Culture LMC-IRAMAT-CNRS-UTBM, Belfort, Franche-Comté, France)

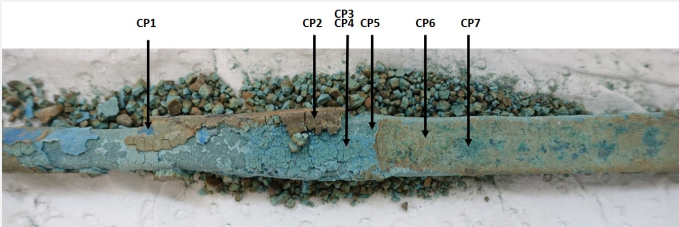
Fig. 1: Chisel covered with a brown crust and blue-green corrosion products and showing areas of flaking,

Description of the artefact	Pointed elongated tool used for piercing holes. It is covered with brown crust and blue-green corrosion products that show areas of flaking. Dimensions: L = ca. 13cm. W = ca. 3cm.
Type of artefact	Tool
Origin	Granges Feuillet, dépôt n°2, Salins-les-Bains, Franche-Comté, France
Recovering date	2012
Chronology category	Late Bronze Age
chronology tpq	1350 B.C. ⌄
chronology taq	1150 B.C. ⌄
Chronology comment	
Burial conditions / environment	Soil
Artefact location	Musée de Lons-le-Saunier, Lons-le-Saunier, Franche-Comté
Owner	Musée de Lons-le-Saunier (dépôt de Salins-les-Bains)
Inv. number	D.2019.4.2.2
Recorded conservation data	N/a

From the time of excavation in 2012 until its entry into the museum in 2015, the object was kept in a food storage box in an uncontrolled environment. Flaking corrosion was documented when the object was collected and stored by the museum in 2015.

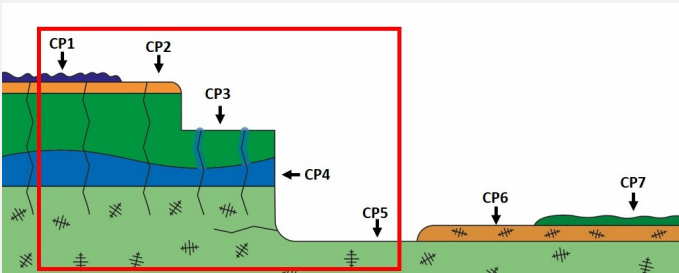
Fig. 4: Stratigraphic representation of the corrosion structure of the chisel by macroscopic and binocular observation with indication of the corrosion structure used to build the MiCorr stratigraphy of Fig. 5 (red square),

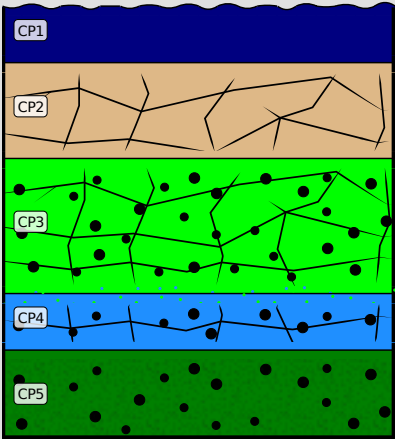
Fig. 5: Stratigraphic representation of the chisel observed macroscopically under binocular using the MiCorr application with reference to Fig. 4. The characteristics of the strata are only accessible by clicking on the drawing that redirects you to the search tool by stratigraphy representation, Credit HE-Arc CR, N.Gutknecht.

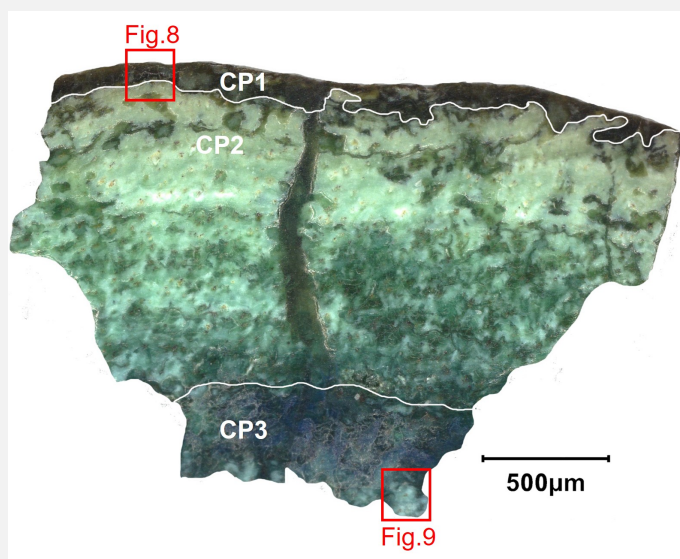
The observation of the sample in cross-section in dark field allowed to identify an external brown 200 μm thick stratum (CP1), a green 1000 μm thick stratum (CP2), a turquoise 400 μm thick stratum (CP3) with blue aggregates.

Fig. 7: Micrograph of the cross-section of the sample in dark field with the identification of the CPs,

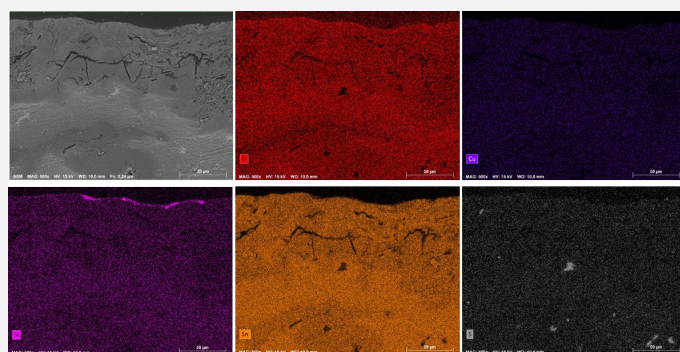
S-rich dark inclusions (Figs. 8-9) were observed in the whole corrosion structure and were identified as covellite (CuS) by Raman spectroscopy (R04).

Fig. 8: SEM image, SE-mode, and elemental chemical distribution of the selected area,

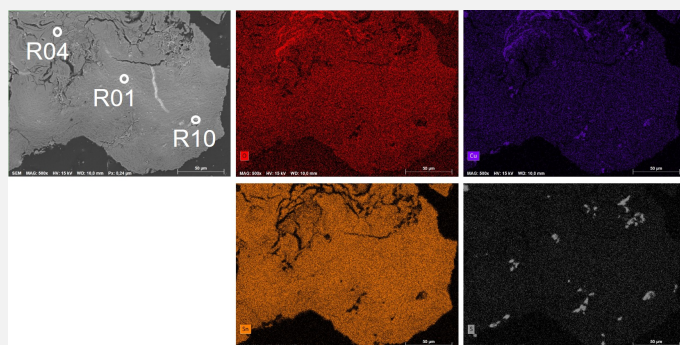
Fig. 9: SEM image, SE-mode, and elemental chemical distribution of the selected area. The selected points for Raman analysis shown in Fig. 10 are indicated,

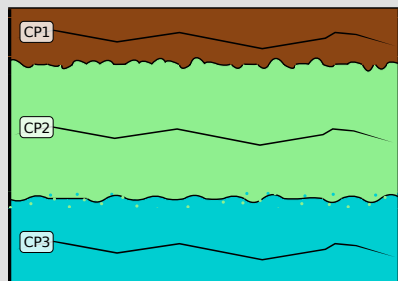
Fig. 10: Stratigraphic representation of the fragment of the chisel observed in cross-section under dark field using the MiCorr application. The characteristics of the strata are only accessible by clicking on the drawing that redirects you to the search tool by stratigraphy representation. This representation was build according to Fig. 7, Credit LMC-CNRS, V.Valbi.

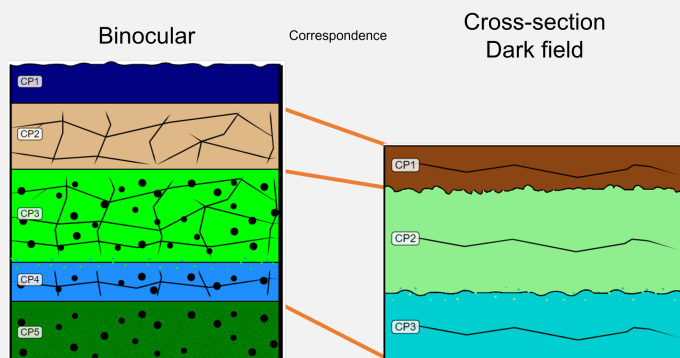
The stratigraphies obtained by binocular and cross-section observation show several differences. The sample observed in cross-section is collected from the flaked material and is thus representing a different location than the binocular observation performed on the whole object (Fig. 2).

The flaked sample used for the cross-section observation includes the corrosion layers above the "flaking interface" located between CP4 and CP5 in binocular view. Thus the strata under the flaking interface did not get sampled. CP1 from the binocular view was not observed in the selected sample either.

Fig. 11: Stratigraphic representation side by side of binocular view and cross-section (dark field),
