AXE D.2019.4.2.1 – CU ALLOY – LATE BRONZE AGE – FRANCE

Artefact name   Axe D.2019.4.2.1

Authors   Christian. Degrigny (HE-Arc CR, Neuchâtel, Neuchâtel, Switzerland) & Naima. Gutknecht (HE-Arc CR, Neuchâtel, Neuchâtel, Switzerland) & Valentina. Valbi (Laboratoire Métallurgie et Culture (LMC), Belfort, Franche-Comté, France)

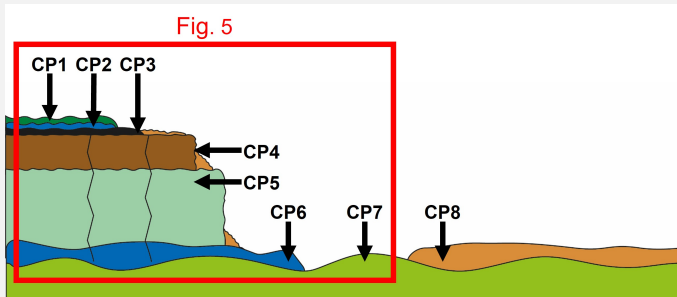
Fig. 4: Stratigraphic representation of the corrosion structure of the axe by macroscopic and binocular observation with indication of the corrosion structure used to build the MiCorr stratigraphy of Fig. 5 (red square),

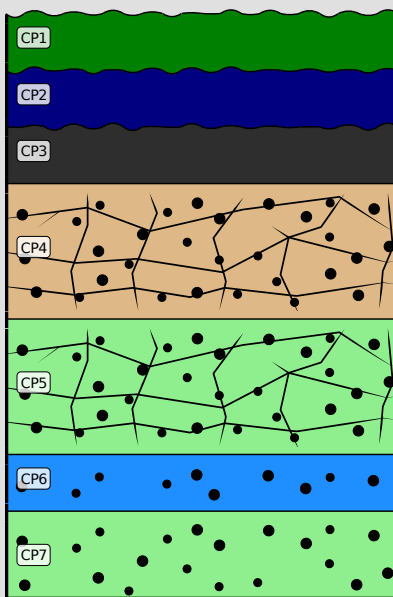
Fig. 5: Stratigraphic representation of the corrosion structure of the axe observed macroscopically under binocular microscope using the MiCorr application with reference to Fig. 4. The characteristics of the strata are only accessible by clicking on the drawing that redirects you to the search tool by stratigraphy representation, Credit HE-Arc CR, N.Gutknecht.

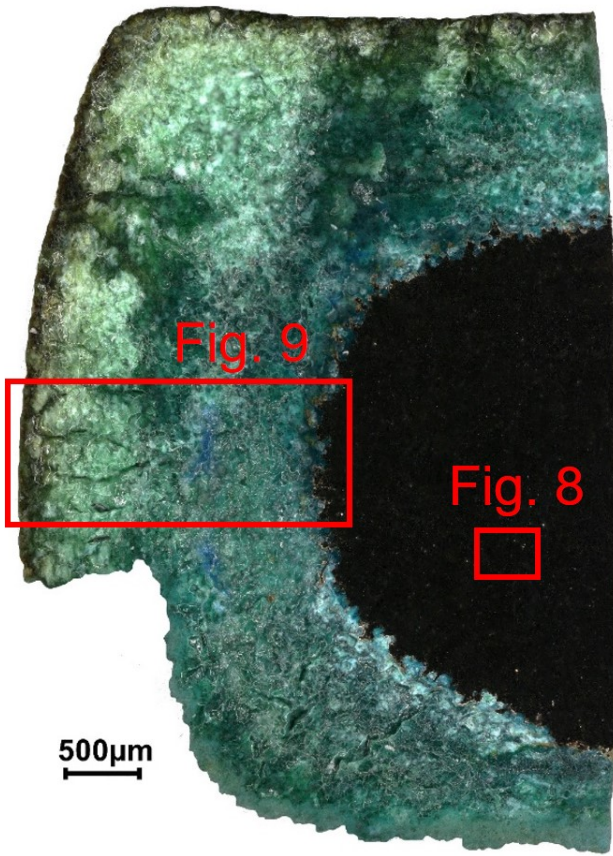
Fig. 6: Micrograph of the cross-section of the sample from Fig. 2 in dark field showing the location of Figs. 8-9,

Description of sample	The cross-section corresponds to a lateral cut (Fig. 2) and is representative of the entire thickness of the axe's body. A metallic core is present below the corrosion layers (Fig. 6).
Alloy	Cu Alloy
Technology	Annealed after cold working
Lab number of sample	
Sample location	Centre de Conservation et d'Etude René-Rémond, Lons-le-Saunier
Responsible institution	Centre de Conservation et d'Etude René-Rémond, Lons-le-Saunier
Date and aim of sampling	April 2021

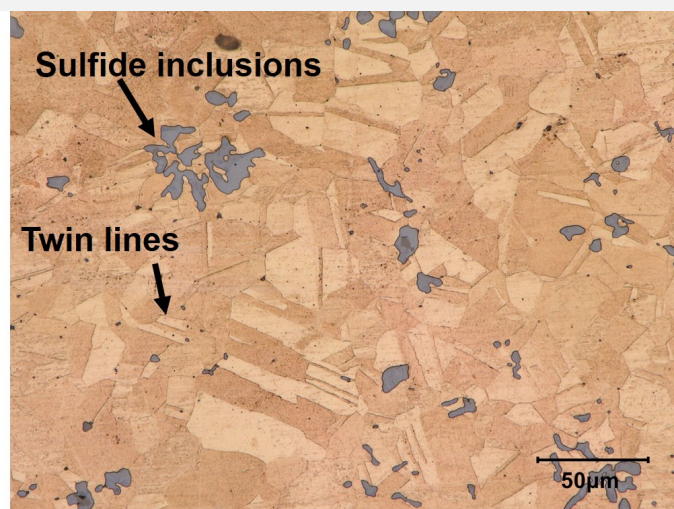
EDX analysis (Table 2) of the residual metal analyzed on cross-section indicates that it is a low tin bronze with 8 wt% of Sn and 1 wt% of S. The metal has a polygonal grains microstructure (Figs. 7 & 8) with several twinned grains (Fig. 8) revealing that the object underwent an annealing procedure. Sulfide Cu-S-Fe inclusions (10-50 µm, Fig. 8) and Pb inclusions (1-3 µm) are homogeneously distributed on the whole sample.

Fig. 7: Micrograph of the cross-section of the sample (same as Fig. 6) in bright field after chemical etching,

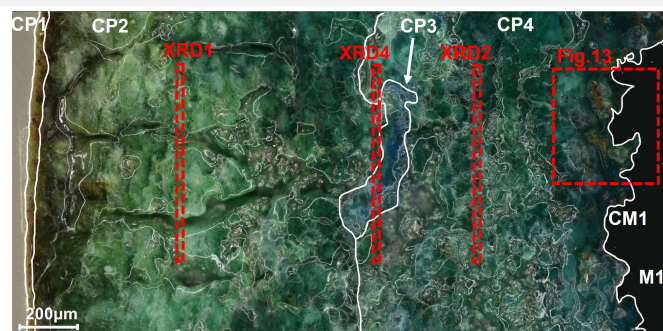
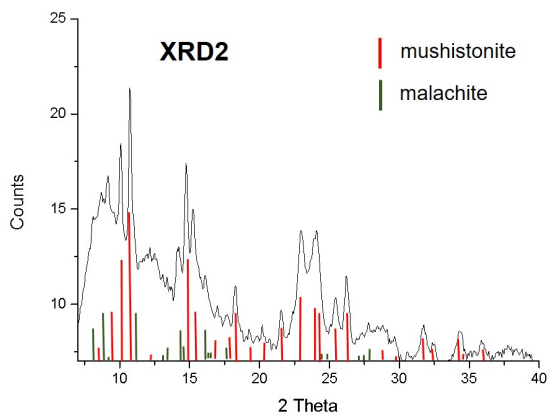
Fig. 8: Micrograph of the metal sample from Fig. 7 (detail), etched, bright field. In color, polygonal grains with twin lines and in grey sulfide inclusions,

The observation of the sample in dark field mode shows the presence of a thick (1500-2000 μm) and porous/fractured corrosion structure. The corrosion structure can be subdivided into: a thin external olive green CP1, a light green thick CP2, a blue discontinuous CP3, a light blue CP4 with red and black inclusions, CM1 and M1 (Fig. 9).

Fig. 9: Micrograph of the corrosion structure from Fig. 6 (detail), unetched, dark field with indication of the different strata of table 3 and location of XRD analyses and Fig. 13,

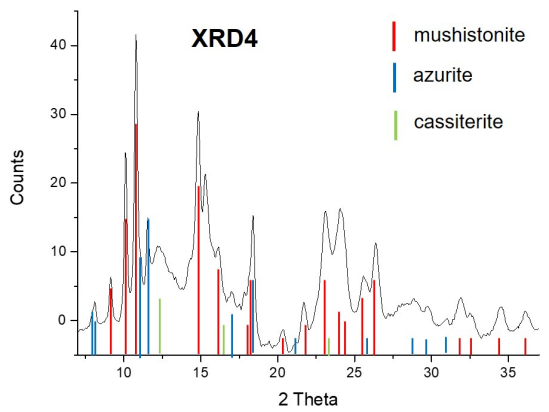
XRD (Figs. 10-12) and Raman analyses (Figs. 13-16) allowed to identify different compounds of the corrosion structure. The CP2 stratum is composed of cassiterite (SnO_2). CP3 was identified as the hydroxicarbonate azurite $Cu_3(CO_3)_2(OH)_2$. CP4 is composed of mushistonite (a mixed Cu/Sn hydroxide with general formula $Cu^{2+}Sn^{4+}(OH)_6$), together with localized presence of the hydroxicarbonate malachite $Cu_2(CO_3)(OH)_2$ in the more external part close to CP3, while the red areas and the black spots inside CP4 are identified respectively as cuprite Cu_2O and (silver-bearing) covellite CuS.

Fig. 10: XRD diffractogram 1 collected on CP2 (see location on Fig. 9),

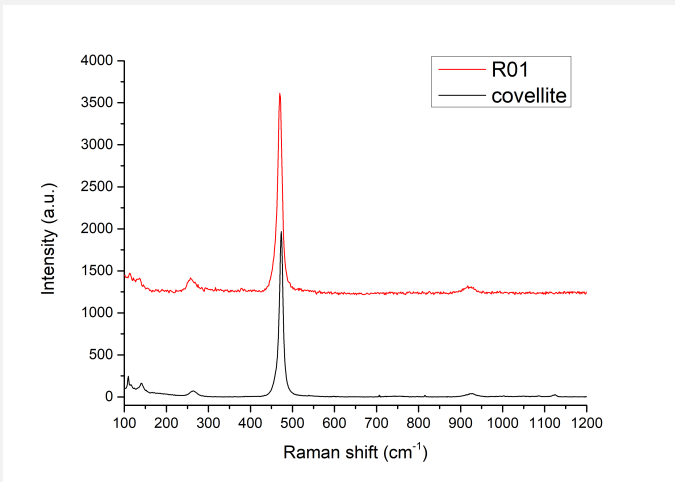
Fig. 14: Raman spectrum of point R01 performed on the black spots in CP4, as shown in Fig. 13, together with the reference for covellite RRUFFID=R060306,

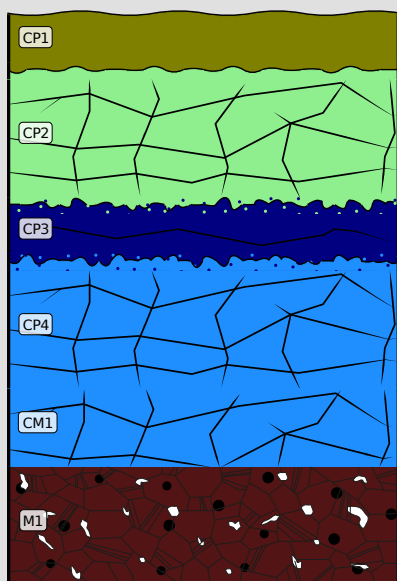
Fig. 17: Stratigraphic representation of the sample of the axe observed in cross-section under dark field using the MiCorr application. The characteristics of the strata are only accessible by clicking on the drawing that redirects you to the search tool by stratigraphy representation. This representation was build according to Fig. 9, Credit LMC-CNRS, V.Valbi.

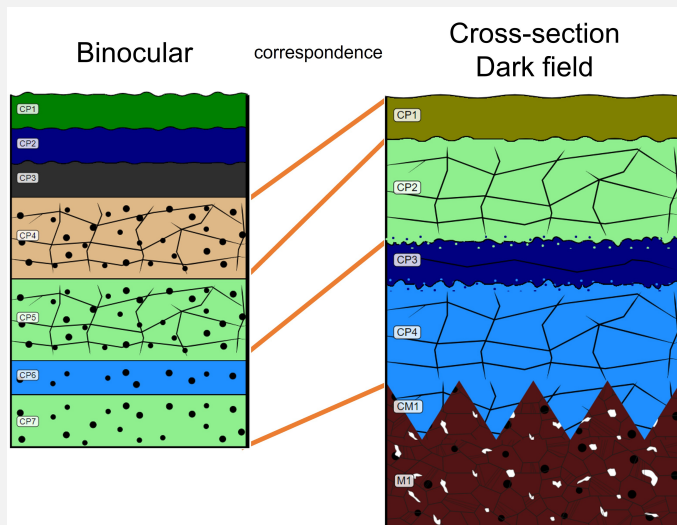
The stratigraphies obtained by binocular and cross-section observation show a few differences. The blue, green and black CPs 1, 2 and 3 observed in binocular stratigraphy are not present in the cross-section stratigraphy. The location of sampling (Fig. 2) being different from the location of binocular observation can explain their absence in the sample taken. The CP4 observed under binocular microscope (Bi) probably could correspond to the olive green CP1 observed in cross-section (CS). CP5 observed under Bi could be the CP2 in CS. CP6 observed under Bi can correspond to the blue CP3 observed in CS. The light green CP7 under Bi shows a direct correspondence with the light blue CP4

identified in CS. The difference in the identified colours can be explained by the different perceptions of colours with the two observation modes and the operator bias. A CM was observed in CS, but was not documented in Bi.

Fig. 18: Stratigraphic representation side by side of binocular view and cross-section (dark field),
