AXE D.2019.4.2.1 - CU ALLOY - LATE BRONZE AGE - FRANCE

Artefact name Axe D.2019.4.2.1

Authors Christian. Degrigny (HE-Arc CR, Neuchâtel, Neuchâtel, Switzerland) & Naima. Gutknecht (HE-Arc CR, Neuchâtel, Neuchâtel, Switzerland) & Valentina. Valbi (Laboratoire Métallurgie et Culture (LMC), Belfort, Franche-Comté, France)

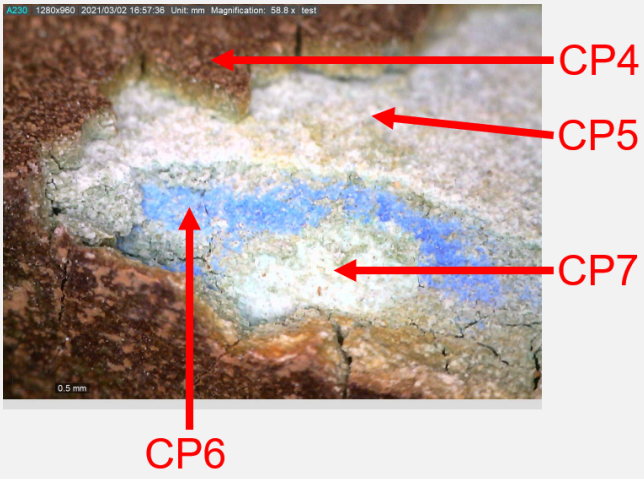
Fig. 2: Axe with location of Fig.3 and sampling area (red triangle),

Fig. 3: Detail from Fig. 2 showing part of the documented strata,

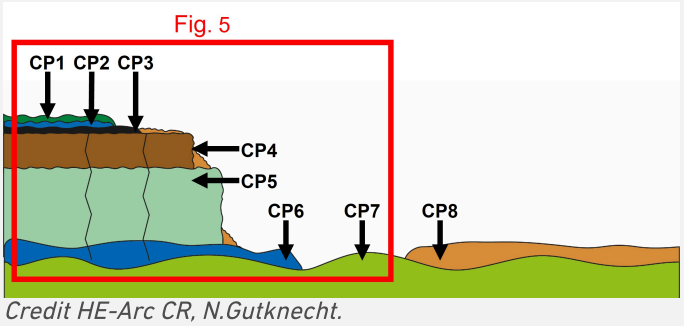
Strata	Type of stratum	Principal characteristics
CP1	Corrosion product	green, thin, isolated, non-compact, soft
CP2	Corrosion product	blue, thin, isolated, compact, soft
CP3	Corrosion product	black, thin, isolated, compact, soft

CP4	Corrosion product	light brown, thick, discontinuous, non-compact, soft
CP5	Corrosion product	light green, thick, discontinuous, non-compact, soft
CP6	Corrosion product	blue, thin, discontinuous, non-compact, very soft
CP7	Corrosion product	light green, medium, continuous, non-compact, soft
CP8	Corrosion product	orange, thin, isolated, non-compact, soft

Table 1: Description of the principal characteristics of the strata as observed under binocular and described according to Bertholon's method.

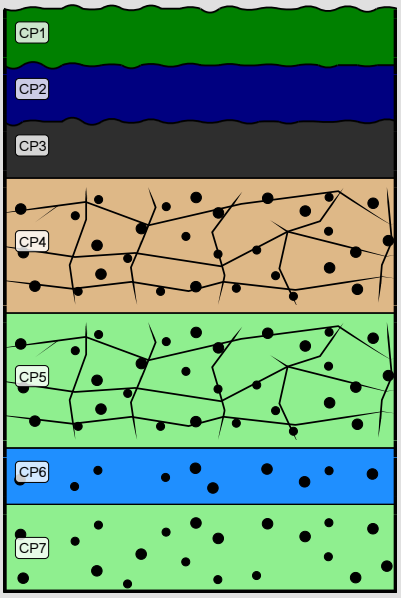
Fig. 5: Stratigraphic representation of the corrosion structure of the axe observed macroscopically under binocular microscope using the MiCorr application with reference to Fig. 4. The characteristics of the strata are only accessible by clicking on the drawing that redirects you to the search tool by stratigraphy representation, Credit HE-Arc CR, N.Gutknecht.

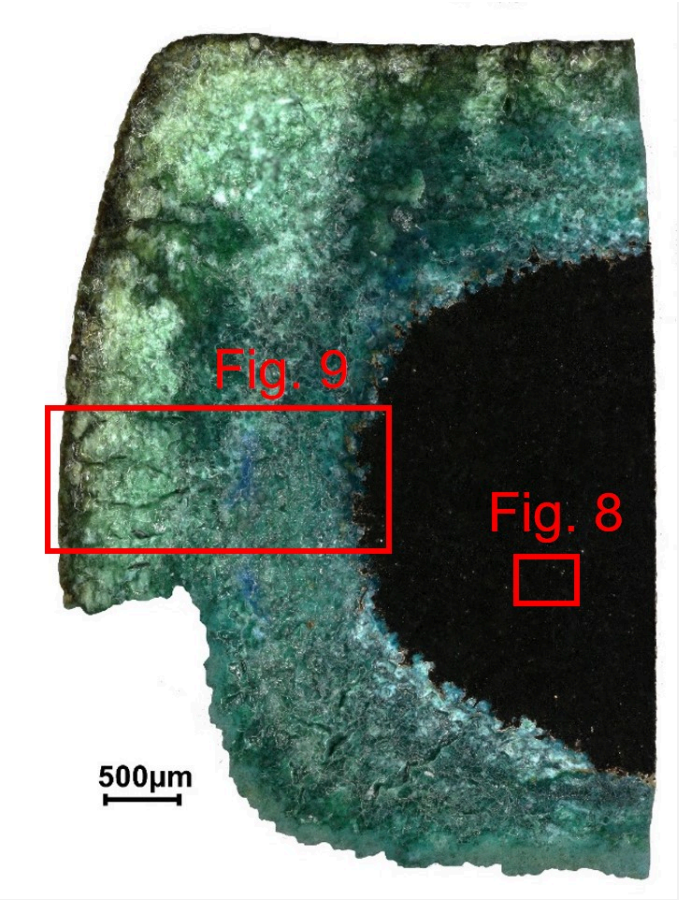
Fig. 6: Micrograph of the cross-section of the sample from Fig. 2 in dark field showing the location of Figs. 8-9,

Description of sample	The cross-section corresponds to a lateral cut (Fig. 2) and is representative of the entire thickness of the axe's body. A metallic core is present below the corrosion layers (Fig. 6).
Alloy	Cu Alloy
Technology	Annealed after cold working
Lab number of sample	
Sample location	Centre de Conservation et d'Etude René-Rémond, Lons-le-Saunier
Responsible institution	Centre de Conservation et d'Etude René-Rémond, Lons-le-Saunier
Date and aim of sampling	April 2021

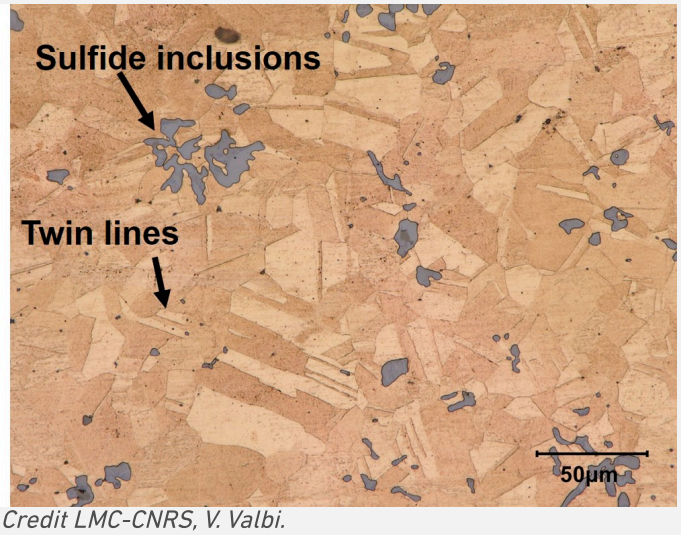
EDX analysis (Table 2) of the residual metal analyzed on cross-section indicates that it is a low tin bronze with 8 wt% of Sn and 1 wt% of S. The metal has a polygonal grains microstructure (Figs. 7 & 8) with several twinned grains (Fig. 8) revealing that the object underwent an annealing procedure. Sulfide Cu-S-Fe inclusions (10-50 µm, Fig. 8) and Pb inclusions (1-3 µm) are homogeneously distributed on the whole sample.

Fig. 7: Micrograph of the cross-section of the sample (same as Fig. 6) in bright field after chemical etching,

Fig. 8: Micrograph of the metal sample from Fig. 7 (detail), etched, bright field. In color, polygonal grains with twin lines and in grey sulfide inclusions,

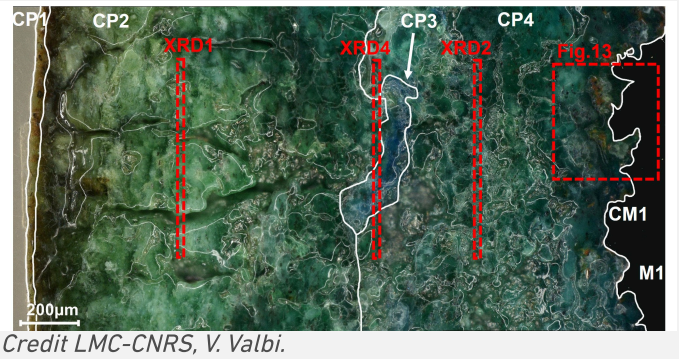
The observation of the sample in dark field mode shows the presence of a thick (1500-2000 µm) and porous/fractured corrosion structure. The corrosion structure can be subdivided into: a thin external olive green CP1, a light green thick CP2, a blue discontinuous CP3, a light blue CP4 with red and black inclusions, CM1 and M1 (Fig. 9).

The EDX elemental analysis (Table 3) reveals a Sn-enrichment in the whole corrosion structure (27-54 wt%) when compared to the original amount of this element in the alloy (8 wt%). The strongest Sn-enrichment is observed for CP1 and CP2, with 52-54 Sn wt%, low amounts of Cu (9-10 wt%), and a few percents of external elements such as Si and Al (1-2 wt%). CP3 is richer in Cu (around 40 Cu wt% and 27 Sn wt%), while the CP4 is richer in Sn than Cu (36 Sn wt% and 28 Cu wt%). It was also possible to analyze the black spots inside the CP4, which are composed mainly of Cu (55 wt%) and S (around 30 wt%) with 11 wt% of Ag.

XRD (Figs. 10-12) and Raman analyses (Figs. 13-16) allowed to identify different compounds of the corrosion structure. The CP2 stratum is composed of cassiterite (SnO_2). CP3 was identified as the hydroxicarbonate azurite $Cu_3(CO_3)_2(OH)_2$. CP4 is composed of mushistonite (a mixed Cu/Sn hydroxide with general formula $Cu^{2+}Sn^{4+}(OH)_6$), together with localized presence of the hydroxicarbonate malachite $Cu_2(CO_3)(OH)_2$ in the more external part close to CP3, while the red areas and the black spots inside CP4 are identified respectively as cuprite Cu_2O and (silver-bearing) covellite CuS.

Fig. 9: Micrograph of the corrosion structure from Fig. 6 (detail), unetched, dark field with indication of the different strata of table 3 and location of XRD analyses and Fig. 13,

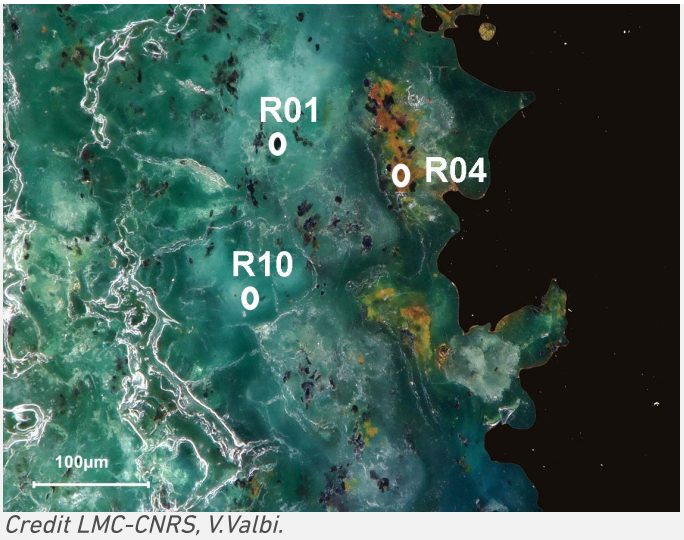
Fig.13: Micrograph of the corrosion structure, detail of CP4 from Fig.9, showing the presence of black spots of covellite and red spots of cuprite identified by Raman spectroscopy,

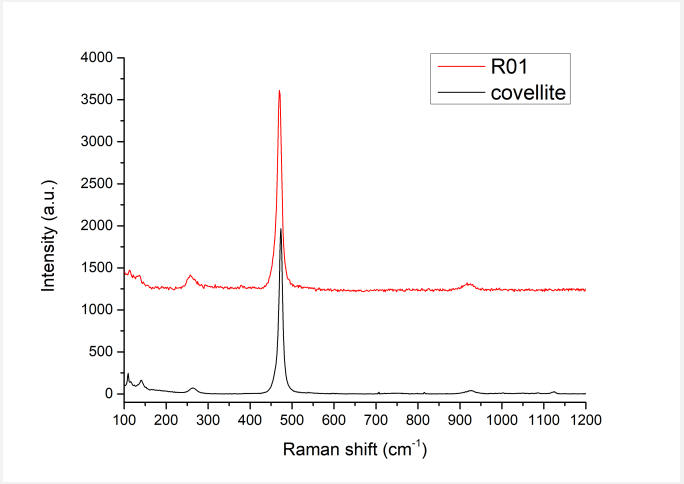
Fig. 14: Raman spectrum of point R01 performed on the black spots in CP4, as shown in Fig. 13, together with the reference for covellite RRUFFID=R060306,

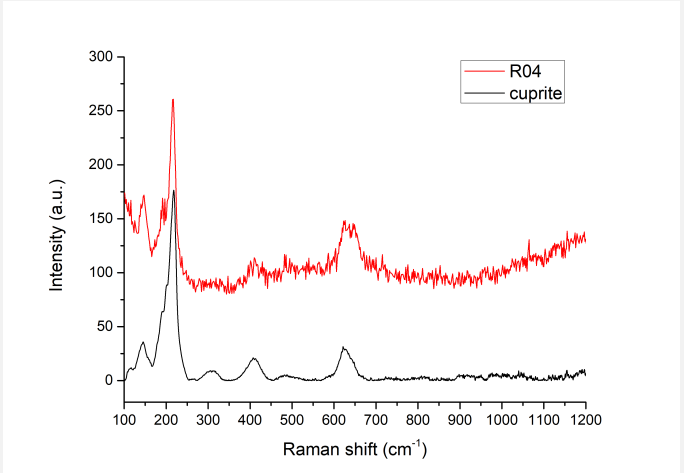
Fig. 15: Raman spectrum of point R04 performed on the red areas in CP4, as shown in Fig. 13, together with the reference for RRUFFID=R140763,

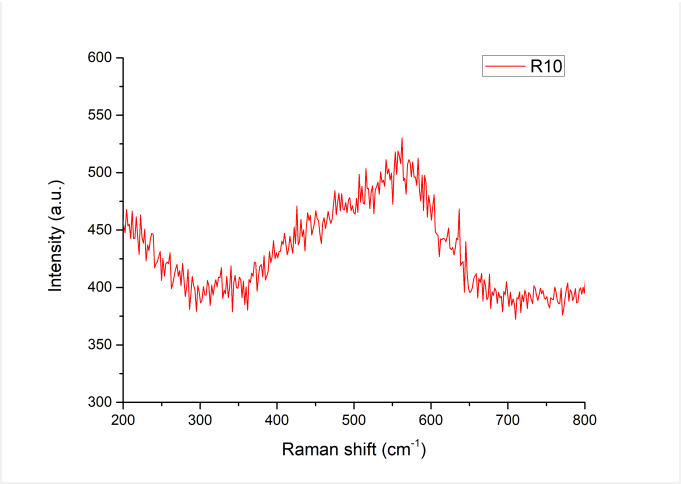
Fig. 16: Raman spectrum of point R10 performed on the blue CP4, as shown in Fig. 13, and identified as nano-cassiterite by comparison with the work of Ospitali et al. 2012,

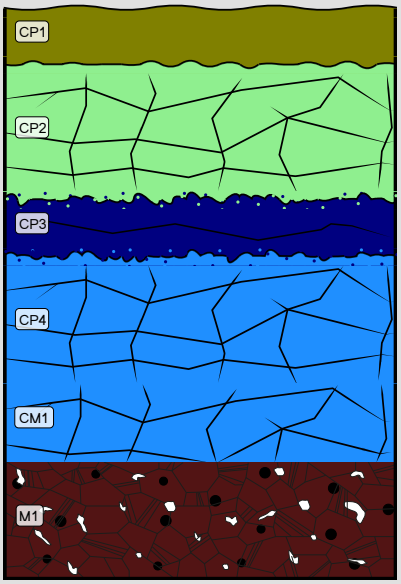
Fig. 17: Stratigraphic representation of the sample of the axe observed in cross-section under dark field using the MiCorr application. The characteristics of the strata are only accessible by clicking on the drawing that redirects you to the search tool by stratigraphy representation. This representation was build according to Fig. 9, Credit LMC-CNRS, V.Valbi.

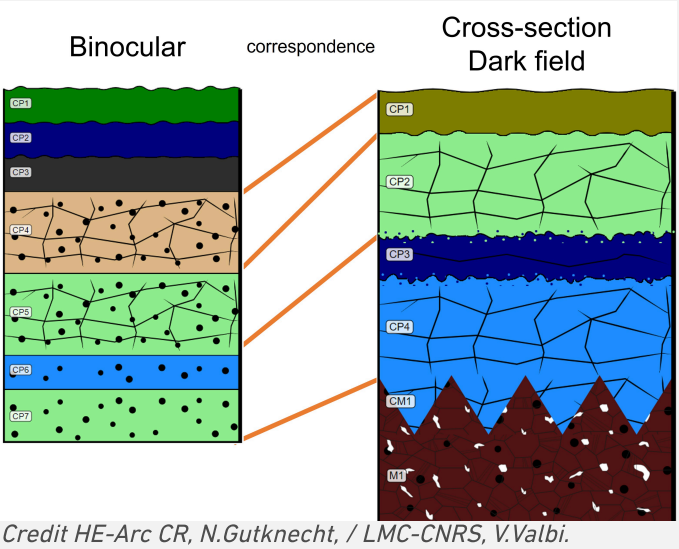
The stratigraphies obtained by binocular and cross-section observation show a few differences. The blue, green and black CPs 1, 2 and 3 observed in binocular stratigraphy are not present in the cross-section stratigraphy. The location of sampling (Fig. 2) being different from the location of binocular observation can explain their absence in the sample taken. The CP4 observed under binocular microscope (Bi) probably could correspond to the olive green CP1 observed in cross-section (CS). CP5 observed under Bi could be the CP2 in CS. CP6 observed under Bi can correspond to the blue CP3 observed in CS. The light green CP7 under Bi shows a direct correspondence with the light blue CP4

identified in CS. The difference in the identified colours can be explained by the different perceptions of colours with the two observation modes and the operator bias. A CM was observed in CS, but was not documented in Bi.

Fig. 18: Stratigraphic representation side by side of binocular view and cross-section (dark field),
