AXE D.2019.4.2.1 - CU ALLOY - LATE BRONZE AGE - FRANCE

Artefact name Axe D.2019.4.2.1

Authors Christian. Degrigny (HE-Arc CR, Neuchâtel, Neuchâtel, Switzerland) & Naima. Gutknecht (HE-Arc CR, Neuchâtel, Neuchâtel, Switzerland) & Valentina. Valbi (Laboratoire Métallurgie et Culture (LMC), Belfort, Franche-Comté, France)

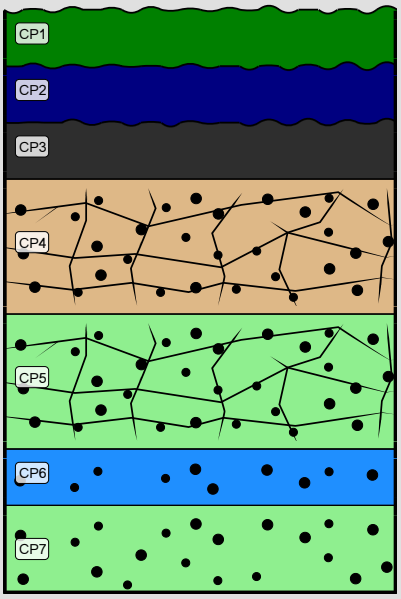
Fig. 5: Stratigraphic representation of the corrosion structure of the axe observed macroscopically under binocular microscope using the MiCorr application with reference to Fig. 4. The characteristics of the strata are only accessible by clicking on the drawing that redirects you to the search tool by stratigraphy representation, Credit HE-Arc CR, N.Gutknecht.

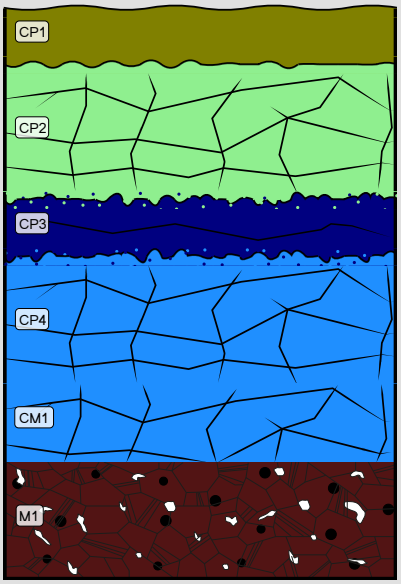
Fig. 17: Stratigraphic representation of the sample of the axe observed in cross-section under dark field using the MiCorr application. The characteristics of the strata are only accessible by clicking on the drawing that redirects you to the search tool by stratigraphy representation. This representation was build according to Fig. 9, Credit LMC-CNRS, V.Valbi.
