PIN LNR40339 – BRONZE – BRONZE AGE – SWITZERLAND

Artefact name	Pin Lnr40339
Authors	Brechbühl. Sabine (archaological service canton Bern, Bern, Bern, Switzerland) & Naima. Gutknecht (HE-Arc CR, Neuchâtel, Neuchâtel, Switzerland) & Valentina. Valbi (Laboratoire Métallurgie et Culture LMC-IRAMAT-CNRS-UTBM, Belfort, Franche-Comté, France)
Url	/artefacts/1255/

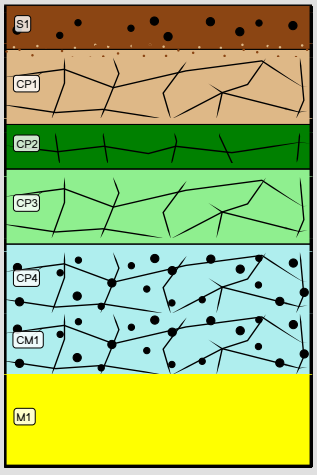
Fig. 3: Stratigraphic representation of the corrosion structure of the pin by macroscopic and binocular observation with location of Fig. 4,

Fig. 4: Stratigraphic representation of the corrosion structure of the pin observed macroscopically under binocular microscope using the MiCorr application with reference to Fig. 3. The characteristics of the strata are only accessible by clicking on the drawing that redirects you to the search tool by stratigraphy representation, Credit HE-Arc CR, N.Gutknecht.

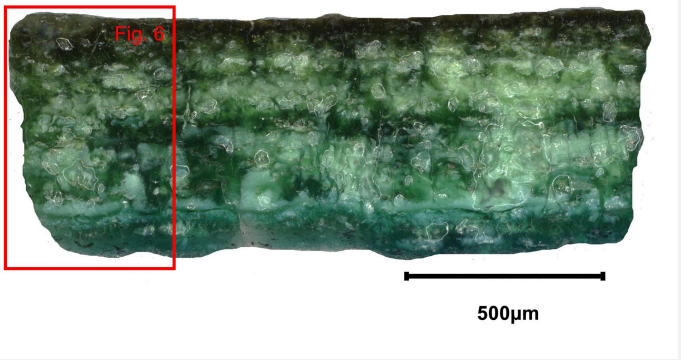
Fig. 5: Micrograph of the cross-section of the fragment from the pin (Fig. 2, left fragment) in dark field showing the location of Fig. 6. The external surface is on top,

Description of sample	The sample is a fragment (a flake) of the corrosion stratigraphy that spontaneously detached from the object (Fig. 5).
Alloy	Bronze
Technology	None
Lab number of sample	
Sample location	archaeological service canton Bern, Bern, Bern
Responsible institution	archaeological service canton Bern, Bern, Bern
Date and aim of sampling	May 2021

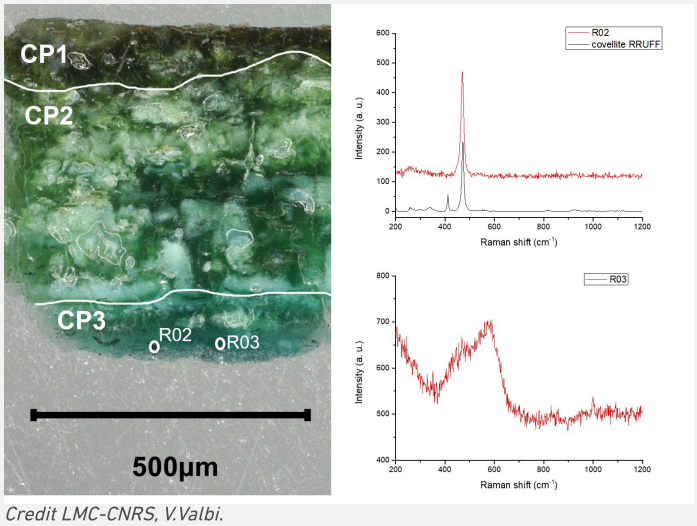
The observation of the sample in cross-section in dark field (Fig. 6) allowed to identify an external 150 µm thick brown stratum (CP1), a green 400 µm thick stratum (CP2), and a blue 150 µm thick stratum (CP3). The EDX analysis (Table 2) shows that the whole corrosion structure has a low Cu content and a much higher Sn content, suggesting then that the metal is a bronze where the corrosion stratigraphy is Cu depleted (14 mass%) and Sn enriched (51 mass%) with none or low polluting elements from external source (Si, P, Al, Fe, Ca, Cl). Dark inclusions mainly observable in the CP3 layer were also analysed and are believed to be copper sulphide. They might be residual metal inclusions.

µ-Raman analyses were performed on the three identified strata but it was not possible to obtain a clear signal for CP1 and CP2 strata. For the blue CP3 stratum the spectrum obtained has a broad peak at 560 cm^{-1} that can be attributed to nanocrystals of cassiterite Sn_2O thanks to comparison with the work of Ospitali et al. 2012. The µ-Raman analysis performed on the dark inclusions showed a spectrum with a peak at 470 cm^{-1} compatible with that of covellite (CuS).

Fig. 6: Micrograph of the corrosion stratigraphy with the subdivision of the different strata from Fig. 5 (detail), dark field with location of Raman analysis points and the respective obtained spectra of covellite for R02 (RRUFFID=R060306) and nanocassiterite for R03 as determined by comparison of the work of Ospitalie et al. 2012,

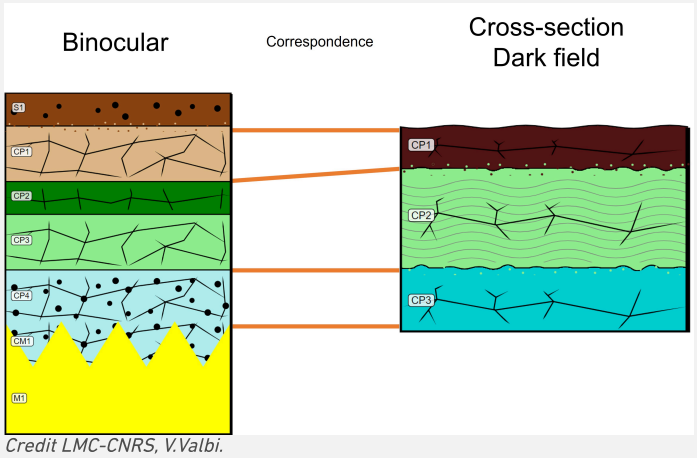
One sediment stratum and 4 CPs were identified by binocular observation on the whole object, while only 3 CPs were identified by cross-sectional observation on one flake of the corrosion stratigraphy. The binocular description allows to discriminate more strata based on texture parameters that do not correspond to clear differences observable in cross-section, thus more than one stratum observed by binocular corresponds to only one stratum in cross-section. The outer sediment layer (S1) and the CP1 identified by the binocular observation coincide with the CP1 observed in cross-section, while the CP2 and CP3 observed by binocular coincide with the CP2 in cross-section. The blue CP4 in binocular coincide with the blue CP3 in cross-section.

The metal is not represented in cross-section as the analysis was carried out on a fragment of the corrosion stratigraphy that spontaneously got detached from the object. In this case, the double approach by binocular and cross-section observation is particularly useful and allows to have a more comprehensive understanding of the object with minimal sampling.

Fig. 8: Stratigraphic representation side by side of binocular view and cross-section (dark field),
