IRON-BASED BAR - FE ALLOY - MODERN TIMES - FRANCE

Artefact name	Iron-based bar
Authors	Christian. Degrigny (HE-Arc CR, Neuchâtel, Neuchâtel, Switzerland) & Mathea. Hovind (University of Oslo, Department of archaeology, conservation and history (IAKH-UiO), Oslo, Oslo, Norway)
Url	/artefacts/1256/

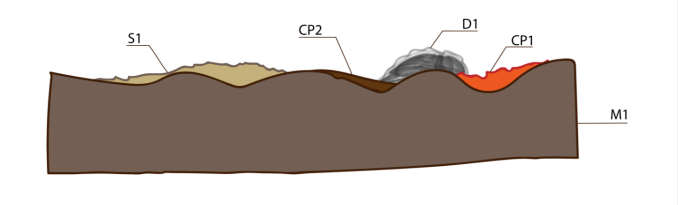
Captions	Description
S1	Light brown soil with a porous and friable consistency.
D1	Black, powdery deposit. Very loosely bound to the surface. Probably charcoal.
CP2	Dark brown and strongly adherent corrosion crust. Almost uniform in appearance - except in areas where it is disturbed by corrosion blisters.
CP1	Bright to dark orange corrosion products.
M1	Remaining metal. Dark grey to brown and matte in appearance. Highly irregular surface with dark pits ranging from approximately 1 – 5 mm in diameter.

Fig. 3: Preliminary stratigraphy of the corrosion structure based on visual microscopic observation,

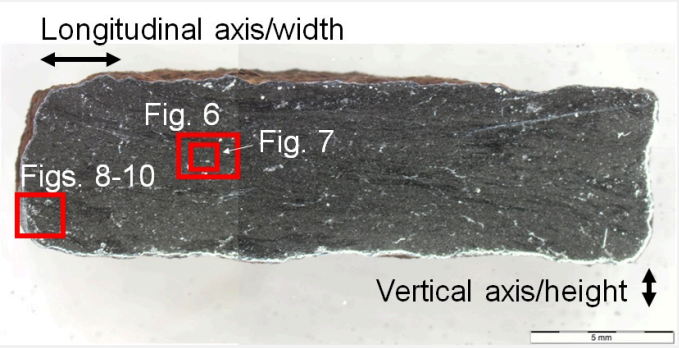
Fig. 4: Micrograph of the cross-section of the iron-based bar with location of Figs. 6-10,

Description of sample	A rectangular section (Fig. 4) was cut out from the tip of the iron bar. Its longitudinal axis corresponds to the width of the iron bar while the height/thickness of the bar is represented by the vertical axis.
Alloy	Fe Alloy
Technology	Puddled iron
Lab number of sample	WIB2018 (Wrought Iron Bar sampled in 2018)
Sample location	HE-Arc CR, Neuchâtel, Neuchâtel
Responsible institution	HE-Arc CR, Neuchâtel, Neuchâtel
Date and aim of sampling	March 2018, study of corrosion stratigraphy and chemical analyses

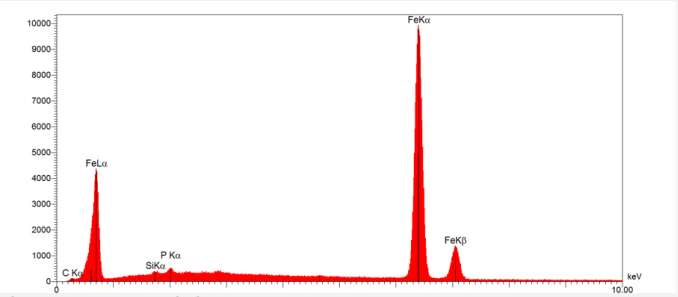
As the section was cut across the iron bar – it is the cross section of the inclusions that are visible. Thus, their length and direction cannot be deduced directly from the sample.

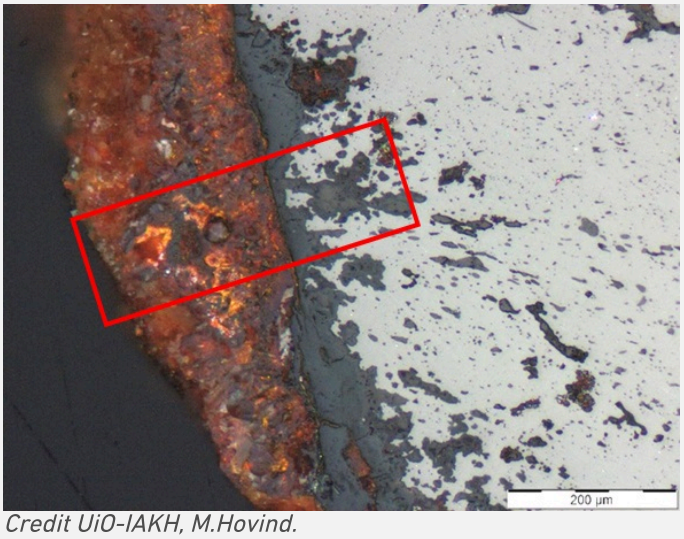
The corrosion crust is typical of exposure of iron to the atmosphere: it is relatively thick and consists of two layers: CP1 and CP2. The latter is a dense product layer appearing light grey under both bright field and polarized light (Figs. 8 and 9). The outermost layer (CP1) is a porous crust, appearing dark grey under bright field and bright orange under polarized light (Figs. 8 and 9). The corroded metal (CM1) appears as isolated areas of corrosion within the sound metal.

Fig. 8: Micrograph of the metal sample from Fig. 4 (detail), unetched, bright field to be compared to the stratigraphy representation of Fig. 11,

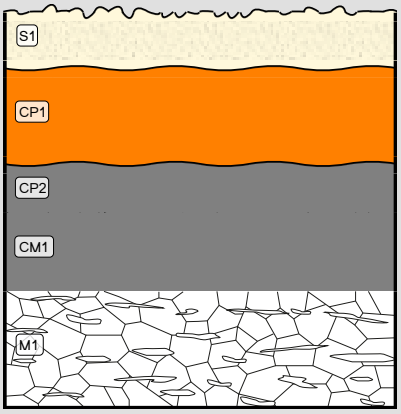
Fig. 11: Stratigraphic representation of the iron-based bar in cross-section (dark field) using the MiCorr application. The characteristics of the strata are only accessible by clicking on the drawing that redirects you to the search tool by stratigraphy representation. This representation can be compared to Figs. 8 and 9, Credit UiO-IAKH, M.Hovind.

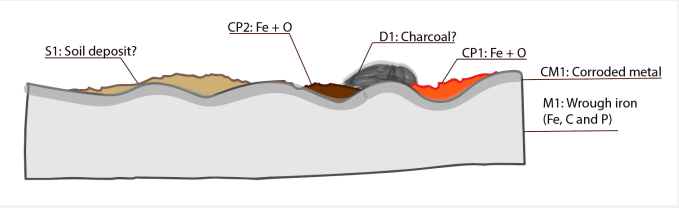
Fig. 12: Improved stratigraphic representation of the iron-based bar based on analyses from cross-section and visual microscopic observation, CP = corrosion product, D = deposit, M = metal S = soil, CM = corroded metal,

The corrosion products on the surface of the iron bar are typical for iron exposed outdoors with varying contents of Fe an O in addition to a layer of Ca-containing soil.
