DOMED CAP NUT - ZN AL SN CU ALLOY - MODERN TIMES - FRANCE

Artefact name Domed cap nut

Authors Christian. Degrigny (HE-Arc CR, Neuchâtel, Neuchâtel, Switzerland) & Mathea. Hovind (University of Oslo, Department of archaeology, conservation and history (IAKH-UiO), Oslo, Oslo, Norway)

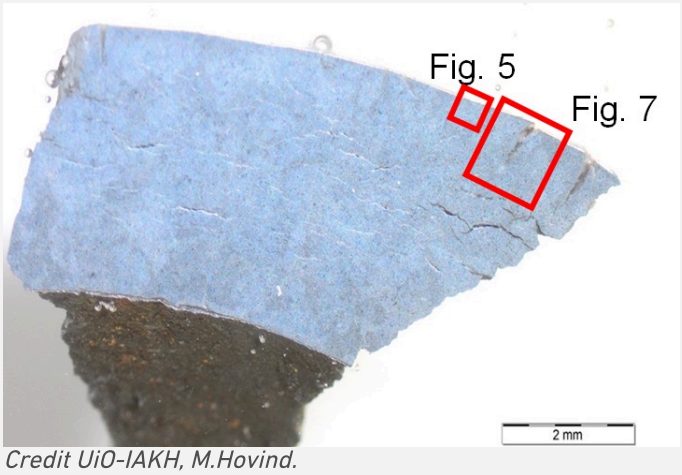
Fig. 4: Micrograph of the cross-section of the sample taken from the domed cap nut showing the locations of Figs. 5 and 7,

Description of sample	The sample is a cross section of the metal, representative of the domed cap nut. It shows external cracks extending from the metal surface and into its structure in addition to internal cracks, visible as thin lines along its longitudinal axis (Fig. 4).
Alloy	Zn Al Sn Cu Alloy
Technology	Cast and plated
Lab number of sample	NZC2018 (Ni/Zn Cap, sampled in 2018)
Sample location	HE-Arc CR, Neuchâtel, Neuchâtel
Responsible institution	HE-Arc CR, Neuchâtel, Neuchâtel
Date and aim of sampling	March 2018, study of corrosion stratigraphy and chemical analyses

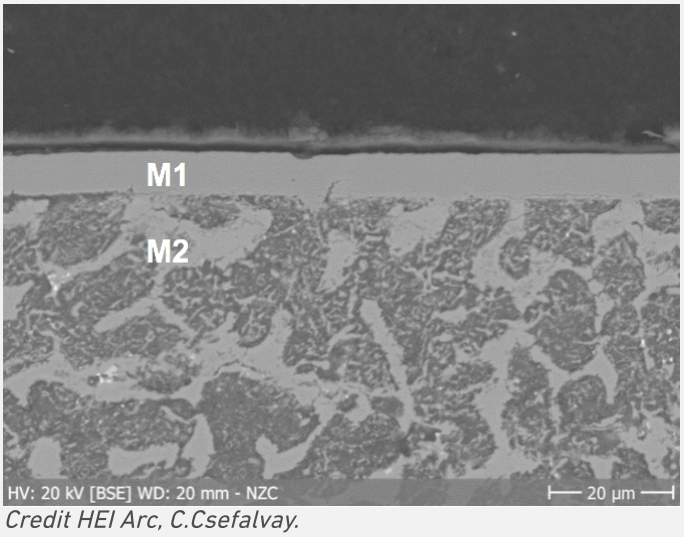
The metal of the domed cap nut (M2) consists of a Zn/Al/Pb/Cu/Sn alloy (Table 1) externally covered by a nickel-based plating (M1) (Figs. 5 and 6) containing some cobalt (Co). The bulk metal (M2) has a dendritic microstructure appearing light grey in bright field, while the interdendritic phase appears white (Fig. 7). The latter is Zn-rich, while the dendritic phase consists of approximately equal amounts of Zn and Al (Table 2, Fig. 9). Observation in SEM (BSE-mode) reveals the presence of Pb-nodules, visible as white irregular spots with a scattered distribution, in addition to opaque grey patches which are rich in Al and Fe (Fig. 8).

Fig. 5: SEM-image (BSE-mode) of a selected area from Fig. 4 (detail), showing the metal plating (M1) and the bulk metal (M2),

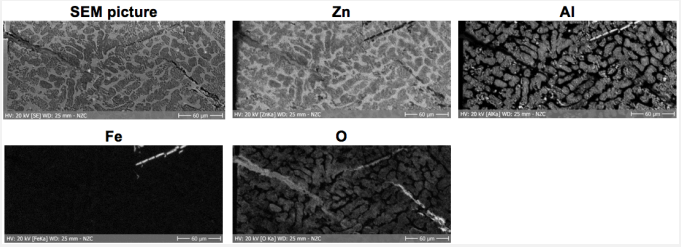
Fig. 9: SEM image and elemental chemical distribution of the selected area from Fig. 7 (rotated 270° and inversed). Method of analysis: SEM-EDS. Lab. of Electronic Microscopy and Microanalysis, Néode, HEI Arc,

The dendritic phase is heavily oxidized compared to the interdendritic phase (Table 2 and Fig. 10). The corrosion has developed throughout the entire metal body, generating cracks (Fig. 7). The cracks are Zn and O-rich (Fig. 10) and could be composed of zinc oxide or carbonate. It could be a case of zinc pest, a corrosion phenomenon known to cause disintegration in poor quality alloys (Selwyn 2004, Zhang 2011).

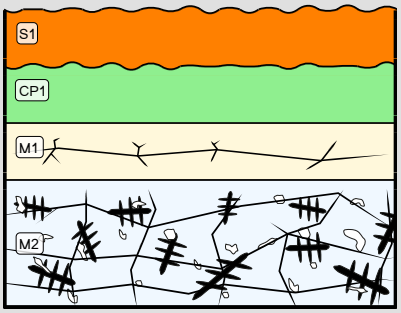
Fig. 11: Stratigraphic representation of the sample taken from the domed cap nut in cross-section (dark field) using the MiCorr application. The characteristics of the strata are only accessible by clicking on the drawing that redirects you to the search tool by stratigraphy representation. Stratigraphy representative of an area with intact metal plating (M1). S1 represents Fe-polluted soil while CP1 is a green translucent corrosion product, Credit UiO-IAKH, M.Hovind.
