ROOF GUTTER ELEMENT – ZN ALLOY – MODERN TIMES – FRANCE

Artefact name	Roof gutter element
Authors	Christian. Degrigny (HE-Arc CR, Neuchâtel, Neuchâtel, Switzerland) & Mathea. Hovind (University of Oslo, Department of archaeology, conservation and history (IAKH-UiO), Oslo, Oslo, Norway)
Url	/artefacts/1258/

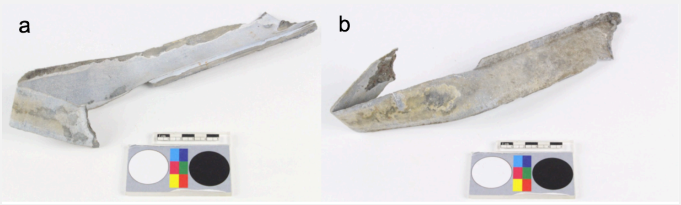
Fig. 1: Roof gutter element having different appearances on each of its surfaces: "a" on the left and "b" on the right,

Description of the artefact	A roof gutter element with remains of lead solder (Fig. 1). Its surfaces are covered by a white, strongly adherent oxide layer. Surface “b” is slightly darker in colour than surface “a” due to the presence of soil particles. Dimensions: L = 265mm; W = 47mm; T = 1mm; WT = 93g.
Type of artefact	Architectural element
Origin	Château de Germolles, Mellecey, Bourgogne, France
Recovering date	Unknown
Chronology category	Modern Times
chronology tpq	1900 A.D.
chronology taq	2000 A.D.
Chronology comment	19th-20th century
Burial conditions / environment	Outdoor atmosphere
Artefact location	HE-Arc CR, Neuchâtel, Neuchâtel
Owner	Château de Germolles, Mellecey, Bourgogne

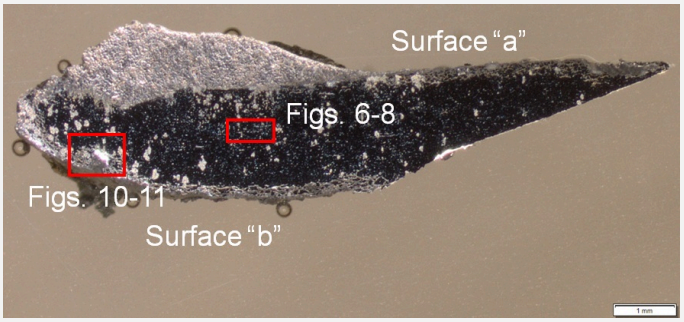
Fig. 4: Micrograph of the sample taken from the roof gutter showing the locations of Figs. 6-8 and 10-11. The uppermost area (in white) is remains of solder, while the zinc metal appears dark grey to black (the white patches are due to secondary oxidation of the sample),

Description of sample	A cross-section (Fig. 4) was cut out where the metal is at an angle of approximately 90° to the flat surface. Its upper edge corresponds to surface “a” and contains remains of solder, while the lower edge corresponds to surface “b”.
Alloy	Zn Alloy
Technology	Annealed after (hot) rolling
Lab number of sample	ZG2018 (zinc gutter sampled in 2018)
Sample location	HE-Arc CR, Neuchâtel, Neuchâtel
Responsible institution	HE-Arc CR, Neuchâtel, Neuchâtel
Date and aim of sampling	March 2018, metallography and chemical analyses

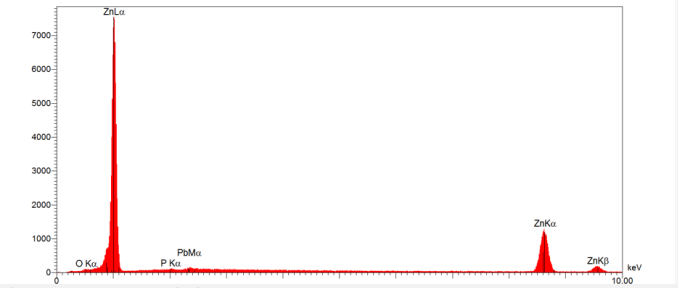
The roof gutter element is composed of Zn with P and Pb at lower concentrations (Fig. 5). The latter is probably originating from the solder that was applied to adjoin several metal sheets for the roof gutter.

Fig. 5: Chemical composition of the metal. Method of analysis: SEM-EDS. Lab. of Electronic Microscopy and Microanalysis, Néode, HEI Arc,

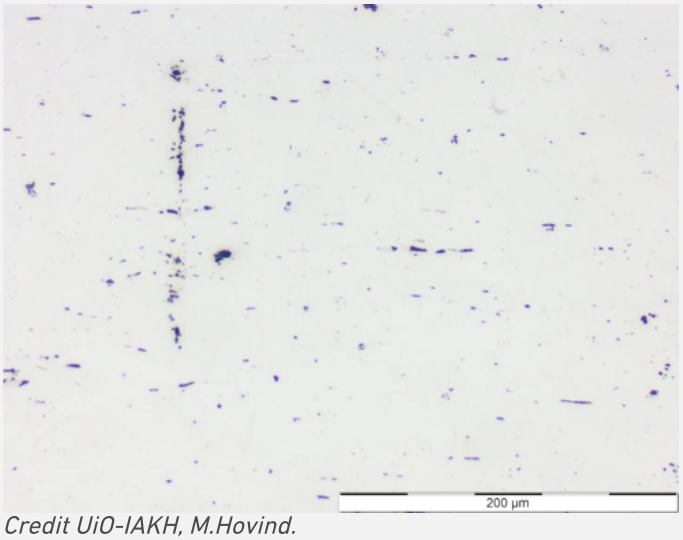
Fig. 6: Micrograph of the metal sample from Fig. 4 (detail). Unetched, bright field,

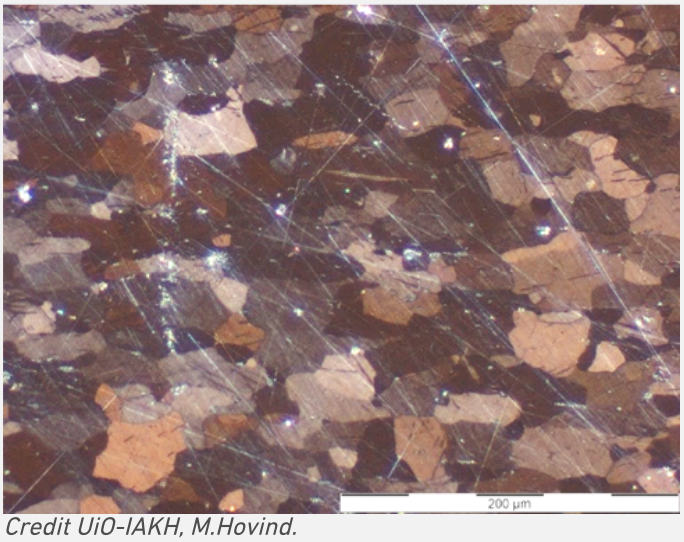
The metal appears white to light grey under bright field (Fig. 6). Under polarized light however (Fig. 78), the microstructure of the metal is visible as small polygonal grains appearing in various shades of brown, a coloured effect due to the anisotropic properties of the metal (Scott 1991: 49). In the SEM-image, white elongated inclusions are visible (Fig. 8) consisting mainly of Zn and Pb with some O (Fig. 90).

Fig. 7: Micrograph similar to Fig. 6, but under polarized light.The microstructure of the metal shows the presence of small and polygonal grains in shape,

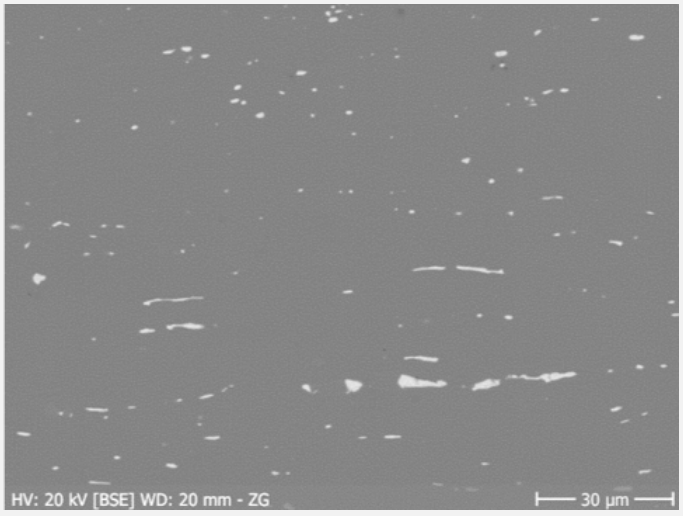
Fig. 8: SEM-image (BSE-mode) of the metal sample from Fig. 4 (detail) showing the white elongated inclusions,

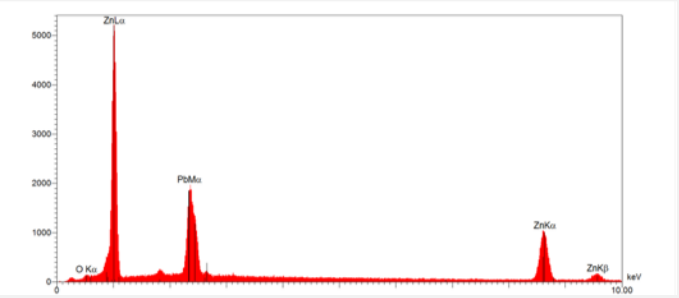
Fig. 9: SEM-EDS spectrum showing the composition of the elongated inclusions from Fig. 8. Method of analysis: SEM-EDS. Lab. of Electronic Microscopy and Microanalysis, Néode, HEI Arc,

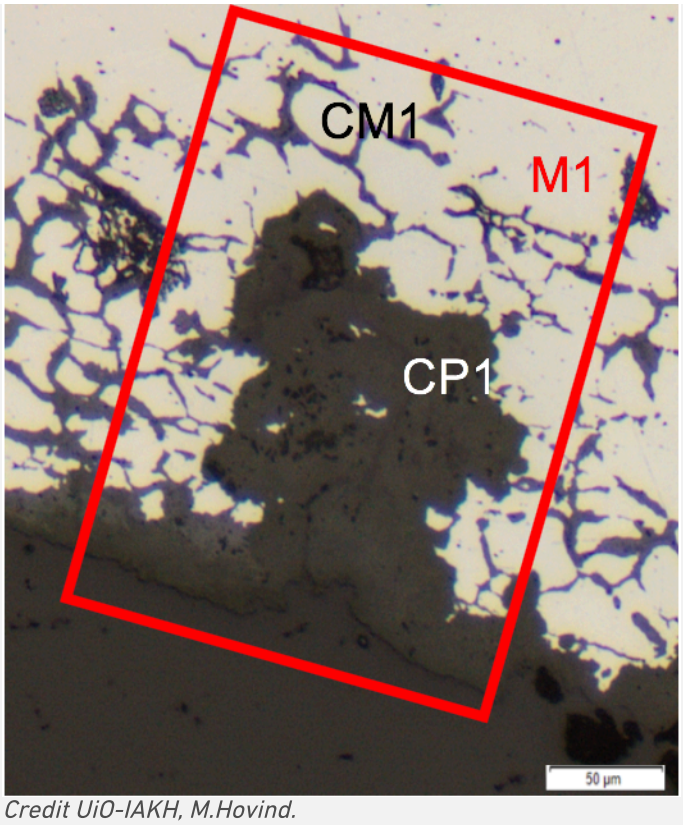
The metal is suffering from intergranular corrosion visible as a white corrosion product (CP1) located within crevices and along the grain boundaries (Figs. 10 and 11). The porous and powdery corrosion product (CP1) appears dark grey in bright field (Fig. 10) and white-grey under polarized light (Fig. 11). It consists of Zn and O (Table 1). The external corrosion product (CP1) contains some S (and not Pb as suggested by Table 1 and Fig. 13) which is probably due to atmospheric pollution. The structural composition of the corrosion product was determined by crystallographic analysis (XRD) to consist of a mixture of zincite (ZnO) and pure zinc (Zn) (Table 2, Fig 12). Mapping of the corroded area by SEM-EDS displays a similar composition but shows additionally the presence of Cl in some of the veins of the corroded metal (Fig. 13). S1 (soil material) is found on the very top of CP1.

Elements mass %* Stratum	C	O	Zn	Pb	S	Al	Si	Fe	Cu	Sn
CP1, white corrosion product	7	33	51	3	5	-	<1	<1	<1	<1
CM1, intergranular corrosion	6	22	68	3	<1	<1	<1	<1	<1	<1

Fig. 10: Micrograph of the metal sample from Fig. 4 (detail). Unetched, bright field. The corrosion product (CP1) is located at the surface of the metal and in its crevices. Intergranular corrosion (CM1) is visible as thin grey lines in between the metal grains (M1). The corrosion structure is to compare to the stratigraphy representation of Fig. 14. The area selected for elemental chemical distribution (Fig. 13) is marked by a red rectangle,

The roof gutter element consists of Zn with some Pb from the lead solder. It is covered by a strongly adherent layer of zincite (a zinc oxide), indicative of exposure to an unpolluted environment. Still, the metal exhibits intergranular corrosion, a deterioration phenomenon indicative of aggressive conditions. This can possibly be explained by the different locations of the samples. The cross-section studied is likely to correspond to the surface that was exposed to the atmosphere (surface "b"), while the powder samples were from the rear, unexposed surface (surface "a"). Exposure to moisture and low pH in the form of acidic rain are environmental parameters that would encourage intergranular corrosion. Furthermore, the presence of Cl inside the cracks could be due to pollution and its rather concealed location implies that it would be retained inside the metal and not washed away by rain (Selwyn 2004:153-154).

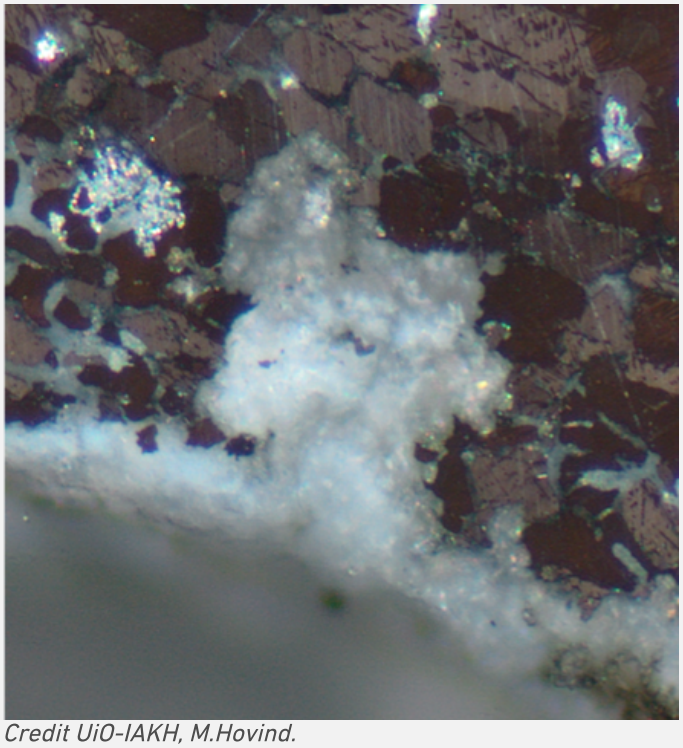
Fig. 11: Micrograph similar to Fig. 10 but under polarized light, the corrosion product (CP1) and the corroded metal (CM1) appear white,

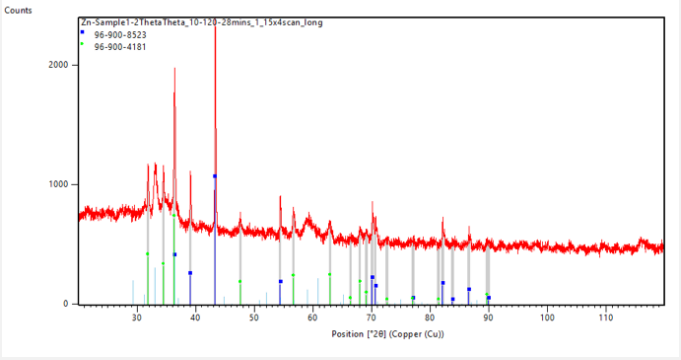
Table 2: Summary of the results from the crystallographic analysis of the white corrosion product (CP1). A representative spectrum is given in Fig. 12. Method of analysis: XRD. Center of X-ray Analytics, Empa-Swiss Federal Laboratories for Materials Science and Technology (Dübendorf), credit MiCorr_Empa, Z.Balogh-Michels. *The results are based on the analysis of two powder samples from different areas (see Fig. 2 for sample locations).

Fig. 12: XRD-spectrum for the analysis of powder sample 1. Ref. 96-900-8523 (in blue) corresponds to pure zinc and 96-900-4181 (in green) to zincite (ZnO),

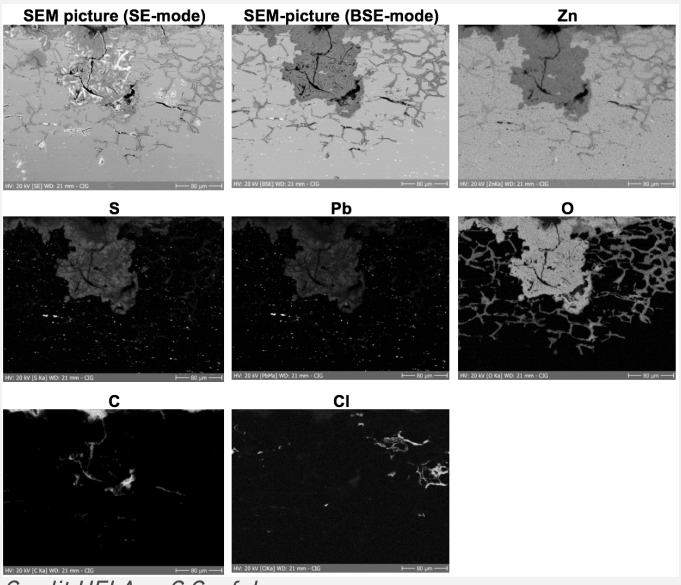
Fig. 13: SEM image and elemental chemical distribution of a selected area of Fig. 10 (rotated almost 180° and reversed). Method of analysis: SEM-EDS. Lab. of Electronic Microscopy and Microanalysis, Néode, HEI Arc,

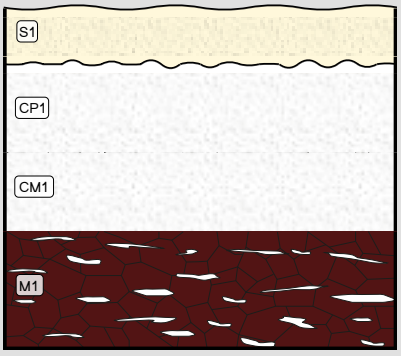
Fig. 14: Stratigraphic representation of the sample taken from the roof gutter (surface "b") in cross-section (dark field) using the MiCorr application. The characteristics of the strata are only accessible by clicking on the drawing that redirects you to the search tool by stratigraphy representation. This representation can be compared to Figs. 10 and 11, Credit UiO-IAKH, M.Hovind.
