COATED LAMP POST(?) FRAGMENT - GREY CAST IRON - MODERN TIMES - SWITZERLAND

Artefact name	Coated lamp post(?) fragment
Authors	Christian. Degrigny (HE-Arc CR, Neuchâtel, Neuchâtel, Switzerland) & Mathea. Hovind (University of Oslo, Department of archaeology, conservation and history (IAKH-UiO), Oslo, Oslo, Norway)
Url	/artefacts/1259/

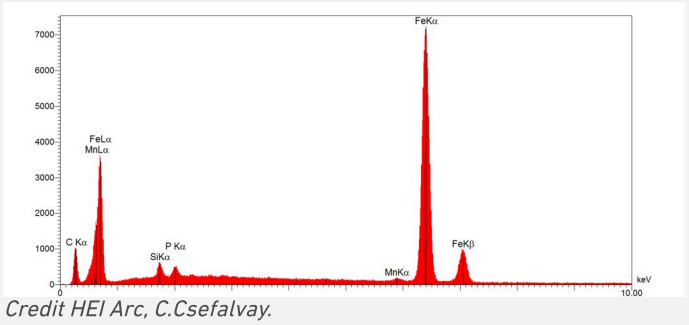
The metal is a grey cast iron with characteristic graphite flakes (Fig. 6). It contains C in addition to P, Mn and some Si (Fig. 7). Its matrix consists of a P-rich eutectoid and a dendritic phase; the latter containing a significant amount of C, but less P than the aforementioned eutectoid (Table 1).

Fig. 6: Micrograph of the metal sample from Fig. 4 (detail), unetched, bright field. The microstructure of the metal consists of graphite flakes in a matrix of dendrites (light grey) and an interdendritic eutectoid phase (light brown). The global analysis of the metal (Fig. 7) was carried out on a surface area of similar size,

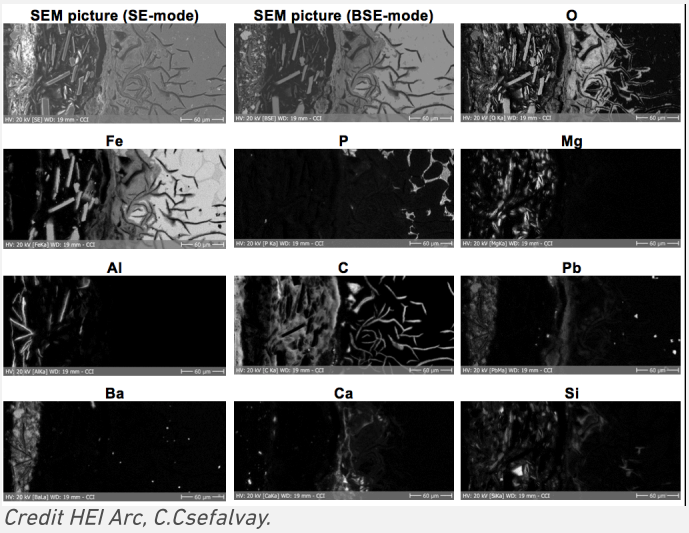
The metal has developed a thin graphitized layer (CP1) as well as a corroded metal phase (CM1). The later is located just beneath NMM3 and appears dark grey under polarized light (Fig. 8). It consists mainly of Fe and O with Pb and Ca (Table 4, Fig. 10). Pb can probably be explained by the proximity to the Pb-rich paint layer NMM3 (Table 2). The presence of Ca is more interesting however, as it might originate from past exposure to the environment, implying that the paint was not applied immediately after fabrication. The composition of CP1 was not analyzed.

Fig. 10: SEM image and elemental chemical distribution of the selected area from Fig. 9 (rotated 270°). Method of analysis: SEM-EDS. Lab. of Electronic Microscopy and Microanalysis, Néode, HEI Arc,

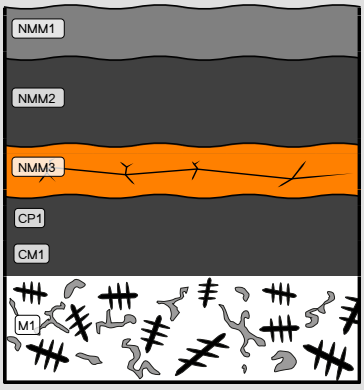
Fig. 11: Stratigraphic representation of the sample taken from the lamp post (?) fragment in cross-section (dark field) using the MiCorr application. The characteristics of the strata are only accessible by clicking on the drawing that redirects you to the search tool by stratigraphy representation. This representation can be compared to Fig. 8, Credit UiO-IAKH, M.Hovind.

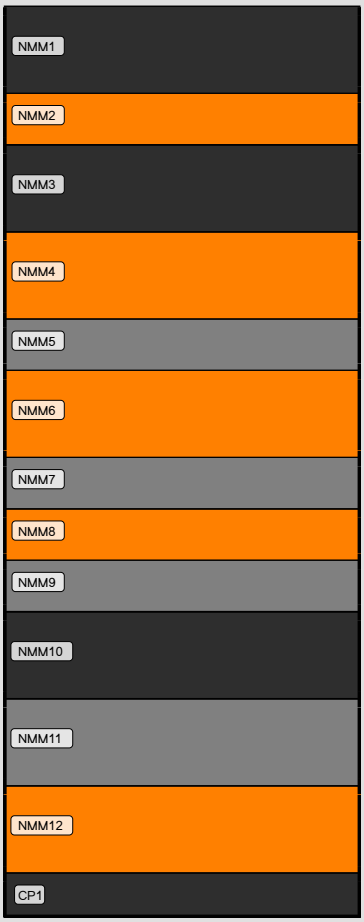
Fig. 12: Stratigraphic representation of paint layer in cross-section based on Fig. 5 using the MiCorr application. The characteristics of the strata are only accessible by clicking on the drawing that redirects you to the search tool by stratigraphy representation, Credit UiO-IAKH, M.Hovind.

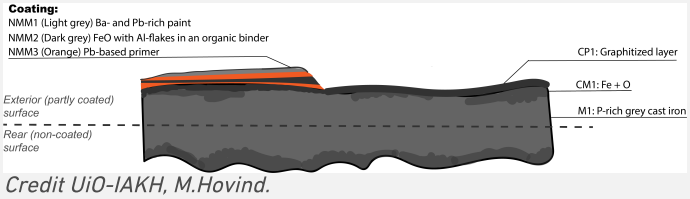
Fig. 13: Improved stratigraphic representation of the lamp post (?) fragment with results from analyses by SEM-EDS and visual microscopic observation. The colour of the metal was changed to grey as this was the colour of the metal when viewed in cross-section. NMM = non-metallic material, CP = corrosion product, CM = corroded metal, M = metal,

The lamp post (?) fragment is a grey cast iron with a microstructure consisting of graphite flakes and a P-rich eutectic phase. It is coated by several paint layers, up to 12 in total. What appears to be a Pb-based primer is located right next to the metal, followed by a black layer consisting of aluminium flakes and iron oxide in an organic binder and superimposed by a light grey, Ba- and Pb-rich paint layer. Inhibitive primers often contain red lead in linseed oil (Hare 2011:979). The uppermost layer is dark in colour and corresponds to the black paint layer previously mentioned.

It seems likely that the lamp post(?) fragment has been treated with a system of at least three different paints which have all been applied several times, hence the relatively thick coating. The efficiency of the paint system is proven by the fact that internal corrosion is much more prominent in areas that are not protected by paint system. Corrosion control by application of paint films is a well-known treatment of metals (Hare 2011:971, Selwyn 2004:109). The use of an anti-corrosion system consisting of several layers of paint with different colours is known to facilitate monitoring as a break in the coating will be readily visible. Additionally, the presence of more than one paint layer will minimize the risk for a hole in the coating and help avoid localized corrosion (Selwyn 2004:105).
