RAIN GUTTER FRAGMENT – GREY CAST IRON – MODERN TIMES – FRANCE

Artefact name	Rain gutter fragment
Authors	Christian. Degrigny (HE-Arc CR, Neuchâtel, Neuchâtel, Switzerland) & Mathea. Hovind (University of Oslo, Department of archaeology, conservation and history (IAKH-UiO), Oslo, Oslo, Norway)
Url	/artefacts/1261/

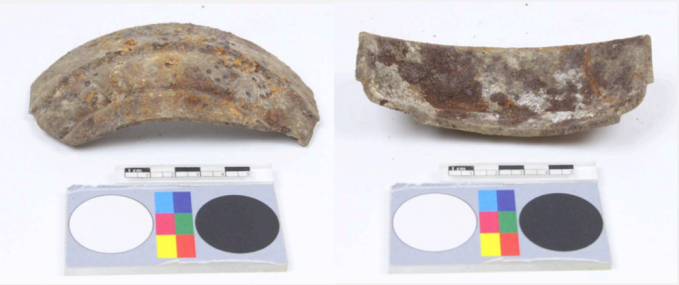
Fig. 1: Rain gutter fragment, exterior and interior faces (to the left and right, respectively),

Description of the artefact	Rain gutter fragment (Fig. 1), possibly part of the extension of a roof drain pipe. Both the exterior and interior surfaces are covered by heterogeneous corrosion crusts. The underlying metal seems however to be well preserved, including features such as a difference in thickness etc. Dimensions: L = 55mm; W (interior) = 120mm; Tmax. = 6mm; WT = 176g.
Type of artefact	Architectural element
Origin	Château de Germolles, Mellecey, Bourgogne, France
Recovering date	Unknown
Chronology category	Modern Times
chronology tpq	1801 A.D.
chronology taq	2000 A.D.
Chronology comment	19th - 20th century

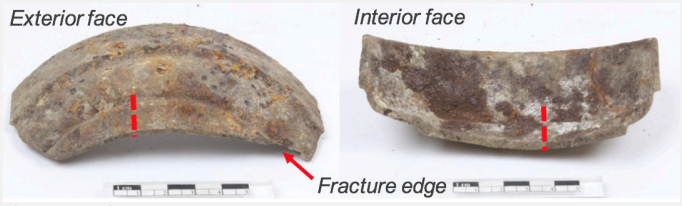
Fig. 2: The exterior and interior faces before sampling. The dotted line represents the sample location (a cross-section of the metal). The fracture edge corresponds to the edge that was formerly attached to the remaining artefact,

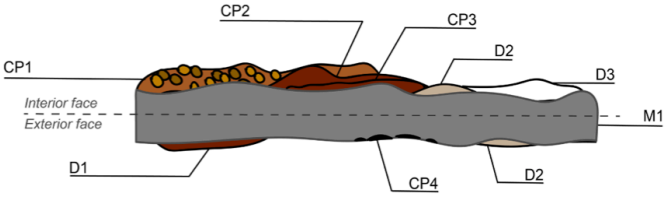
Captions	Description
D1	Scattered, orange to dark red encrustations. Probably corrosion products mixed with soil.
D2	Grey-brown and matte deposit, somewhat powdery - possibly corrosion product mixed with soil. This layer is located both on the interior and exterior surface of the artefact.
D3	Localized, white and strongly adherent deposit.
CP1	Bright orange to dark red corrosion product. Uneven surface with pustules.
CP2	Red-brown corrosion crust. Brittle, but adherent. Flakes off in bits when force is applied perpendicular to the surface with a scalpel.
CP3	Similar to CP2 but appears to be an individual layer.
CP4	Isolated corrosion blisters. Circular and black in colour. Mainly located on the exterior surface.
M1	Intact metal with a dark grey metallic sheen.

Fig. 3: Preliminary stratigraphy of the corrosion structure based on visual microscopic observation,

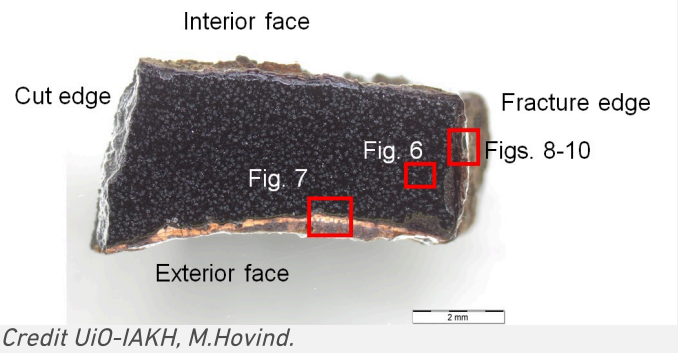
Fig. 4: Micrograph of the sample taken from the rain gutter fragment showing its orientation relative to the artefact and the locations of Figs. 6-10,

Description of sample	The sample consists of a rectangular section (Fig. 4) which was cut out from the fractured edge of the gutter fragment. It is representative of three surfaces: the exterior and interior surface, as well as the fracture edge. Dimensions: L = 7mm; Wmax. = 5mm; Tmax. = 4mm (approx.).
Alloy	Grey cast iron
Technology	Cast
Lab number of sample	CIG2018 (Cast Iron Gutter, sampled in 2018)
Sample location	HE-Arc CR, Neuchâtel, Neuchâtel
Responsible institution	HE-Arc CR, Neuchâtel, Neuchâtel
Date and aim of sampling	March 2018, study of corrosion stratigraphy and chemical analyses

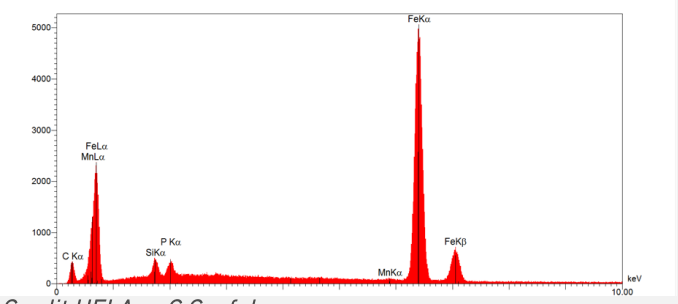
The metal is a P-rich grey cast iron with Si and Mn (Fig. 5). Its microstructure is characterized by evenly distributed graphite flakes in a matrix composed of dendrites and an interdendritic eutectic phase (Fig. 6). What appears to be irregular graphite flakes / porosity is in fact deformed graphite flakes; graphite is soft and prone to destruction by smearing and/or preferential removal during polishing (Scott 1991).

Fig. 5: EDS-spectrum showing the chemical composition of the metal. Method of analysis: SEM-EDS. Lab. of Electronic Microscopy and Microanalysis, Néode, HEI Arc,

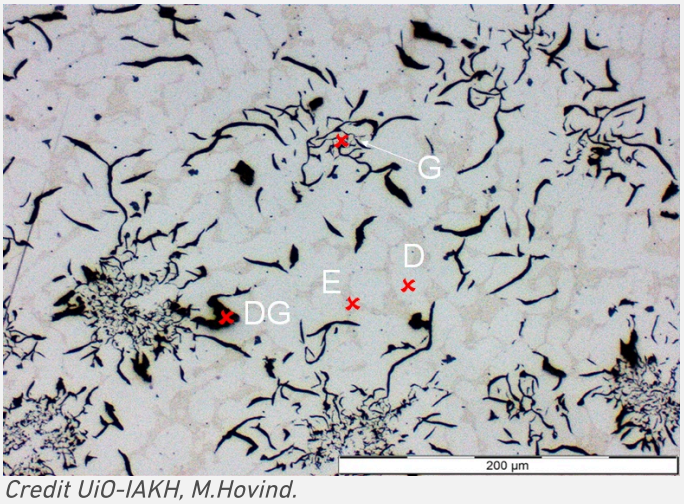
The dendrites appear light grey under polarized light, while the eutectic phase appear light brown (Fig. 6). The eutectic phase is rich in Fe and P and contains small amounts of C and Si, whereas the dendritic phase contains much less P (Table 1).

Fig. 6: Micrograph of the metal sample from Fig. 4 (detail). Unetched, bright field. Graphite flakes (G) in black, the dendrites (D) in light grey and the eutectoid phase (E) in light brown. Deformed graphite (DG) flakes are visible as irregular black inclusions,

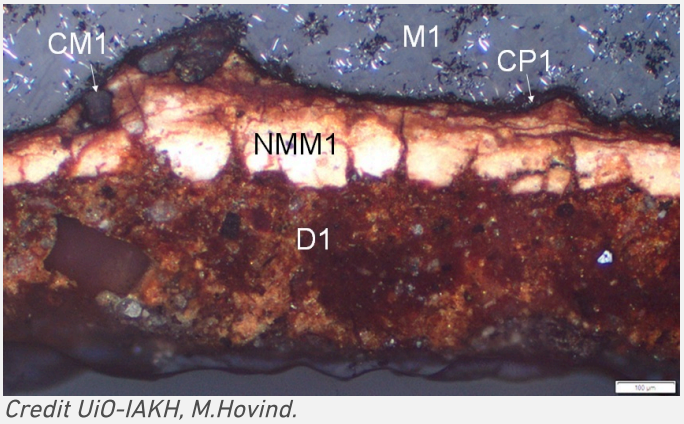
The exterior face (Figs. 2, 4 and 7) consists of a white / light yellow cracked layer (NMM1 in Fig. 7) superimposed by a layer of deposit mixed with orange-red corrosion products (D1 in Fig. 7). Local analysis by SEM-EDS (Table 2) revealed that the white / light yellow layer is rich in Ba, O, S, Fe, C and Zn. It has a chemical composition similar to Lithopone ($BaSO_4$,ZnS), a preparatory paint layer. Fe is probably a contamination from the superimposed porous deposit / corrosion product D1 (Table 2). The latter (D1) is Fe- and O-rich and contains Si, Al and some Ca, in addition to a range of elements (K, P, Na, Cl, S and Ti) present in minor amounts (Table 2). A thin layer of corrosion products (CP1) is located just beneath the paint layer, appearing dark grey under polarized light (Fig. 7). This layer is followed by a corroded metal phase (CM1). Their exact composition was not analyzed but is likely to correspond to the corroded metal phase of the fracture edge, described below.

Fig. 7: Micrograph of the metal sample from Fig. 4 (detail), unetched, polarized light, 5x. Stratigraphy of the exterior surface, to be compared to Fig. 11 and from top to bottom: the metal (M1) in grey, a layer of corroded metal (CM1) followed by a thin layer of CP1, and a white cracked layer (NMM1) superimposed by a porous dark-red deposit (D1),

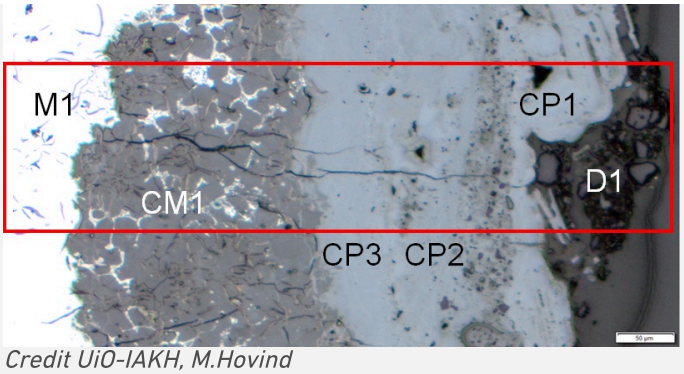
The interior face (Figs. 2 and 4) shows similar characteristics but does not include a white layer similar to NMM1. The fracture edge however (Figs. 2, 4 and 8), shows a more complex stratigraphy consisting of a dense product layer which can be further divided into two individual strata (CP3 and CP2), superimposed by a porous corrosion crust appearing orange under polarized light (CP1) (Fig. 9). The corroded metal (CM1) is located just beneath CP3 and contains remnants of the P-rich eutectic phase (Figs. 8-10). The M/CP ratio (metal to corrosion products) is rather high, implying extensive internal corrosion. Furthermore, cracks are traversing the whole corrosion layers – indicating a fragilization of the structure. As for the composition of the corrosion products CP1, CP2 and CP3, they all contain Fe and O (Fig. 10). A marbling effect within CP2 and CP3 indicates a variation in the concentration of Fe and O (particularly visible in bright field - Fig. 8). The white deposit (D1 in Figs. 8 and 9) might originate from exposure to calcareous water (Table 2). The presence of exogenous elements such as Si, Ca, Al, Na and O (Table 2) was confirmed by elemental mapping (Fig. 10).

Fig. 8: Micrograph of the metal sample from Fig. 4 (detail), unetched, bright field. Stratigraphy of the fracture edge, to be compared to Fig. 12 and from left to right: intact metal (M1) in white, followed by preferentially corroded metal (CM1) and dense product layers (CP3 and CP2) in various shades of grey. CP1 is slightly porous and covered by grain-like particles (D1). The area selected for elemental chemical distribution (Fig. 12) is marked by a red rectangle,

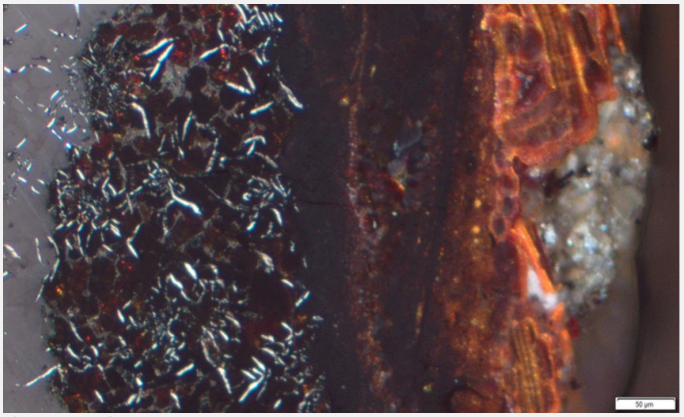
Fig. 9: Micrograph similar to Fig. 8 but under polarized light. The external deposit (D1) appears grey-white, CP1 in bright orange, while CP2 and CP3 appear dark red to brown. The corroded metal (CM1) contains remnants of graphite flakes (in white) and the P-rich eutectic (in grey),

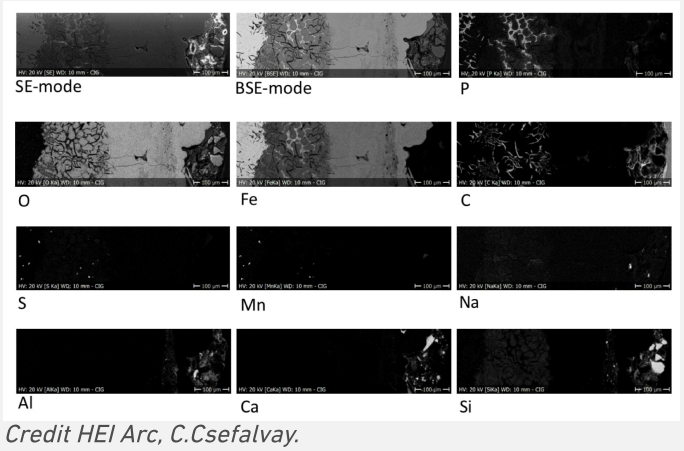
Fig. 10: SEM image and elemental chemical distribution of the selected area from Fig. 8. Method of analysis: SEM-EDS. Lab. of Electronic Microscopy and Microanalysis, Néode, HEI Arc,

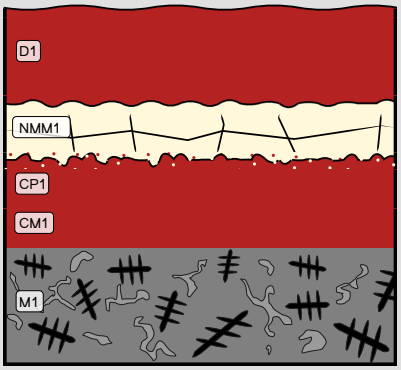
Fig. 11: Stratigraphic representation of the sample taken from the rain gutter fragment in cross-section (dark field) using the MiCorr application. The characteristics of the strata are only accessible by clicking on the drawing that redirects you to the search tool by stratigraphy representation. This representation can be compared to Fig. 7 (exterior surface). CP1 corresponds to CP2 in Fig. 3, Credit UiO-IAKH, M.Hovind.

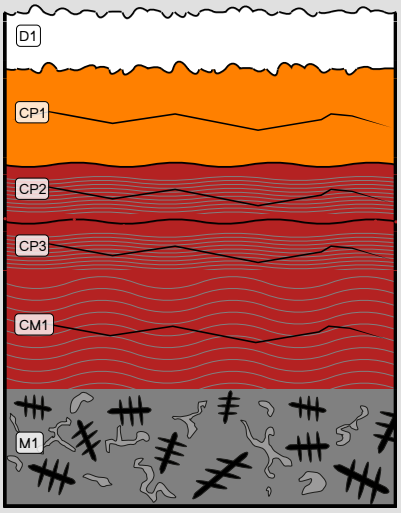
Fig. 12: Stratigraphic representation of the sample taken from the rain gutter fragment in cross-section (dark field) using the MiCorr application. The characteristics of the strata are only accessible by clicking on the drawing that redirects you to the search tool by stratigraphy representation. This representation can be compared to Figs. 8 and 9 (fracture edge). D1 corresponds to D3 in Fig. 3, Credit UiO-IAKH, M.Hovind.

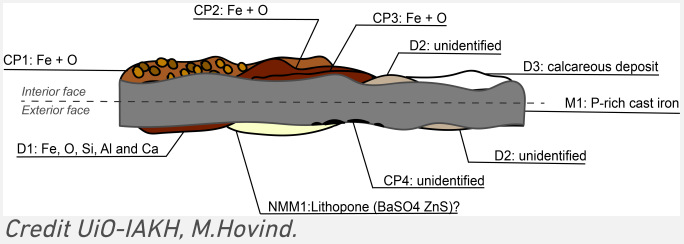
Fig. 13: Improved stratigraphic representation of the rain gutter fragment based on analysis from cross-section and visual microscopic observation,

The rain gutter fragment is a grey cast iron with a microstructure consisting of graphite flakes and a P-rich eutectic phase. The corrosion layers of the exterior surface contains a preparatory paint layer, located beneath a layer of iron corrosion products mixed with soil. It seems likely that the cast iron gutter has been covered with a protective paint layer (e.g. Lithopone) to slow down the rate of atmospheric corrosion. The presence of Lithopone reinforces the suggested dating of the artefact (20th century) as this pigment was developed and used from the 1880s and onwards (Lithopone 2007). However, it seems that the protective layer has none or only very limited effect as (pitting) corrosion is present also in these areas.

The corrosion layers consist mainly of Fe and O, indicating atmospheric corrosion with presence of only a very small amount of contaminants/pollution. The scattered white deposit is possibly originating from exposure to calcareous

water as it is localized mainly on the interior face of the fragment, where rain water would hit the metal before entering the ground.
