VOTIVE FIGURE OF A BAT IVB4168 – GILDED BRASS – MODERN TIMES

Artefact name Votive figure of a bat IVb4168

Authors Christian. Degrigny (HE-Arc CR, Neuchâtel, Neuchâtel, Switzerland) & Naima. Gutknecht (HE-Arc CR, Neuchâtel, Neuchâtel, Switzerland) & Valentin. Boissonnas (HE-Arc CR, Neuchâtel, Neuchâtel, Switzerland)

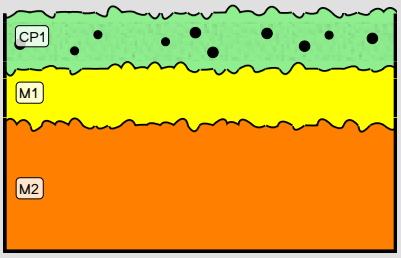
Fig 5: Stratigraphic representation of the corrosion structure of area 1 (Fig. 4) observed macroscopically under binocular microscope using the MiCorr application. The characteristics of the strata are only accessible by clicking on the drawing that redirects you to the search tool by stratigraphy representation, Credit HE-Arc CR, N.Gutknecht.

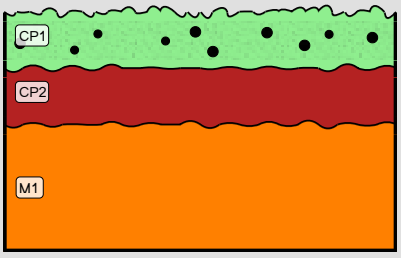
Fig. 6: Stratigraphic representation of the corrosion structure of area 2 (Fig. 4) observed macroscopically under binocular microscope using the MiCorr application. M1 is M2 in Fig. 5. The characteristics of the strata are only accessible by clicking on the drawing that redirects you to the search tool by stratigraphy representation, Credit HE-Arc CR, N.Gutknecht.

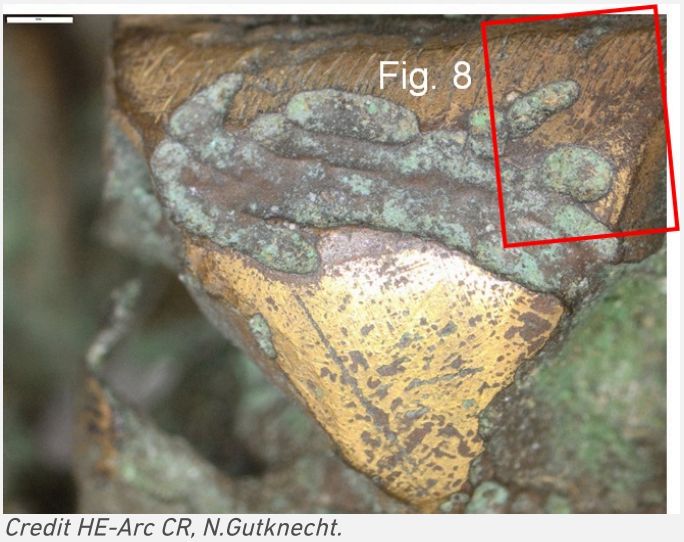
The metal seems to have been heavily attacked (acid dissolution). There are several perforations on the lower part of the object, and where the gold layer is absent the surface is unevenly pitted by corrosion (Figs. 1, 2 and 7). The submetallic core is not visible from the surface.

There are two corrosion products (Figs. 7 and 8). The red one (CP2) has a submetallic brightness and is opaque, non-magnetic, compact, hard and adherent. It is very thin (less than a few microns thick) and only appears where the gold layer has been lost. The EDX spectrum (Fig. 9) shows that it is a Cu- and O rich product, probably cuprite (Cu_2O).

Fig. 7: Binocular image of the nose of the bat showing detail of Fig. 8,
