VOTIVE FIGURE OF A BAT IVB4168 – GILDED BRASS – MODERN TIMES

Artefact name Votive figure of a bat IVb4168

Authors Christian. Degrigny (HE-Arc CR, Neuchâtel, Neuchâtel, Switzerland) & Naima. Gutknecht (HE-Arc CR, Neuchâtel, Neuchâtel, Switzerland) & Valentin. Boissonnas (HE-Arc CR, Neuchâtel, Neuchâtel, Switzerland)

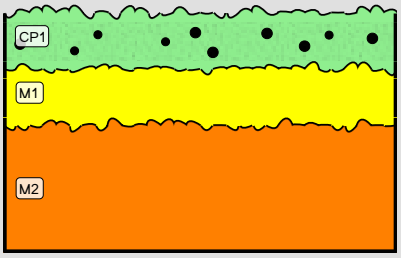
Fig 5: Stratigraphic representation of the corrosion structure of area 1 (Fig. 4) observed macroscopically under binocular microscope using the MiCorr application. The characteristics of the strata are only accessible by clicking on the drawing that redirects you to the search tool by stratigraphy representation, Credit HE-Arc CR, N.Gutknecht.

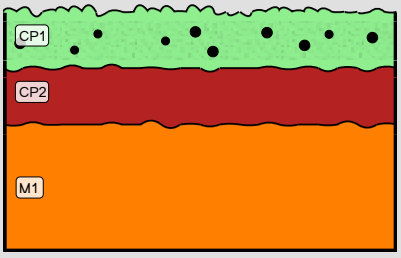
Fig. 6: Stratigraphic representation of the corrosion structure of area 2 (Fig. 4) observed macroscopically under binocular microscope using the MiCorr application. M1 is M2 in Fig. 5. The characteristics of the strata are only accessible by clicking on the drawing that redirects you to the search tool by stratigraphy representation, Credit HE-Arc CR, N.Gutknecht.
