COOKING POT HANDLE FRAGMENT V.008.2/2948.1. - LEADED BRONZE - ROMAN TIMES - SWITZERLAND

Artefact name Cooking pot handle fragment V.008.2/2948.1.

Authors Christian. Degrigny (HE-Arc CR, Neuchâtel, Neuchâtel, Switzerland) & Lucile. Ruynat (HE-Arc CR, None) & Valentin. Boissonnas (HE-Arc CR, Neuchâtel, Neuchâtel, Switzerland)

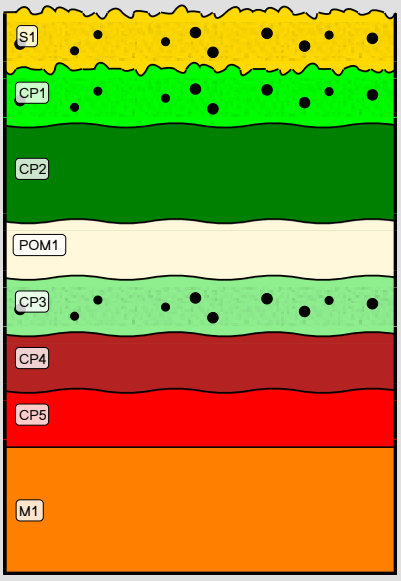
S1	Sediments with sand forming isolated and highly porous ochre-colored clusters
CP1	Scattered clusters of highly porous medium green corrosion product
CP2	Continuous layer of compact dark green corrosion product
SV1	Structural voids within CP2
POM1	Pseudomorphs of organic remains
POM2	Pseudomorphs of wood remains
CP3	Scattered clusters of highly porous light green corrosion product
CP4	Discontinuous layer of compact dark-red corrosion products
CP5	Discontinuous layer of compact red corrosion product
M1	Continuous and compact metal

Fig. 3: Stratigraphic representation of the cooking pot handle fragment in cross-section based on macroscopic global observation and indication of Fig. 4,
