FRAGMENT OF AN AEGIS OF NEÏTH 1886.305.0096 - LEADED BRONZE

Artefact name Fragment of an Aegis of Neïth 1886.305.0096

Authors Line. Pedersen (HE-Arc, Neuchâtel, Neuchâtel, Switzerland) & Christian. Degrigny (HE-Arc CR, Neuchâtel, Neuchâtel, Switzerland) & Valentin. Boissonnas (HE-Arc CR, Neuchâtel, Neuchâtel, Switzerland)

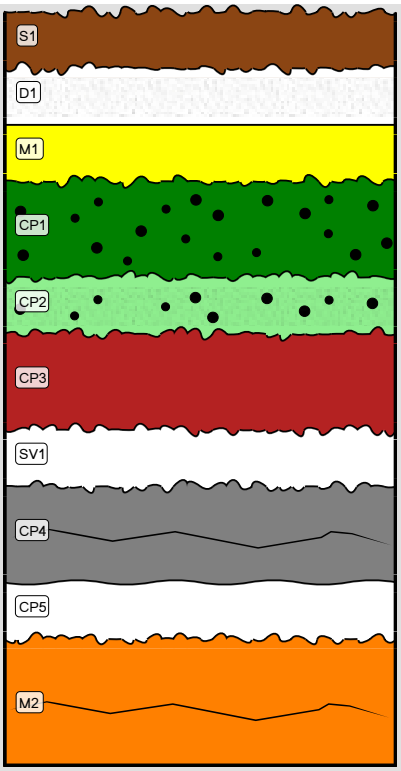
Fig.9: Schematic representation combining stratigraphies 1 and 2 under binocular microscope and using the MiCorr application. The characteristics of the strata are only accessible by clicking on the drawing that redirects you to the search tool by stratigraphy representation, Credit He-Arc CR, L.Pedersen.

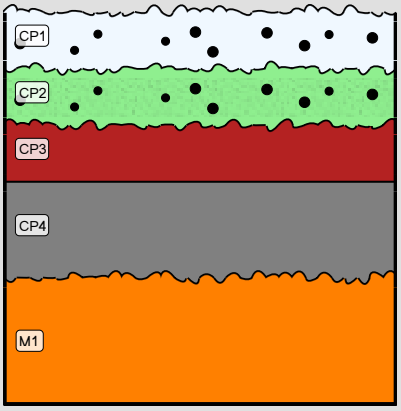
Fig.10: Schematic representation of stratigraphy 3 under binocular microscope and using the MiCorr application. CP1 is CP6 in Fig. 8. The characteristics of the strata are only accessible by clicking on the drawing that redirects you to the search tool by stratigraphy representation, Credit He-Arc CR, L. Pedersen.

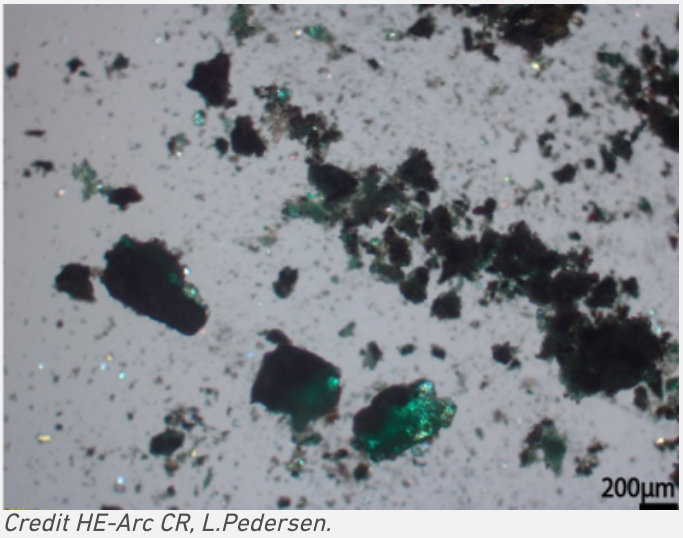
Fig. 13: Observation of the dark green corrosion product,

Fig. 14: Dark green corrosion product identified as paratacamite, atacamite Cu2Cl(OH)3 by XRD. Microscopic examination under polarized light,
