FRAGMENT OF AN AEGIS OF NEÏTH 1886.305.0096 - LEADED BRONZE

Artefact name Fragment of an Aegis of Neïth 1886.305.0096

Authors Line. Pedersen (HE-Arc, Neuchâtel, Neuchâtel, Switzerland) & Christian. Degrigny (HE-Arc CR, Neuchâtel, Neuchâtel, Switzerland) & Valentin. Boissonnas (HE-Arc CR, Neuchâtel, Neuchâtel, Switzerland)

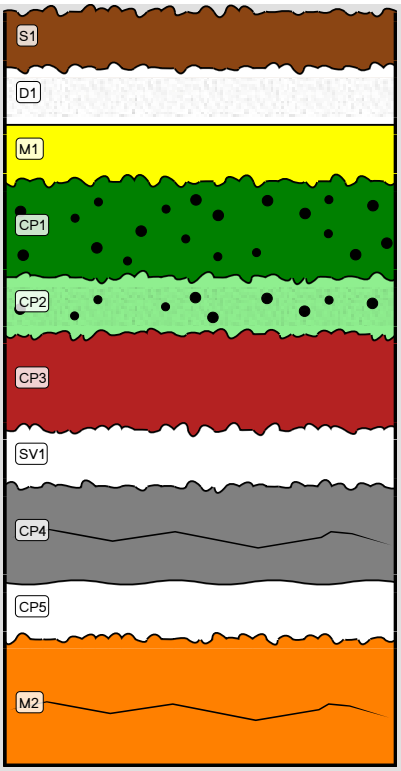
Fig.9: Schematic representation combining stratigraphies 1 and 2 under binocular microscope and using the MiCorr application. The characteristics of the strata are only accessible by clicking on the drawing that redirects you to the search tool by stratigraphy representation, Credit He-Arc CR, L.Pedersen.

The metal (M2 in Fig.9 and M1 in Fig. 10) was analysed on the broken edge of the bottom of the artefact where despite a highly corroded surface, the metal seems to be the best preserved. The XRF analyses revealed that the metal is a leaded bronze with remains of gold leaf on the surface (Table 1, Au was detected in the measurement spots 4,5 and 6) (Scott 2002; Gouda 2012; Mohammed 2012).

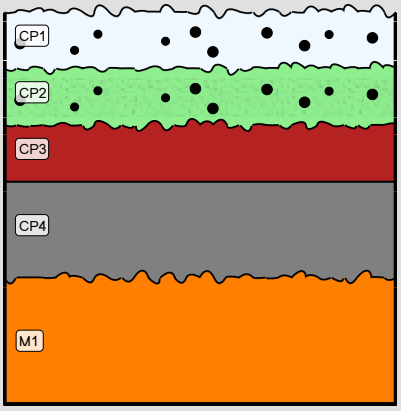
Fig.10: Schematic representation of stratigraphy 3 under binocular microscope and using the MiCorr application. CP1 is CP6 in Fig. 8. The characteristics of the strata are only accessible by clicking on the drawing that redirects you to the search tool by stratigraphy representation, Credit He-Arc CR, L. Pedersen.
