SICKLE AUV-310 – LATE BRONZE AGE – SWITZERLAND

Artefact name	Sickle AUV-310
Authors	Rémy. Léopold (HE-Arc CR, Neuchâtel, Neuchâtel, Switzerland)
Url	/artefacts/1272/

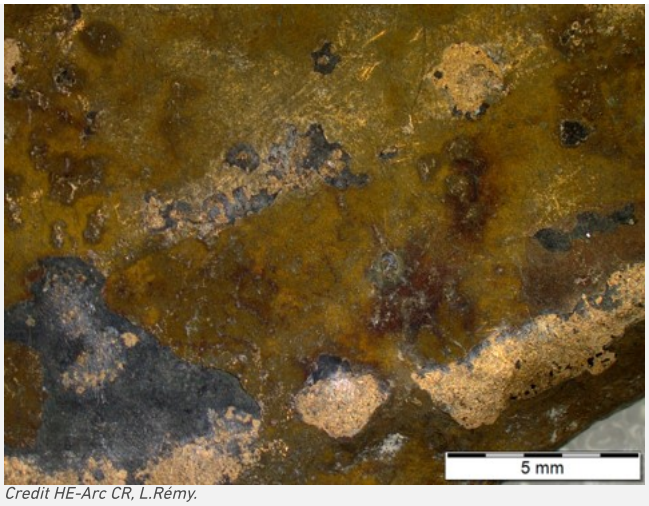
Fig. 1: Sickle (side A) with a groove on the external front side and lacunas of the corrosion layers all over the surface,

Fig. 2: Brown-yellow products (detail) on the tip of the sickle,

Fig. 3: Brown-yellow and dark-grey corrosion products and lacunas (detail) on the middle of the sickle,

Fig. 4: Brown-yellow and dark-grey corrosion products and lacunas (detail) of an area close to the tip of the sickle,

Description of the artefact	Sickle with a groove on the external front side and brown-yellow corrosion products as well as lacunas with some remains of a dark-grey underlayer (Figs. 1-4). Dimensions: L = 12.51cm; Ømax. = 3.5cm; WT = 82.54g.
Type of artefact	Tool
Origin	Hauterive - Champréveyres, Neuchâtel, Neuchâtel, Switzerland
Recovering date	Excavation in 1971
Chronology category	Late Bronze Age
chronology tpq	900 B.C.
chronology taq	800 B.C.
Chronology comment	
Burial conditions / environment	Lake
Artefact location	Laténium, Neuchâtel, Neuchâtel
Owner	Laténium, Neuchâtel, Neuchâtel
Inv. number	Auv 310
Recorded conservation data	No conservation data available, but a coating and inventory number is visible on the surface.

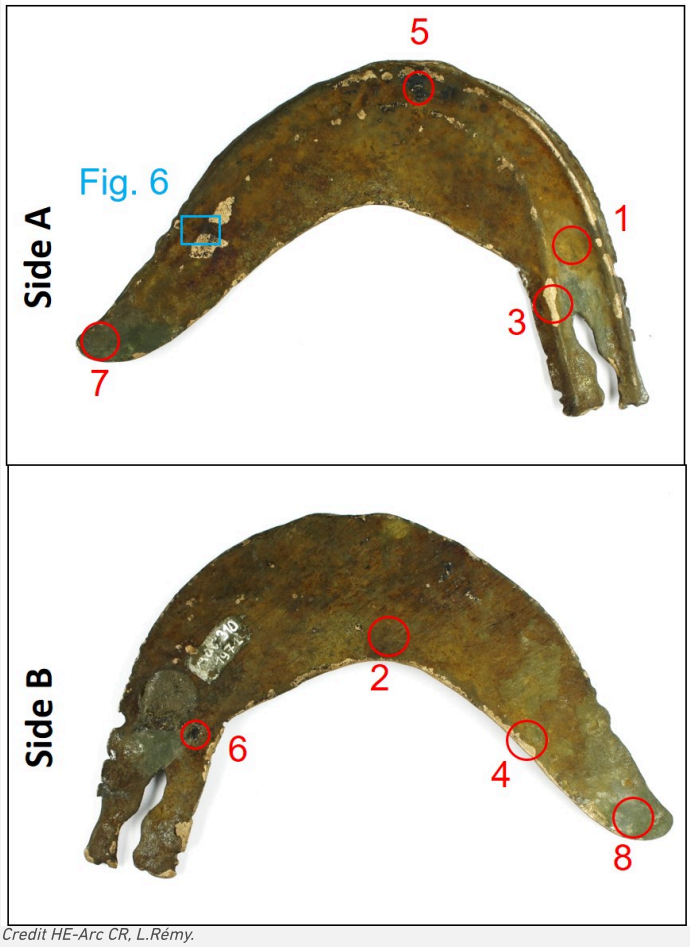
Fig. 5: Both sides (opposed) of the sickle with location of XRF analysis areas (red circles) and location of Fig. 6 (blue square),

XRF analyses of the sickle were carried out on eight representative areas (Fig. 5). Points 1 and 2 were done on the brown corrosion layer of each side (CP1), points 3 and 4 on the yellow areas covered with black and grey corrosion products (CP2 and CP3) of each side, and points 5 and 6 on the black corrosion layer of each side (CP2), and points 7 and 8 on the grey corrosion layer of each side (CP3). All strata (soil, corrosion products, and metal) are analyzed at the same time.

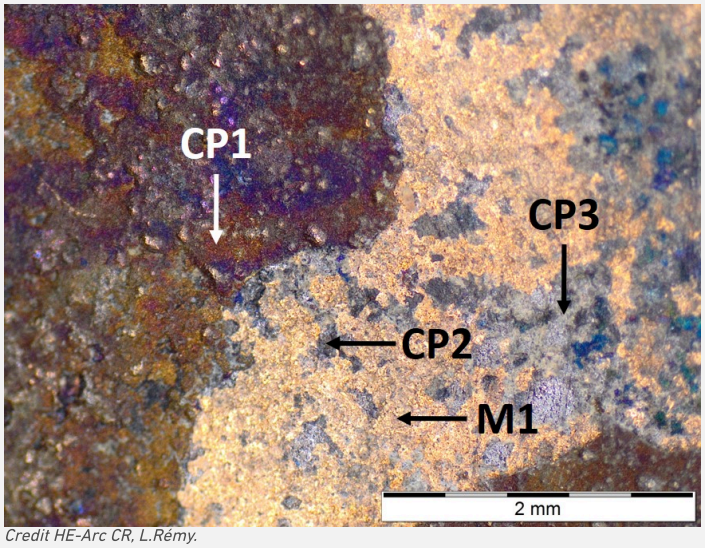
Fig. 6: Corrosion structure (detail) from Fig. 5 showing some of the documented strata in Fig. 7,

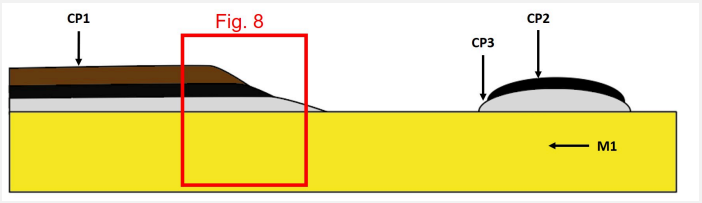
Stratum	Type of stratum	Principal characteristics
CP1	Corrosion product	Brown, pearly, thin, discontinuous, compact, brittle, very soft
CP2	Corrosion product	Black, matte, thin, discontinuous, compact, powdery, very soft
CP3	Corrosion product	Extra light grey, matte, thin, compact, powdery, soft
M1	Metal	Yellow, thick, continuous, compact, tough, very hard

Fig. 7: Stratigraphic representation of the corrosion structure of the sickle by macroscopic and binocular observation with indication of the corrosion structure used to build the MiCorr stratigraphy of Fig. 8 (red square),
