SICKLE AUV-313 – LATE BRONZE AGE – SWITZERLAND

Artefact name	Sickle AUV-313
Authors	Rémy. Léopold (HE-Arc CR, Neuchâtel, Neuchâtel, Switzerland)
Url	/artefacts/1273/

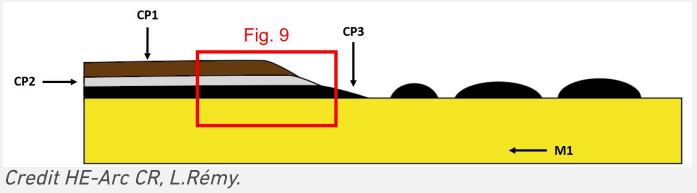
Fig. 8: Stratigraphic representation of the corrosion structure of the sickle by macroscopic and binocular observation with indication of the corrosion structure used to build the MiCorr stratigraphy of Fig. 9 (red square),

The appearance of CP1 and its composition (Cu, Fe, S) seem to indicate that it is either itaite or chalcopyrite.

The sickle is made from a tin bronze. The XRF analysis show that the brown, purple and black corrosion layers (CP1) have higher %Fe and %S and lower % Cu and %Sn than the layer closer to the metal. It would indicate that CP1 is made of copper iron sulfide like itaite (Cu_5FeS_6) or chalcopyrite ($CuFeS_2$) as described by Rychner (1987). According to Schweizer's paper from 1994, it would mean that CP1 could be a lake patina which was generated on the metal by the presence of sulfate-reducing bacteria in the burial environment.
