SICKLE AUV-322 - LATE BRONZE AGE - SWITZERLAND

Artefact name Sickle AUV-322

Authors Rémy. Léopold (HE-Arc CR, Neuchâtel, Neuchâtel, Switzerland)

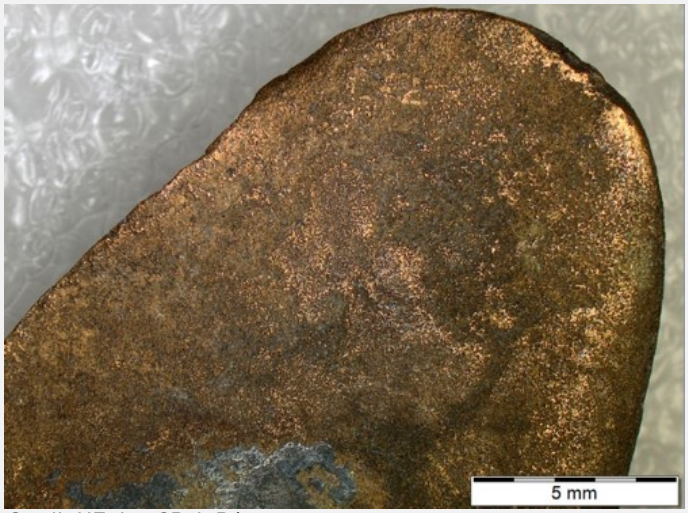
Fig. 1: Sickle (side A) with a groove on the external front side,

Description of the artefact	Sickle with a groove on the external front side and brown-yellow/dark-grey corrosion products (Figs. 1-3). Dimensions: L = 12.0cm; Ømax. = 3.1cm; WT = 91.0g.
Type of artefact	Tool
Origin	Hauterive - Champréveyres, Neuchâtel, Neuchâtel, Switzerland
Recovering date	Excavation in 1971
Chronology category	Late Bronze Age
chronology tpq	900 B.C.
chronology taq	800 B.C.
Chronology comment	
Burial conditions / environment	Lake
Artefact location	Laténium, Neuchâtel, Neuchâtel
Owner	Laténium, Neuchâtel, Neuchâtel
Inv. number	Auv 322
Recorded conservation data	No conservation data available, but a coating and inventory number is visible on the surface.

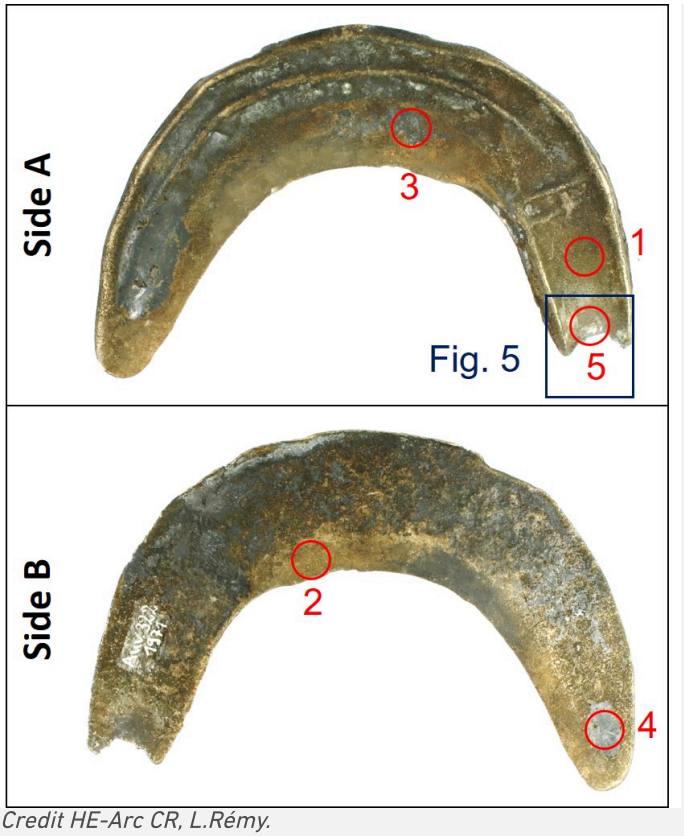
Fig. 4: Both sides (opposed) of the sickle with location of XRF analysis areas (red circles) and location of Fig. 5 (blue square),

XRF analyses of the sickle were carried out on five representative areas (Fig. 4). Points 1 and 2 were done in the brown corrosion layer of each side (CP1), points 3 and 4 on the black corrosion layer of each side (CP2), and point 5 in the extra light grey of side A (CP3). All strata (soil, corrosion products, and metal) are analyzed at the same time.

Results of points 1, 2 and 5 are very similar and give concentrations close to those of the remaining metal surface.

Results of points 3 and 4 are similar but different from those of points 1, 2 and 5: they indicate an enrichment in S and the depletion in Cu.

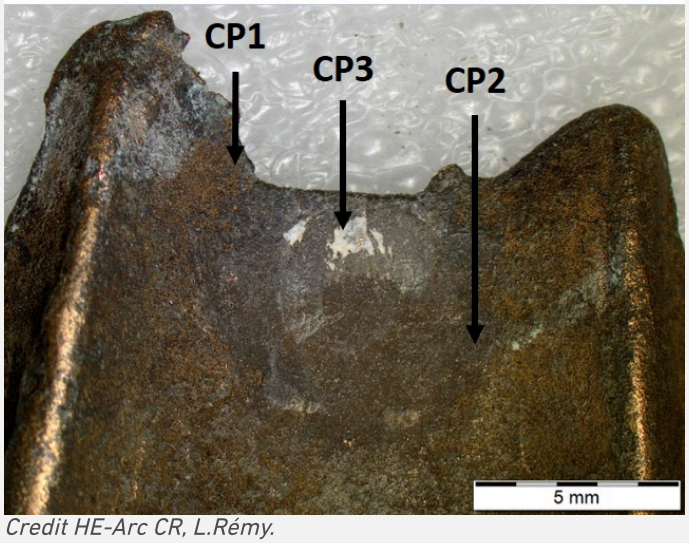
Fig. 5: Corrosion structure (detail) from Fig. 4 showing some of the documented strata in Fig. 6,

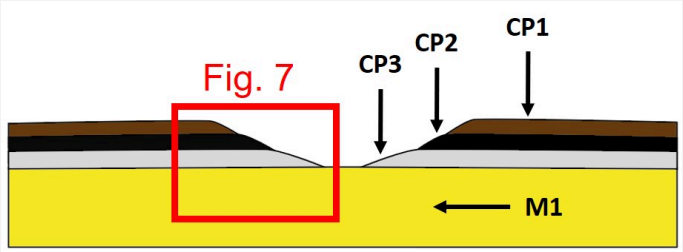
Table 1: Description of the principal characteristics of the strata as observed under binocular and described according to Bertholon's method.

Stratum	Type of stratum	Principal characteristics
CP1	Corrosion product	Brown, matte, thin, discontinuous, compact, powdery, very soft
CP2	Corrosion product	Black, matte, thin, discontinuous, compact, powdery, very soft
CP3	Corrosion product	Extra light grey, matte, thin, discontinuous, compact, powdery, hard
M1	Metal	Yellow, thick, metallic, continuous, compact, tough, very hard
