COIN CDN 2012-1-55 - CU ALLOY - LATE ROMAN TIMES - SWITZERLAND

Artefact name Coin CdN 2012-1-55

Authors Naima. Gutknecht (HE-Arc CR, Neuchâtel, Neuchâtel, Switzerland) & Valentina. Valbi (Laboratoire Métallurgie et Culture (LMC), Belfort, Franche-Comté, France) & Rey-Bellet. Bernadette (Musée d'art et d'histoire, Genève, Genève, Geneva, Switzerland)

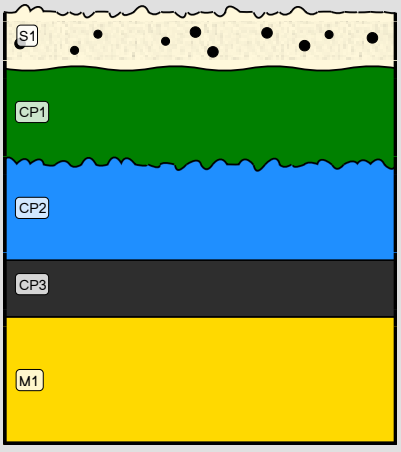
Fig. 5: Stratigraphic representation of the corrosion structure of the coin observed macroscopically under binocular microscope using the MiCorr application. The characteristics of the strata are only accessible by clicking on the drawing that redirects you to the search tool by stratigraphy representation, Credit MAHG, B.Rey-Bellet/HE-Arc CR, N.Gutknecht.

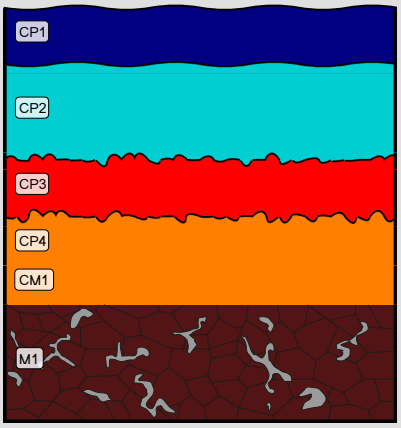
Fig. 13: Stratigraphic representation of the sample of the coin BL55 observed in cross-section under dark field using the MiCorr application. The characteristics of the strata are only accessible by clicking on the drawing that redirects you to the search tool by stratigraphy representation. This representation was build according to Fig. 10, Credit LMC-CNRS, V.Valbi
