PIN LNR40339 – BRONZE – BRONZE AGE – SWITZERLAND

|	
Artefact name	Pin Lnr40339
Authors	Brechbühl. Sabine (archaological service canton Bern, Bern, Bern, Switzerland) & Naima. Gutknecht (HE–Arc CR, Neuchâtel, Neuchâtel, Switzerland) & Valentina. Valbi (Laboratoire Métallurgie et Culture LMC–IRAMAT–CNRS–UTBM, Belfort, Franche-Comté, France)
Url	/artefacts/1277/

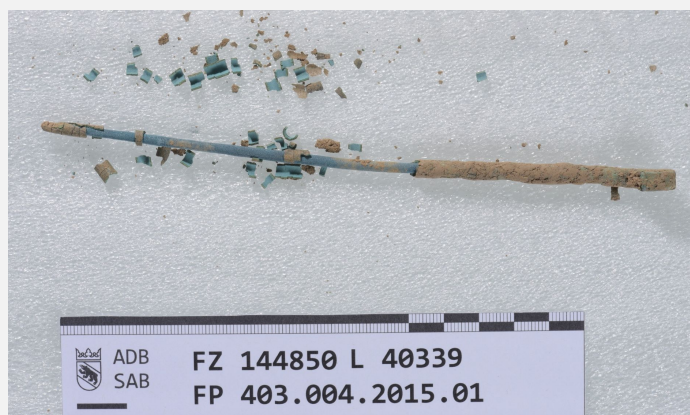
Fig. 1: Pin with surface flaking,

Description of the artefact	Pin with a curved head. The corroded surface is light brown and there is internal blue corrosion visible where the upper layers flaked. Dimensions: L = ca. 12cm. D = ca. 0.5cm.
Type of artefact	Jewellery
Origin	Kehrsatz, Breitenacker, Kehrsatz, Bern, Switzerland
Recovering date	2015
Chronology category	Bronze Age
chronology tpq	____ ⌄
chronology taq	____ ⌄
Chronology comment	Found in disturbed layers of soil during excavation, therefore no chronology can be clearly deduced.
Burial conditions / environment	Soil
Artefact location	archaeological service canton Bern, Bern, Bern
Owner	archaeological service canton Bern, Bern, Bern
Inv. number	Lnr. 40339

| Recorded conservation data | The object was cleaned of soil with ethanol. The flaking of corrosion was glued back and consolidated with Paraloid B-72. |

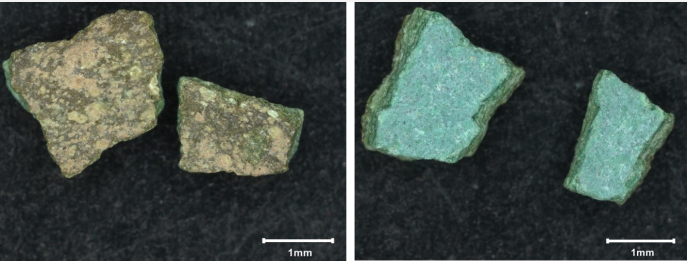
Fig. 2: Fragments of the entire corrosion structure detached from the object and collected before restoration for the study. Appearance of the external (left) and internal (right) surfaces of the fragments,

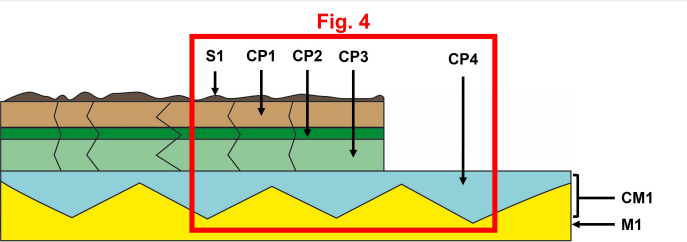
Stratum	Type of stratum	Principal characteristics
S1	Soil	brown, thin, limons microstructure, discontinuous, non compact, very soft
CP1	Corrosion product	light brown, medium, discontinuous, compact, soft
CP2	Corrosion product	dark green, thin, discontinuous, compact, soft
CP3	Corrosion product	light green, medium, discontinuous, compact, soft
CP4	Corrosion product	pale turquoise, medium, continuous, non compact, very soft
CM1	Corroded metal	Layer, average ratio (50/50) between CP4 and M1
M1	Metal	yellow, metallic, compact, soft

Fig. 3: Stratigraphic representation of the corrosion structure of the pin by macroscopic and binocular observation with location of Fig. 4,

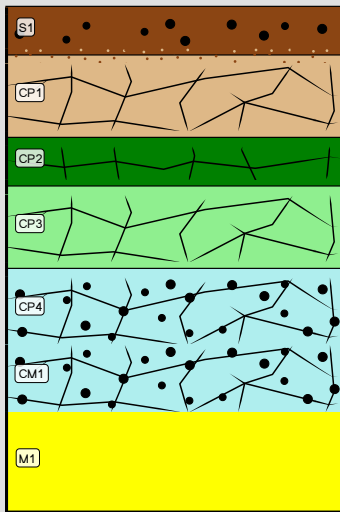
Fig. 4: Stratigraphic representation of the corrosion structure of the pin observed macroscopically under binocular microscope using the MiCorr application with reference to Fig. 3. The characteristics of the strata are only accessible by clicking on the drawing that redirects you to the search tool by stratigraphy representation, Credit HE-Arc CR, N.Gutknecht.

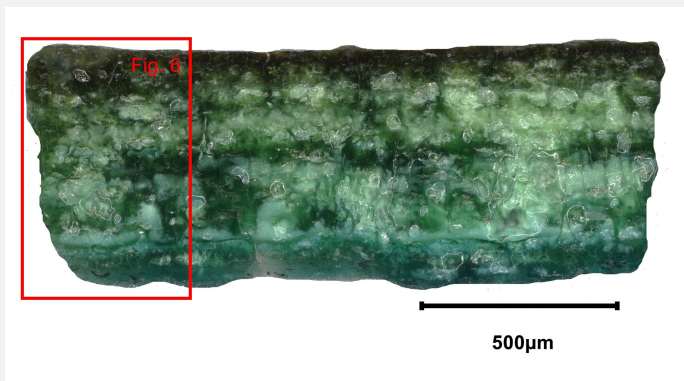
Fig. 5: Micrograph of the cross-section of the fragment from the pin (Fig. 2, left fragment) in dark field showing the location of Fig. 6. The external surface is on top,

Description of sample	The sample is a fragment (a flake) of the corrosion stratigraphy that spontaneously detached from the object (Fig. 5).
Alloy	Bronze
Technology	None
Lab number of sample	
Sample location	archaeological service canton Bern, Bern, Bern
Responsible institution	archaeological service canton Bern, Bern, Bern
Date and aim of sampling	May 2021

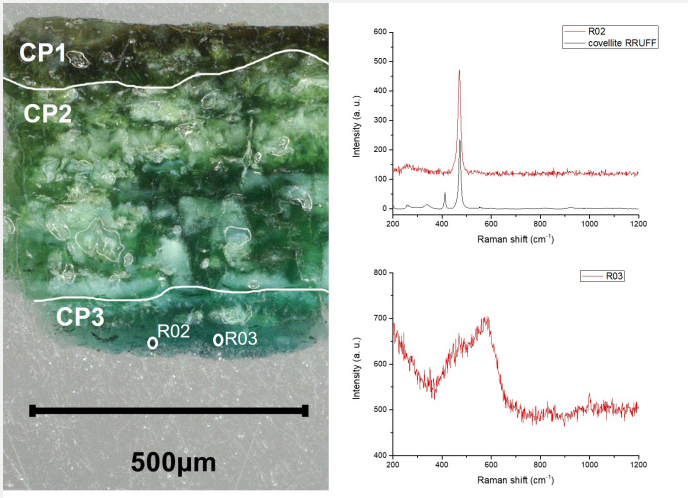
The observation of the sample in cross-section in dark field (Fig. 6) allowed to identify an external 150 μm thick brown stratum (CP1), a green 400 μm thick stratum (CP2), and a blue 150 μm thick stratum (CP3). The EDX analysis (Table 2) shows that the whole corrosion structure has a low Cu content and a much higher Sn content, suggesting then that the metal is a bronze where the corrosion stratigraphy is Cu depleted (14 mass%) and Sn enriched (51 mass%) with none or low polluting elements from external source (Si, P, Al, Fe, Ca, Cl). Dark inclusions mainly observable in the CP3 layer were also analysed and are believed to be copper sulphide. They might be residual metal inclusions.

μ-Raman analyses were performed on the three identified strata but it was not possible to obtain a clear signal for CP1 and CP2 strata. For the blue CP3 stratum the spectrum obtained has a broad peak at 560 cm-1 that can be attributed to nanocrystals of cassiterite Sn_2O thanks to comparison with the work of Ospitali et al. 2012. The μ-Raman analysis performed on the dark inclusions showed a spectrum with a peak at 470 cm-1 compatible with that of covellite (CuS).

Fig. 6: Micrograph of the corrosion stratigraphy with the subdivision of the different strata from Fig. 5 (detail), dark field with location of Raman analysis points and the respective obtained spectra of covellite for R02 (RRUFFID=R060306) and nanocassiterite for R03 as determined by comparison of the work of Ospitalie et al. 2012,

Although the metal has not been analysed, the EDS analysis of the corrosion stratigraphy (low Cu content and high Sn content) seems to indicate that the pin is made of bronze with a typical decuprification phenomenon. The dark covellite compounds in CP3 (cross-sections) are most likely residual of copper sulfide inclusions from the metal microstructure.

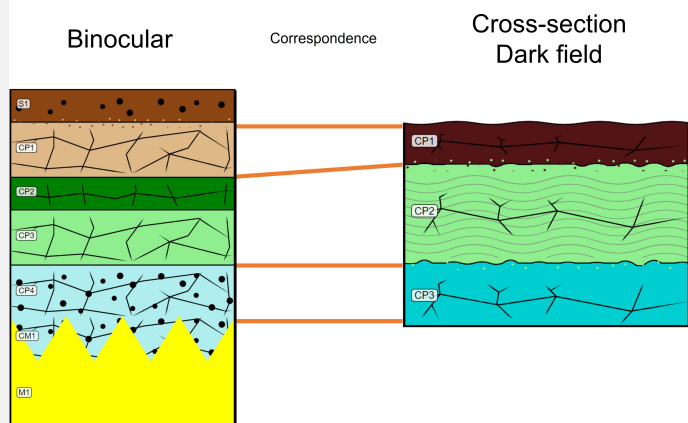
One sediment stratum and 4 CPs were identified by binocular observation on the whole object, while only 3 CPs were identified by cross-sectional observation on one flake of the corrosion stratigraphy. The binocular description allows to discriminate more strata based on texture parameters that do not correspond to clear differences observable in cross-section, thus more than one stratum observed by binocular corresponds to only one stratum in cross-section. The outer sediment layer (S1) and the CP1 identified by the binocular observation coincide with the CP1 observed in cross-section, while the CP2 and CP3 observed by binocular coincide with the CP2 in cross-section. The blue CP4 in binocular coincide with the blue CP3 in cross-section.

Fig. 8: Stratigraphic representation side by side of binocular view and cross-section (dark field),
