BRACELET BUS-NA 98 BZ 11 - BRONZE - IRON AGE - SWITZERLAND

Artefact name Bracelet bus-na 98 BZ 11

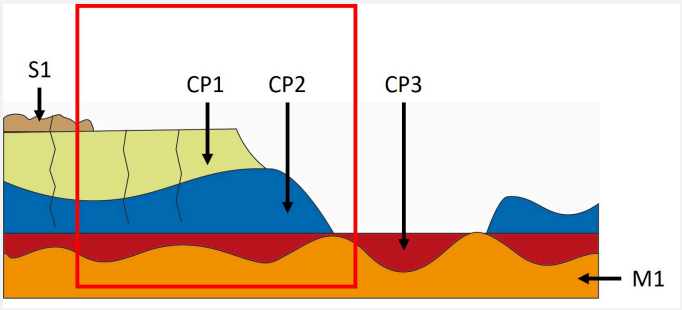
Fig. 3: Detail of the corrosion structure from Fig. 2 showing the documented strata,

The transition between CP3 and the metal M1 is irregular and rough. There are cracks through S1, CP1 and CP2 that generate the flaking of CP1 and CP2.

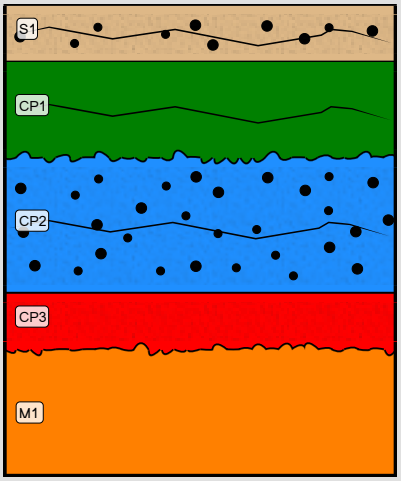
Fig. 4: Stratigraphic representation of the corrosion structure of the bracelet by macroscopic and binocular observation with indication of the corrosion structure used to build the MiCorr stratigraphy of Fig. 5 (red square),

Fig. 5: Stratigraphic representation of the corrosion structure of the bracelet observed macroscopically under binocular microscope using the MiCorr application with reference to Fig. 4. The characteristics of the strata are only accessible by clicking on the drawing that redirects you to the search tool by stratigraphy representation, Credit HE-Arc CR, N.Gutknecht.

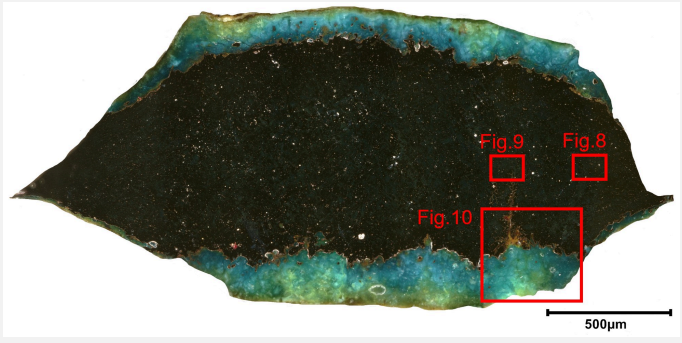
Fig. 6: Micrograph of the cross-section of the sample in dark field taken from the bracelet (Fig. 2) in dark field showing the location of Figs. 8 to 10,

Description of sample	The cross-section corresponds to a lateral cut (Fig. 2) and is representative of the entire thickness of the bracelet's body. A metallic core is present below the corrosion layers (Fig. 6).
Alloy	Bronze
Technology	Cold worked with repeated annealing and final cold working
Lab number of sample	ébauche 11
Sample location	Archaeological Service of the Fribourg Canton, Fribourg
Responsible institution	Archaeological Service of the Fribourg Canton, Fribourg
Date and aim of sampling	February 2020. Metallographic study.

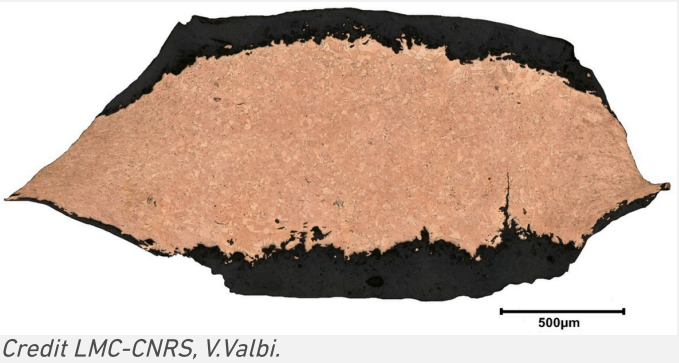
The metal etched with alcoholic ferric chloride reveals a main equiaxe grain structure (Fig. 7) with several twinned grains (Figs. 8 and 9), indicating that the object underwent an annealing procedure. It is possible to observe on the thinner extremities of the sample the deformation of the grains (shown for the right extremity on Fig. 8) and the presence of slip lines (Fig. 8) caused by cold mechanical working of the metal after annealing.

Fig. 7: Micrograph of the etched cross-section of the sample taken from the bracelet (Fig. 2) in bright field,

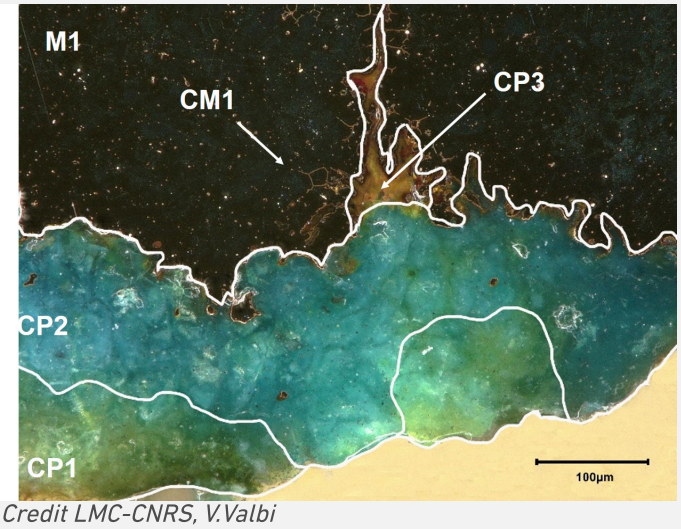
The observation of the sample in cross-section in dark field allowed identification of an external discontinuous greenish/yellowish stratum (CP1), a blue stratum (CP2), a red discontinuous thin stratum (CP3) at the interface with the metal, and a corroded metal area (CM1)(Fig.2). This is confirmed in Fig. 10.

Fig. 10 : Micrograph of the corrosion structure from Fig. 6 (detail) with the subdivision of the different strata, unetched, dark field,

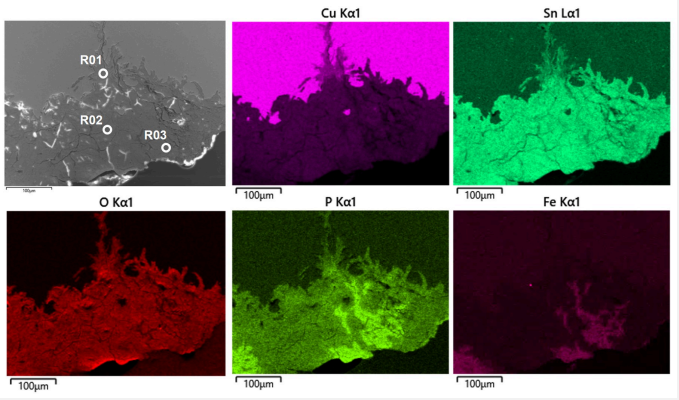
The EDX elemental analysis (Table 4) and mapping (Fig. 11) of the visually identified CPs by binocular and cross-sectional observations show that CP1 is Cu depleted, O, Sn and Pb enriched and polluted with Ca, Fe and P, while CP2 is also Cu depleted and O and Sn-rich but with fewer external polluting elements and CP3 is Cu rich. The results are in agreement with those of the preliminary XRF analysis (table 2), with the exception of aluminum and bismuth which

Fig. 11: SEM image, BSE-mode, and elemental chemical distribution of Fig.10. The selected points for Raman analysis shown in Fig. 12 are indicated,

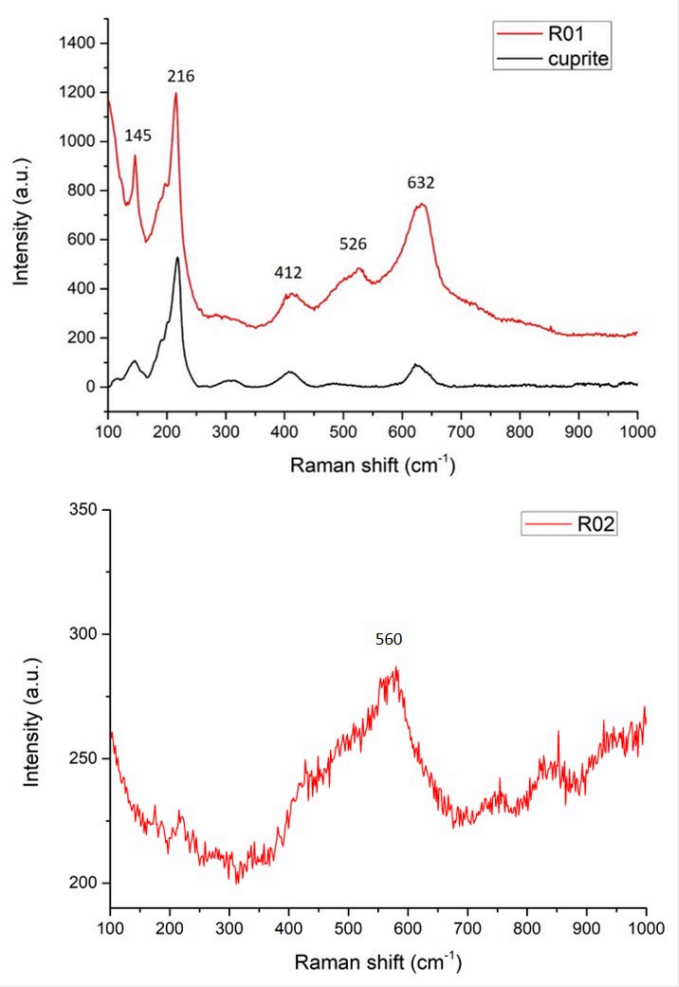
Analyses with µ-Raman were performed on the three identified strata (Fig. 11). The R01 (Fig. 12) point of analysis was performed on the red CP3 layer and the obtained spectrum presented the typical main peaks (145, 218, 632 cm^{-1}) of the Raman RUFF reference spectrum of cuprite Cu_2O (Lafuente et al. 2015). The R02 point of analysis was performed on the blue layer and the spectrum obtained has a broad peak at 560 cm^{-1} that can be attributed to nanocrystals of cassiterite Sn_2O thanks to comparison with the work of Ospitali et al. 2012. The R03 analysis point performed on the green/yellow external phase was too disturbed by fluorescence signal and an identification of the phase was impossible. The blue color of CP2 is probably caused by residual Cu ions, while the greenish/yellowish color of CP1 is given by the presence of Fe ions.

Fig. 12: Raman spectra of points R01 (together with the RRUFF reference RRUFFID=R140763 for cuprite) and R02 showed in Fig. 11,

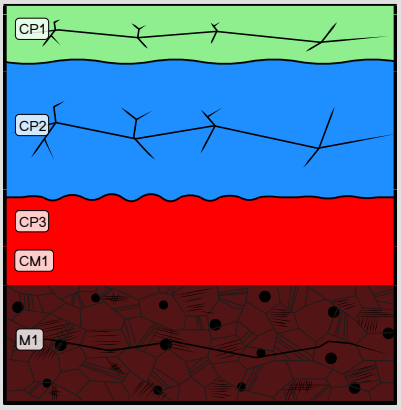
Fig. 13: Stratigraphic representation of the sample of bracelet observed in cross-section under dark field using the MiCorr application. The characteristics of the strata are only accessible by clicking on the drawing that redirects you to the search tool by stratigraphy representation. This representation was build according to Fig. 10, Credit LMC-CNRS, V.Valbi.

Three CPs were identified with both binocular and cross-sectional observations, but some differences between the two methods of observation should be noted. The outer sediment layer (S1), easily identified under binocular, was barely visible as a thin dark yellow layer in the cross-section and could have been interpreted as part of CP1 if observed only under cross-section.

A direct correspondence can be found between CP1(Bi) and CP1(CS), CP2(Bi) and CP2(CS), CP3(Bi) and CP3(CS).
