COIN CDN 2012-1-55 - CU ALLOY - LATE ROMAN TIMES - SWITZERLAND

Artefact name	Coin CdN 2012-1-55
Authors	Naima. Gutknecht (HE-Arc CR, Neuchâtel, Neuchâtel, Switzerland) & Valentina. Valbi (Laboratoire Métallurgie et Culture (LMC), Belfort, Franche-Comté, France) & Rey-Bellet. Bernadette (Musée d'art et d'histoire, Genève, Genève, Geneva, Switzerland)
Url	/artefacts/1340/

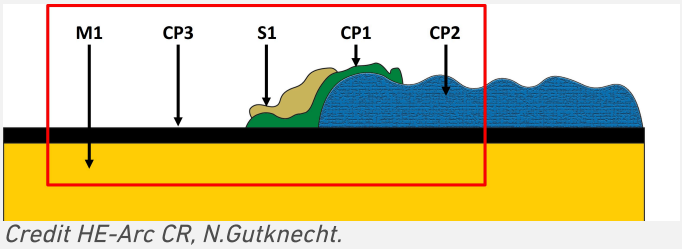
Stratum	Type of stratum	Principal characteristics
S1	Soil	Cluster, light grey, thin, scattered, non-compact, soft
CP1	Corrosion product	Cluster, dark green, medium, scattered, compact, very soft
CP2	Corrosion product	Cluster, blue, medium, scattered, compact, very soft
CP3	Corrosion product	Layer, black, thin, continuous, compact, soft
M1	Metal	Dark yellow, metallic, soft

Fig. 4: Stratigraphic representation of the corrosion structure of the coin by macroscopic and binocular observation with indication of the corrosion structure used to build the MiCorr stratigraphy of Fig. 5 (red square),

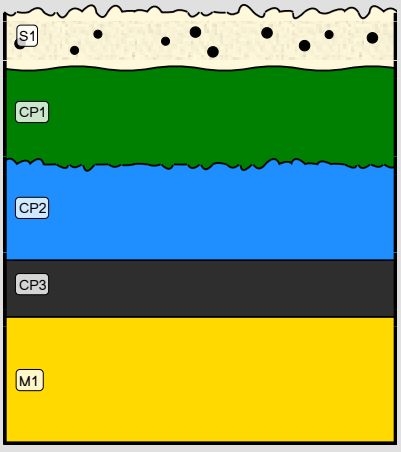
Fig. 5: Stratigraphic representation of the corrosion structure of the coin observed macroscopically under binocular microscope using the MiCorr application. The characteristics of the strata are only accessible by clicking on the drawing that redirects you to the search tool by stratigraphy representation, Credit MAHG, B.Rey-Bellet/HE-Arc CR, N.Gutknecht.

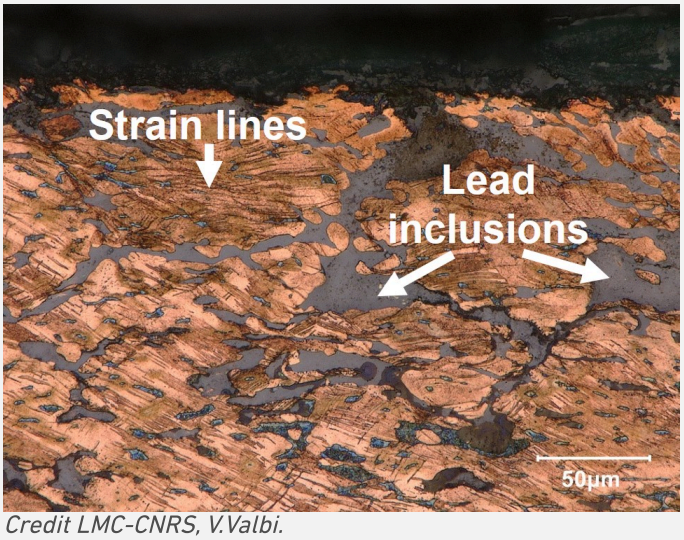
The sample presents on its whole thickness big Pb inclusions (50-100 µm, Figs. 7 and 8) homogeneously distributed. The metal has a polygonal grain structure (Figs. 8-9) with locally elongated grains and slip lines revealing that the object underwent cold working. Several longitudinal cracks are observed and are filled with corrosion products (Fig. 9).

Fig. 7: Micrograph (similar to Fig. 6) of the cross-section of the sample taken from the coin (Fig. 2) in bright field after chemical etching,

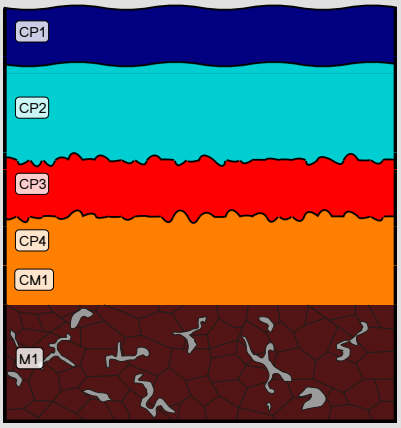
Fig. 13: Stratigraphic representation of the sample of the coin CDN 2012-1-55 observed in cross-section under dark field using the MiCorr application. The characteristics of the strata are only accessible by clicking on the drawing that redirects you to the search tool by stratigraphy representation. This representation was build according to Fig. 10, Credit LMC-CNRS, V.Valbi
