COIN CDN 2012-1-55 - CU ALLOY - LATE ROMAN TIMES - SWITZERLAND

Artefact name Coin CdN 2012-1-55

Authors Naima. Gutknecht (HE-Arc CR, Neuchâtel, Neuchâtel, Switzerland) & Valentina. Valbi (Laboratoire Métallurgie et Culture (LMC), Belfort, Franche-Comté, France) & Rey-Bellet. Bernadette (Musée d'art et d'histoire, Genève, Genève, Geneva, Switzerland)

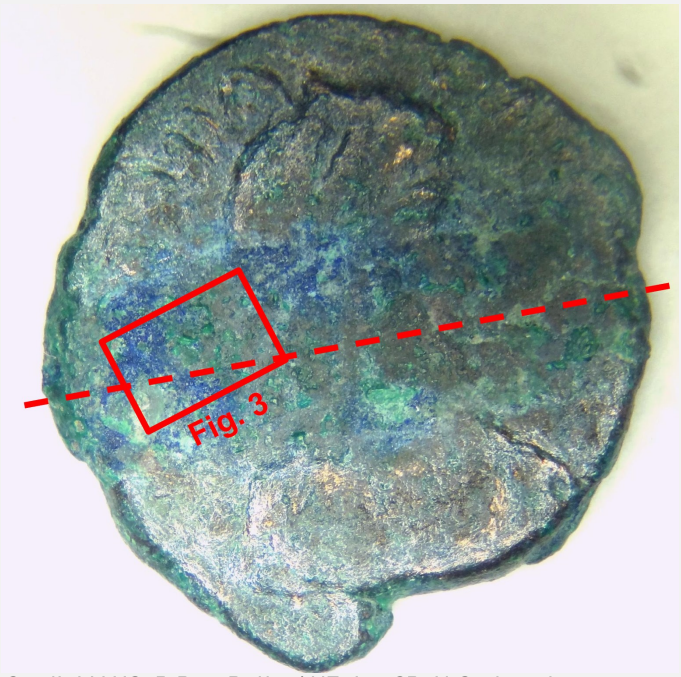
Fig. 2: Location of the detail (Fig. 3) and of the sampling for cross-section,

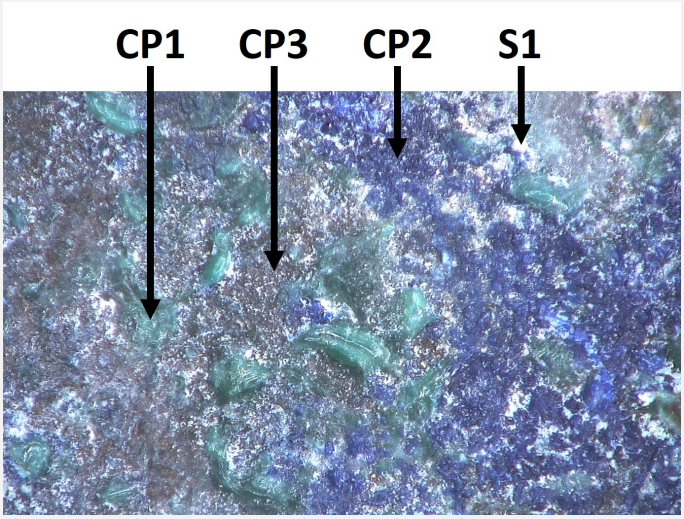
Fig. 3: Detail of the corrosion structure with reference to fig. 4,

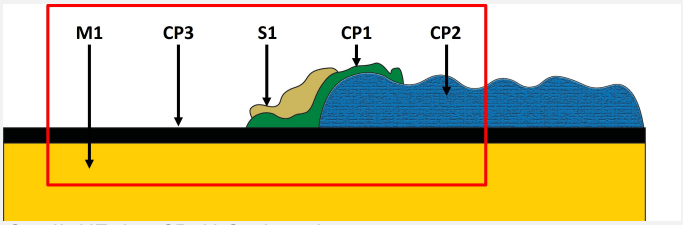
Stratum	Type of stratum	Principal characteristics
S1	Soil	Cluster, light grey, thin, scattered, non-compact, soft
CP1	Corrosion product	Cluster, dark green, medium, scattered, compact, very soft
CP2	Corrosion product	Cluster, blue, medium, scattered, compact, very soft
CP3	Corrosion product	Layer, black, thin, continuous, compact, soft
M1	Metal	Dark yellow, metallic, soft

Fig. 4: Stratigraphic representation of the corrosion structure of the coin by macroscopic and binocular observation with indication of the corrosion structure used to build the MiCorr stratigraphy of Fig. 5 (red square),

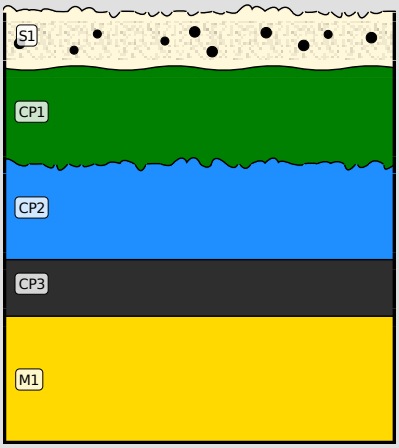
Fig. 5: Stratigraphic representation of the corrosion structure of the coin observed macroscopically under binocular microscope using the MiCorr application. The characteristics of the strata are only accessible by clicking on the drawing that redirects you to the search tool by stratigraphy representation, Credit MAHG, B.Rey-Bellet/HE-Arc CR, N.Gutknecht.

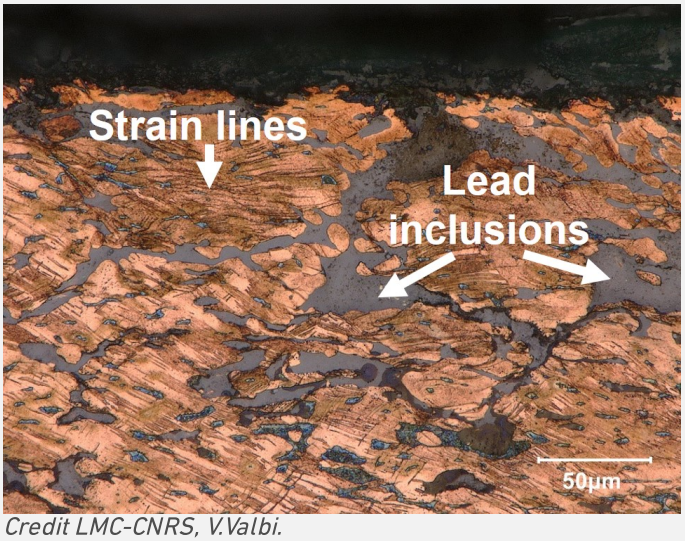
The sample presents on its whole thickness big Pb inclusions (50-100 µm, Figs. 7 and 8) homogeneously distributed. The metal has a polygonal grain structure (Figs. 8-9) with locally elongated grains and slip lines revealing that the object underwent cold working. Several longitudinal cracks are observed and are filled with corrosion products (Fig. 9).

Fig. 8: Micrograph of the metal sample from Fig. 7 (detail), etched, bright field. Elongated grains with slip lines are observed, as well as grey lead inclusions,

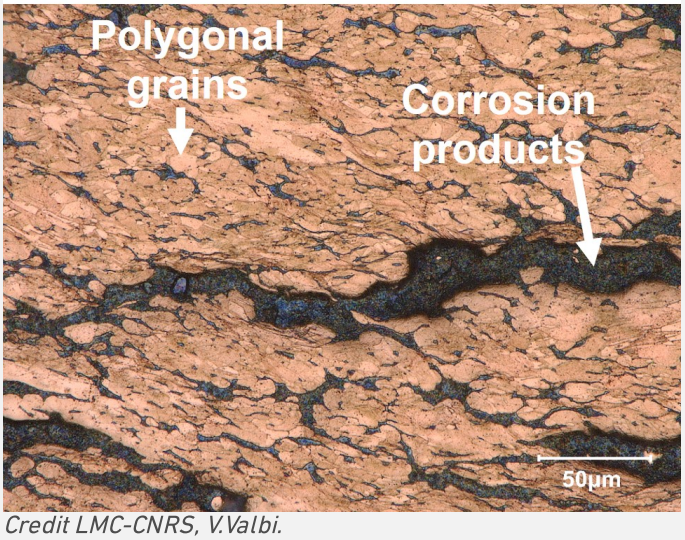
Fig. 9: Micrograph of the metal sample from Fig. 7 (detail), etched, bright field. with polygonal microstructure and presence of longitudinal crack filled with corrosion products (azurite, malachite),

The coin is composed of a Cu-Pb-Sn ternary bronze alloy with high Pb percentages (29 wt%). Pb is not soluble in the metallic structure and large lead inclusions are observed throughout the whole metal thickness. The metallic microstructure reveals that the object underwent cold working. The whole object is fragilised by the presence of longitudinal cracks filled with corrosion products.

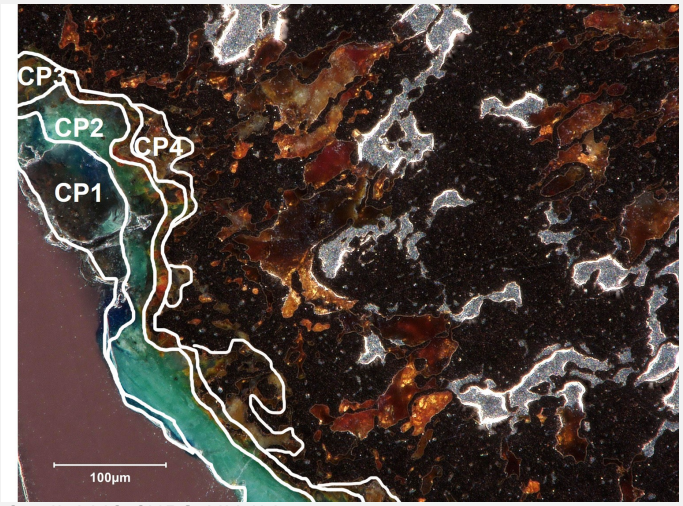
The observation of the sample in cross-section in dark field mode shows the presence of an external blue CP1 layer with sand inclusions, on top of a turquoise CP2 layer, then a red thin internal CP3 layer and an orange CP4 also present in the inclusions inside the corroded metal (Fig. 10).

Fig. 10: Micrograph of the corrosion structure from Fig. 6 (detail) with the subdivision of the different strata, unetched, dark field,

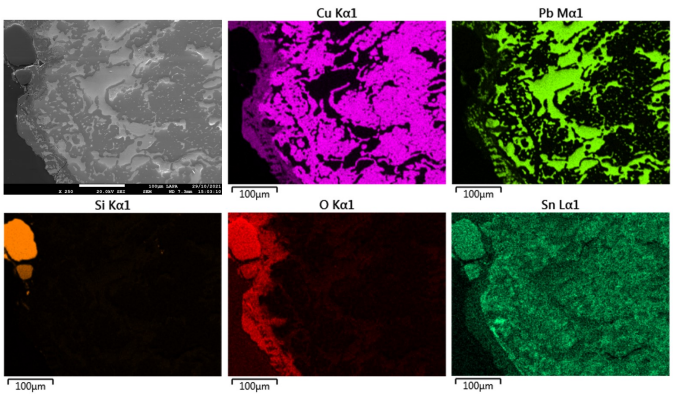
The EDX elemental analysis (Table 4, Fig.11) of the visually identified CPs by cross-sectional observation shows that the external CP1 and CP2 are Cu-based products with only few amounts of lead (3 wt %), while the orange CP4 is a lead-based compound.

Fig. 11: SEM image, BSE-mode, and elemental chemical distribution of Fig. 10,

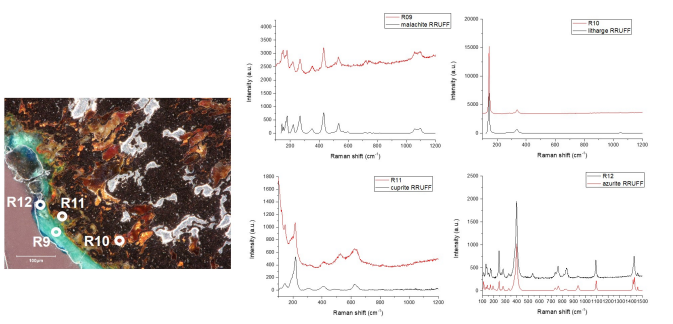
µ-Raman analyses were performed on the identified strata when possible (Fig. 12). The R12 point of analysis was performed on the blue CP1 layer and the corresponding spectrum presented the typical main peaks of azurite ($Cu_3(CO_3)_2(OH)_2$), The R9 point of analysis in the green CP2 layer shows the typical peaks of malachite ($Cu_2(CO_3)(OH)_2$). The R11 point of analysis was performed on the red thin CP3 layer and shows the main peaks of cuprite (Cu_2O), while the R10 point of analysis was performed on the internal orange corrosion products and showed the typical peaks of litharge (PbO).

Fig. 12: Raman points of analysis and corresponding spectra overlapped with reference spectra for malachite RRUFFID=R050508, litharge RRUFFID=R060959, cuprite RRUFFID=R140763, azurite RRUFFID=R050497,

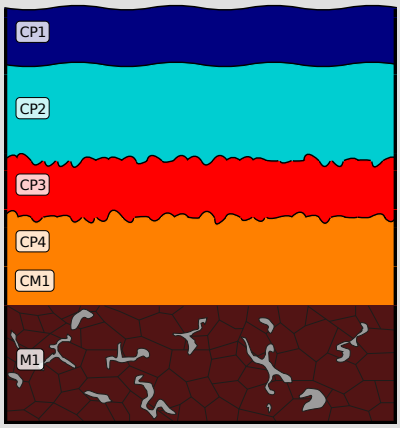
Fig. 13: Stratigraphic representation of the sample of the coin CDN 2012-1-55 observed in cross-section under dark field using the MiCorr application. The characteristics of the strata are only accessible by clicking on the drawing that redirects you to the search tool by stratigraphy representation. This representation was build according to Fig. 10, Credit LMC-CNRS, V.Valbi

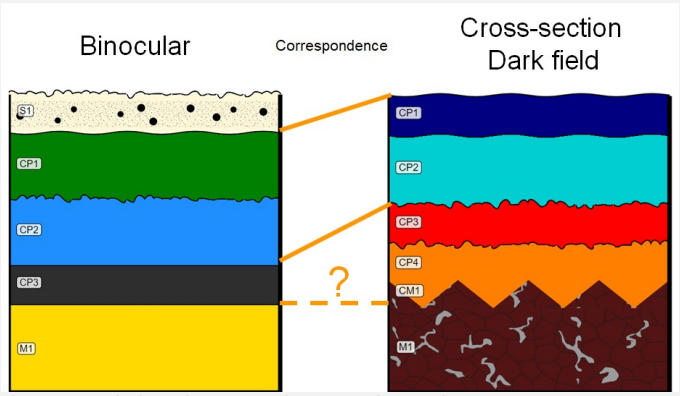
Strata S1 observed in binocular mode is lacking in cross-section observation, probably due to a different observation location. The CP1 and CP2 layers observed under binocular microscope probably correspond to the CP1 and CP2 observed in cross-section, but with the green and the blue layer inversed. The blue CP2 layer observed in binocular mode could correspond to the blue CP1 observed in cross-section and the green CP1 in binocular to the green CP2 in CS. This could be explained as well by the different locations of the observations carried out. Finally, the red cuprite CP3 and the orange litharge CP4 observed in cross-section as well as the corroded metal strata CM1 observed in cross-section were not clearly identified by binocular observation. Still, they could be linked to the black CP3 layers that can not be linked with certainty to any stratum in cross-section, but probably a regrouping of CP3, CP4 and CM1. The binocular view rarely allows documenting CM stratum, as the transition between layers is difficult to assess.

Fig. 14: Stratigraphic representation side by side of binocular view and cross-section (dark field),
