TANG FRAGMENT OF A KNIFE HR-6246 - TIN BRONZE - LATE BRONZE AGE - SWITZERLAND

Artefact name Tang fragment of a knife HR-6246

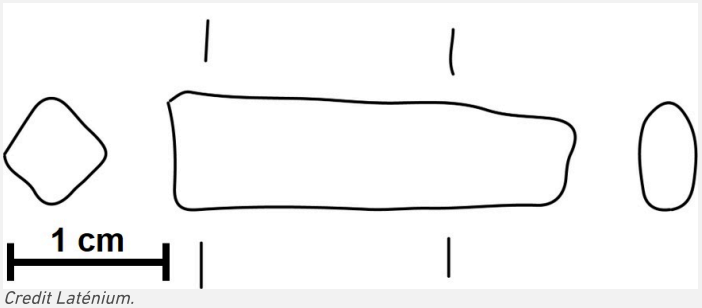
Fig. 1: Tang fragment of a knife (after Rychner-Faraggi 1983, plate 35.35),

Fig. 2: Shiny yellow and green-blue corrosion products on the surface of the tang fragment of a knife,

Description of the artefact Tang fragment of a knife with shiny yellow and green-blue corrosion products (Figs. 1 & 2). Dimensions: L = 2.7cm; Ø = around 5mm; WT = 5.8g.

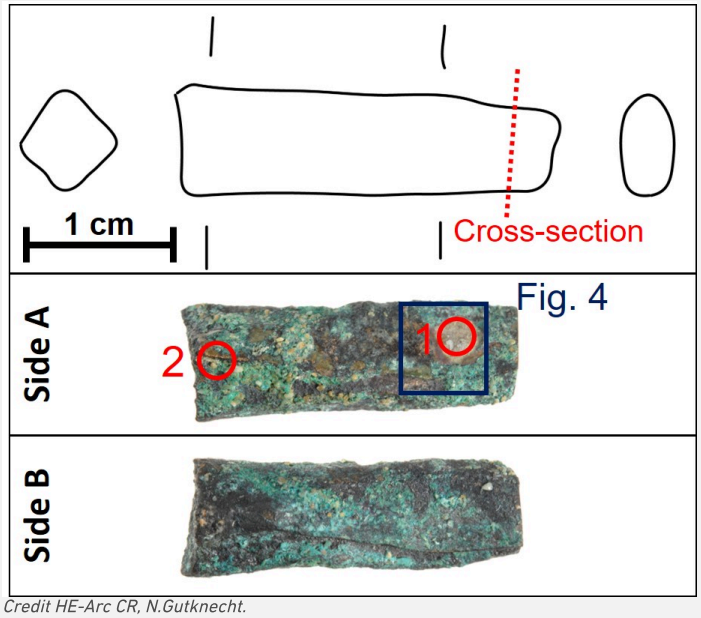
Fig. 3: Location of the cross-section before sampling and both sides of the fragment not sampled with location of the detail of Fig. 4 (blue square) and XRF analysis areas (red circles),

XRF analyses of the tang fragment were carried out on two representative areas (Fig. 3). Point 1 was done in a lacuna of the green-blue corrosion layer, while point 2 was performed on a black corrosion layer (CP4) where all strata (soil, corrosion products, and metal) are analyzed at the same time.

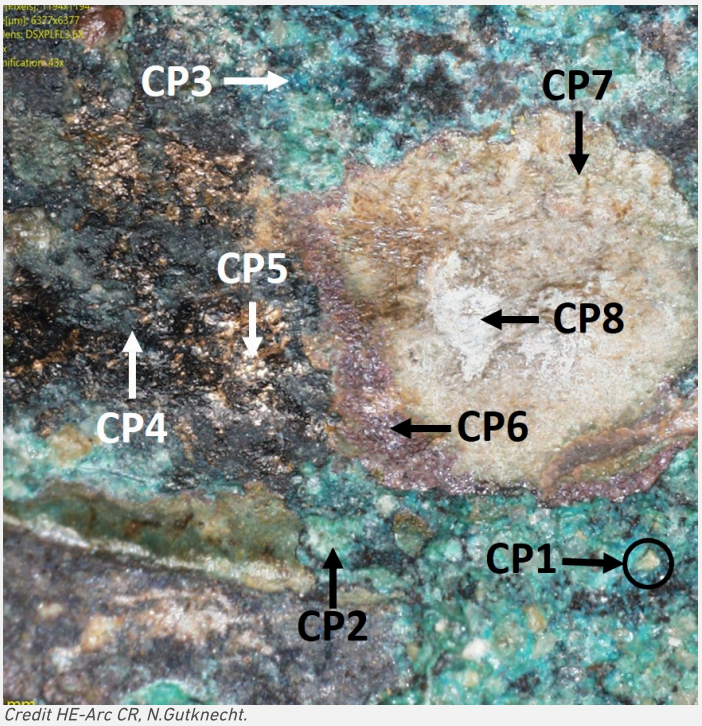
Fig. 4: Corrosion structure (detail) from Fig. 3 showing some of the documented strata,

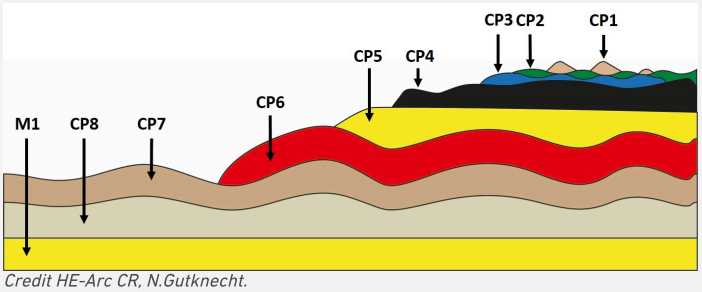
Fig. 5: Stratigraphic representation of the corrosion structure of the tang by macroscopic and binocular observation with reference to Fig. 4,

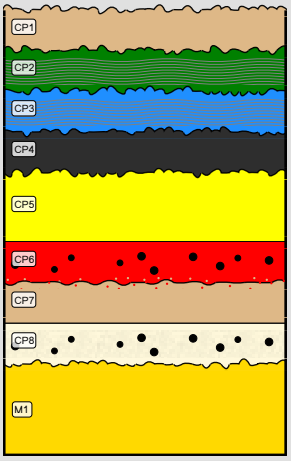
Fig. 6: Stratigraphic representation of the corrosion structure of the tang observed macroscopically under binocular microscope using the MiCorr application with reference to the whole Fig. 5. The characteristics of the strata, such as discontinuity, are accessible by clicking on the drawing that redirects you to the search tool by stratigraphy representation, Credit HE-Arc CR, N.Gutknecht,

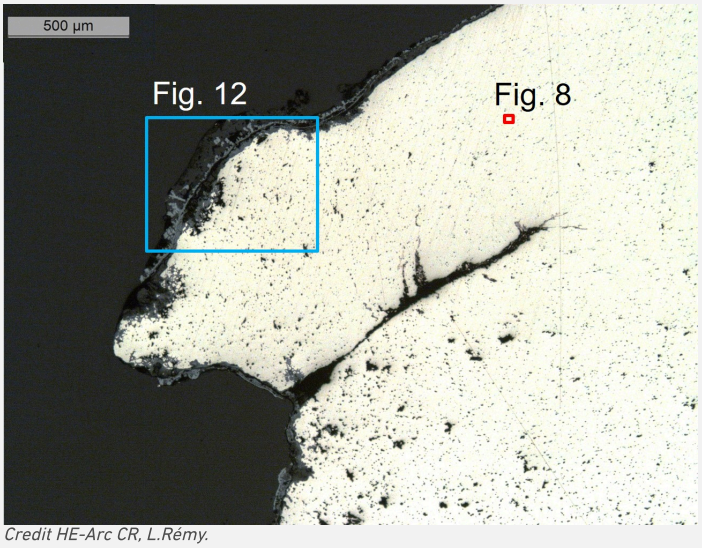
Fig. 7: Micrograph from an area of the cross-section of the sample taken from the tang fragment with location of Fig. 8 (red square) and Fig. 12 (blue square), unetched, bright field,

Description of sample	The cross-section corresponds to a lateral cut (Fig. 3). The surface is covered with a thick corrosion layer but part of it has gone (Fig. 7).
Alloy	Tin Bronze
Technology	Cold worked with partial annealing
Lab number of sample	MAH 87-197
Sample location	Musées d'art et d'histoire, Genève, Geneva
Responsible institution	Musées d'art et d'histoire, Genève, Geneva
Date and aim of sampling	1987, metallography and corrosion characterisation

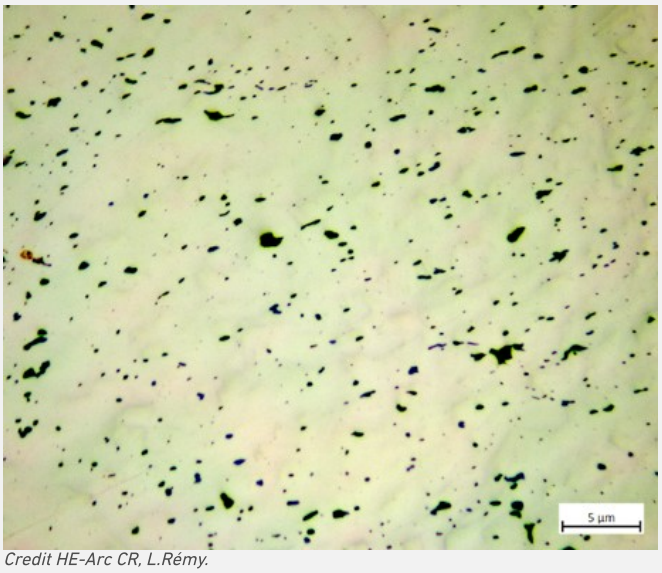
The remaining metal is a tin bronze (Table 3) with high porosity (Figs. 7-9) and large cracks both on the left and right edges of the sample (Fig. 9). The metal contains small, elongated copper sulphide (Table 4) and Pb inclusions. The etched metal shows three zones with a core where elongated grains and slip lines are visible indicating cold working without annealing (Figs. 9-10), while annealing appears on both external sides (Fig. 9-11). The average hardness of the metal is HV1 145, but significant variations are observed, depending on where the measurements are taken.

Fig. 8: Detail of the metal from Fig. 7, unetched, bright field,

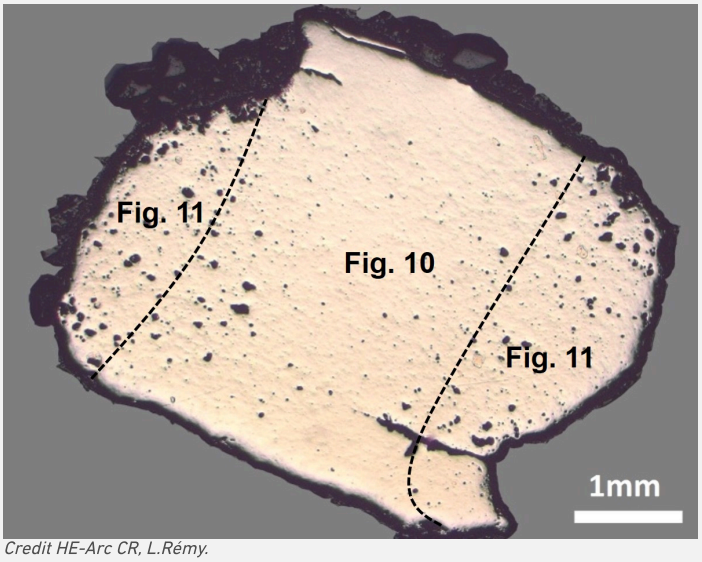
Fig. 9: Micrograph of the cross section of the tang of a knife with three distinct zones: metal core with elongated grains and slip lines (Fig. 10) and external sides with polygonal grains and twin lines (Fig. 11), unetched, bright field,

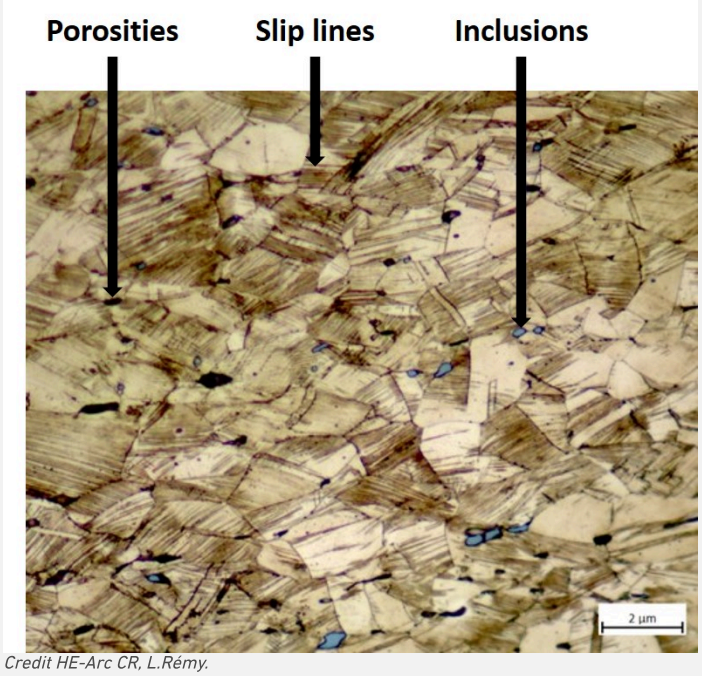
Fig. 10: Micrograph of the metal sample from Fig. 9 (detail), etched, bright field. Elongated grains with slip lines are observed, as well as grey copper sulphide inclusions and dark porosities,

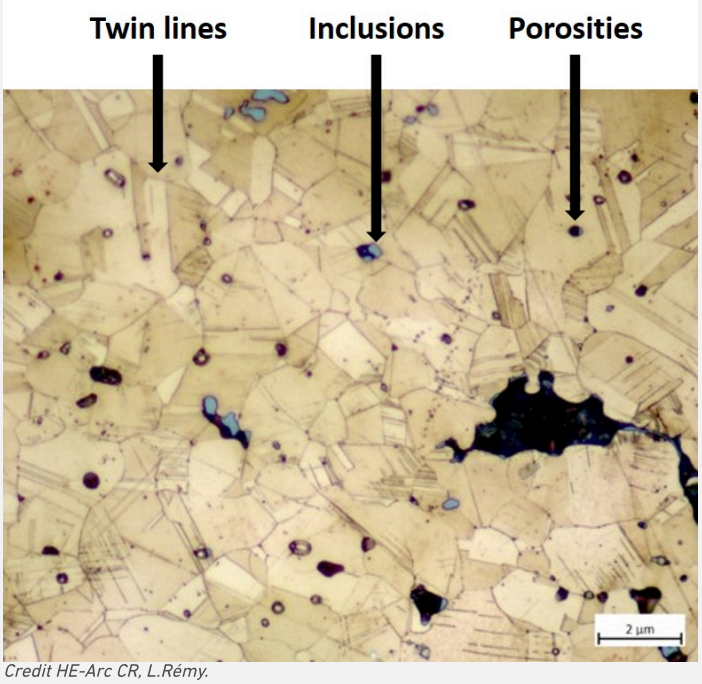
Fig. 11: Micrograph of the metal sample from Fig. 9 (detail), etched, bright field. Twin lines, grey copper sulphide inclusions and dark porosity are observed,

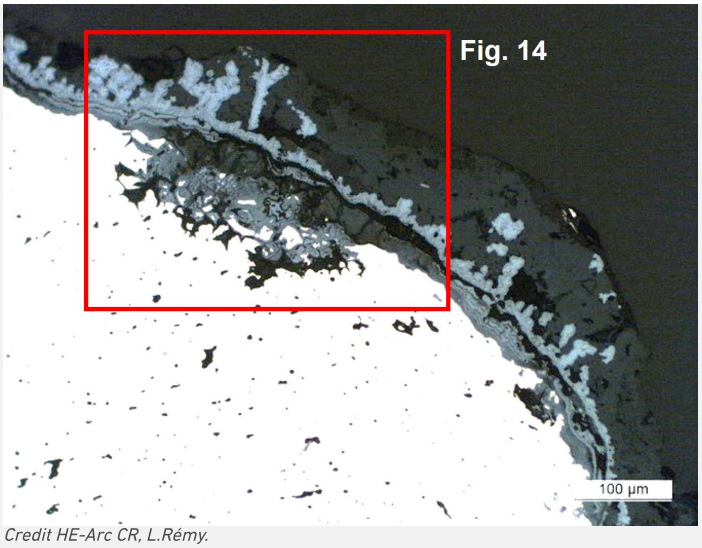
The corrosion layer has a thickness between 130µm and 70µm (Fig. 12). The observation of the sample in cross-section (Figs. 12-13) shows the presence of a succession of layers : S1 sediment, at the very top surface; CP1 thick continuous layer, dark grey in bright field, dark turquoise in dark field; CP2 thin continuous layer which might expand through the whole CP1, extra light grey in bright field, black in dark field; CP3 thin continuous layer, extra light grey in bright field, light brown in dark field; CP4 medium discontinuous layer, dark grey in bright field, light green in dark field; CP5 medium continuous layer, light grey in bright field, dark orange in dark field; CP6 thin discontinuous layer, black in bright field, light brown in dark field; CM1 medium discontinuous layer;

Fig. 12: Micrograph of the metal sample from Fig. 7 (detail, rotated of 90°), unetched, bright field.

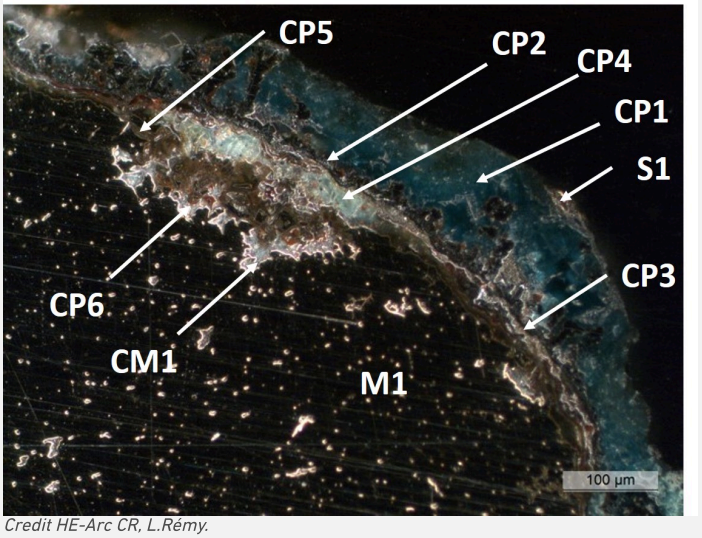
Fig. 13: Micrograph similar to Fig. 12, unetched, dark field and corresponding to the stratigraphy of Fig. 16,

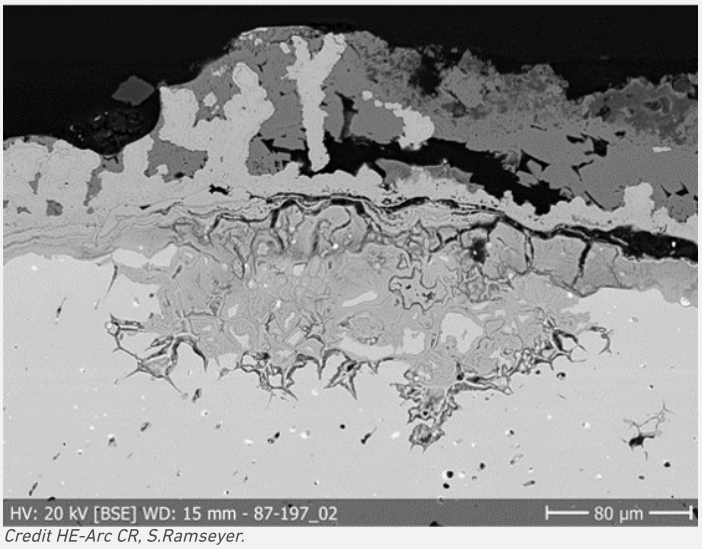
Fig. 14: SEM image, BSE-mode (detail of Fig. 12),

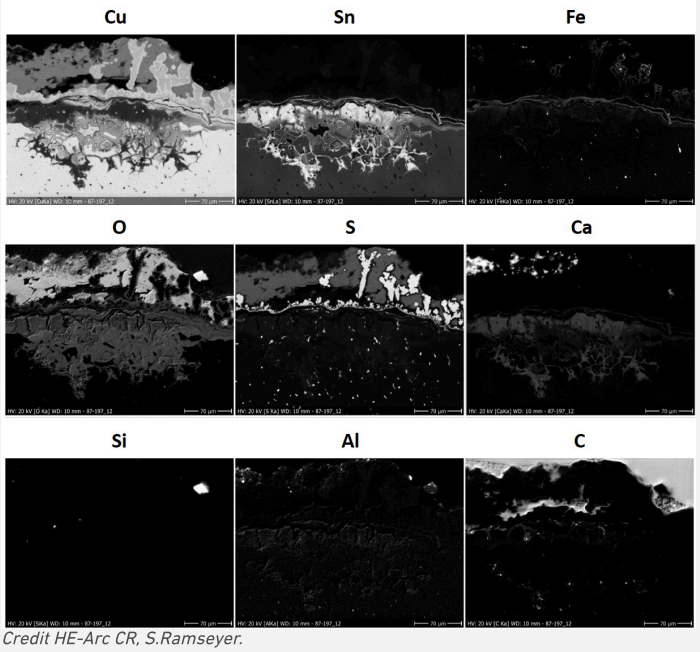
The elemental chemical distribution (Fig. 15) of the SEM image (Fig. 14) of the visually identified strata by cross-sectional observation shows that :
S1 has Ca, Al, Si and O elements;
CP1 stratum contains Cu, O and S;
CP2 stratum contains Cu, S and Fe;
CP3 stratum contains Sn, Fe and S;
CP4 stratum contains Sn and O;
CP5 stratum contains Cu, O and S;
CP6 stratum contains Sn and O, similar to CP4;

Fig. 15: Elemental chemical distribution of Fig. 14 (reversed). Method of examination: SEM/EDS, Microcity,

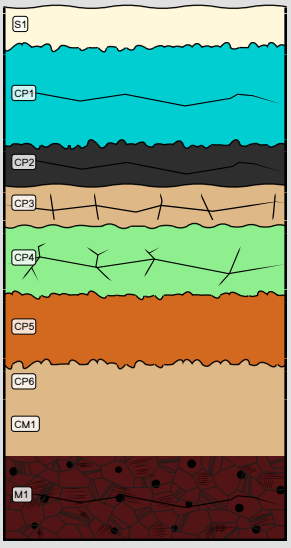
Fig. 16: Stratigraphic representation of the sample taken from the tang fragment in cross-section (dark field) using the MiCorr application. The characteristics of the strata are only accessible by clicking on the drawing that redirects you to the search tool by stratigraphy representation. This representation can be compared to Fig. 13, Credit HE-Arc CR, L.Rémy.

The following correspondence can be found: CP1 in binocular mode as sediment (S1) in cross-section mode. CP2 and CP3 in binocular mode are differentiated by their color. They match CP1 in cross-section mode. CP4 in binocular mode matches CP2 in cross-section mode. CP5 in binocular mode seems to match CP3 in cross-section mode. CP6 and CP7 in binocular mode match CP4 in cross-section mode. CP8 in binocular mode matches CP5, CP6 and CM1 in cross-section mode.

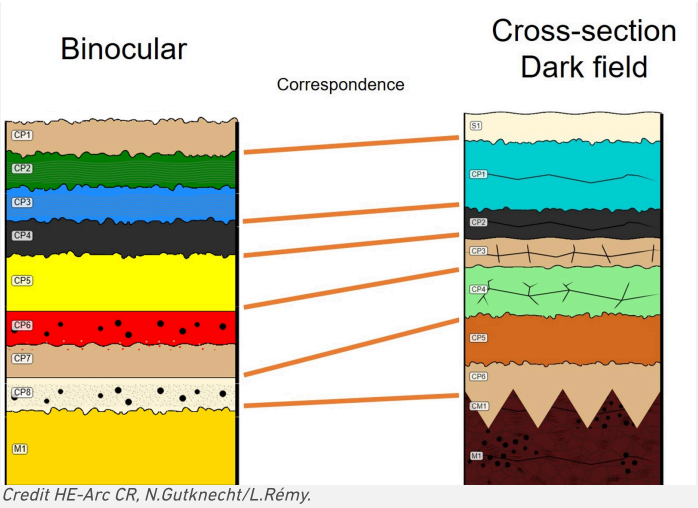
Fig. 17: Stratigraphic representation side by side of binocular view and cross-section (dark field),
