TANG FRAGMENT OF A KNIFE HR-6246 - TIN BRONZE - LATE BRONZE AGE - SWITZERLAND

Artefact name Tang fragment of a knife HR-6246

Authors Marianne. Senn (Empa, Dübendorf, Zurich, Switzerland) & Christian. Degrigny (HE-Arc CR, Neuchâtel, Neuchâtel, Switzerland) & Naima. Gutknecht (HE-Arc CR, Neuchâtel, Neuchâtel, Switzerland) & Rémy. Léopold (HE-Arc CR, Neuchâtel, Neuchâtel, Switzerland)

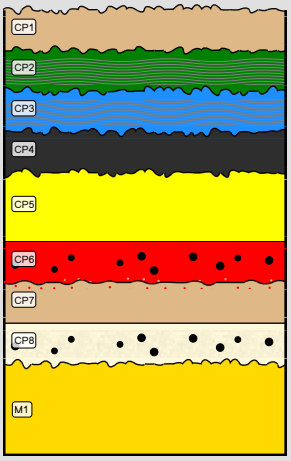
Fig. 6: Stratigraphic representation of the corrosion structure of the tang observed macroscopically under binocular microscope using the MiCorr application with reference to the whole Fig. 5. The characteristics of the strata, such as discontinuity, are accessible by clicking on the drawing that redirects you to the search tool by stratigraphy representation, Credit HE-Arc CR, N.Gutknecht,

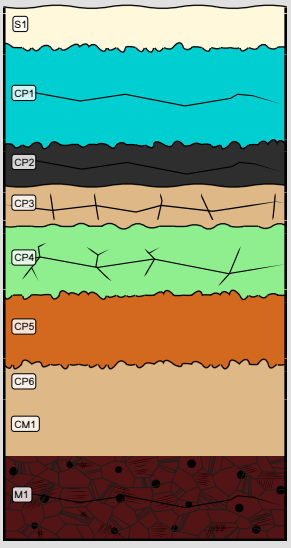
Fig. 16: Stratigraphic representation of the sample taken from the tang fragment in cross-section (dark field) using the MiCorr application. The characteristics of the strata are only accessible by clicking on the drawing that redirects you to the search tool by stratigraphy representation. This representation can be compared to Fig. 13, Credit HE-Arc CR, L.Rémy.
