SICKLE AUV-322 - BRONZE - LATE BRONZE AGE - SWITZERLAND

Artefact name Sickle AUV-322

Authors Rémy. Léopold (HE-Arc CR, Neuchâtel, Neuchâtel, Switzerland)

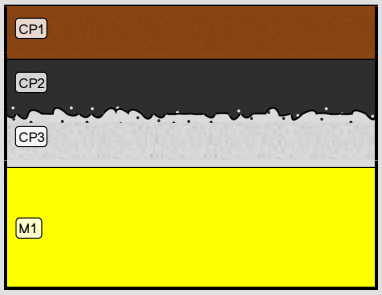
Fig. 7: Stratigraphic representation of the corrosion structure of the sickle observed macroscopically under binocular microscope using the MiCorr application with reference to Fig. 6. The characteristics of the strata, such as discontinuity, are accessible by clicking on the drawing that redirects you to the search tool by stratigraphy representation, Credit HE-Arc CR, L.Rémy.

The corrosion structure has only been documented in binocular mode (Fig. 7).
