PIN WITHOUT HEAD HR-18152 – TIN BRONZE – LATE BRONZE AGE – SWITZERLAND

|	
Artefact name	Pin without head HR-18152
Authors	Marianne. Senn (Empa, Dübendorf, Zurich, Switzerland) & Christian. Degrigny (HE-Arc CR, Neuchâtel, Neuchâtel, Switzerland) & Naima. Gutknecht (HE-Arc CR, Neuchâtel, Neuchâtel, Switzerland) & Rémy. Léopold (HE-Arc CR, Neuchâtel, Neuchâtel, Switzerland)
Url	/artefacts/1362/

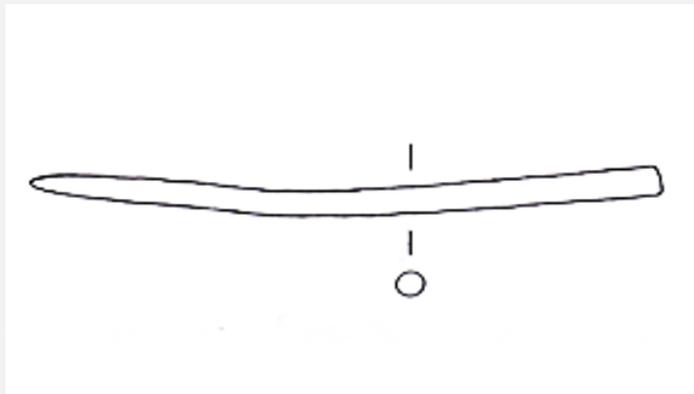
Fig. 1: Pin without head (after Rychner-Faraggi 1993, plate 74.29),

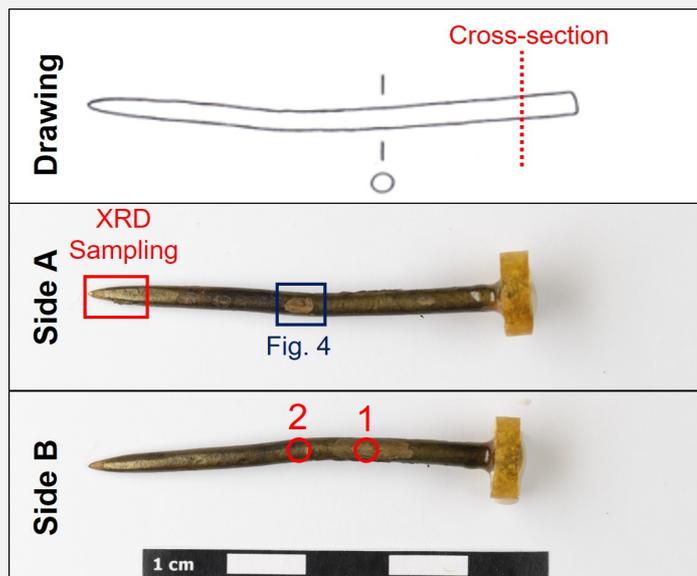
Fig. 3: Location of cross-section on drawing before sampling and sides A and B (opposite sides) with indication of XRF analyses (red circles), XRD sampling (red square) and Fig. 4 (blue square),

XRF analyses of the pin were carried out on two representative areas (Fig. 3). Point 1 was done in a lacuna of the brown-yellow corrosion layer, while point 2 was performed on the brown corrosion layer (CP1) where all strata (soil, corrosion products, and metal) are analyzed at the same time.
The metal is presumably a tin bronze alloy. The other elements detected are : S, Fe, Si, Al, Pb, Sb, As, Ag, Zn, Ni.
Results of point 2 are very different from those of point 1, they indicate the surface enrichment in Fe and in S and the depletion in Cu.

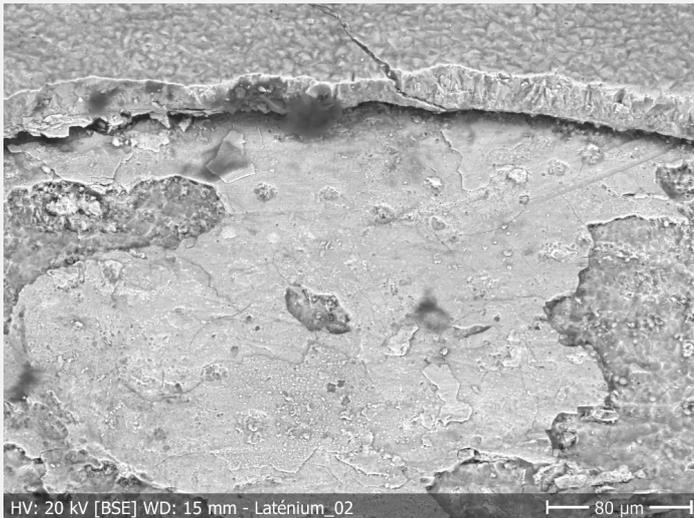
Fig. 4: Lacuna showing the underlying metal with location of Fig. 6 (red rectangle),

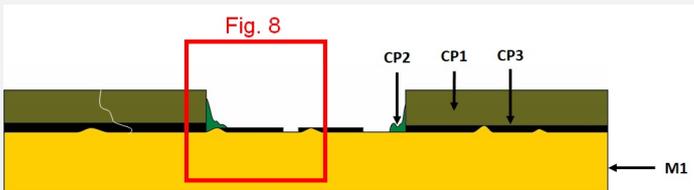
Fig. 7: Stratigraphic representation of the corrosion structure of the pin without head by macroscopic and binocular observation with indication of the corrosion structure used to build the MiCorr stratigraphy of Fig. 8 (red square),

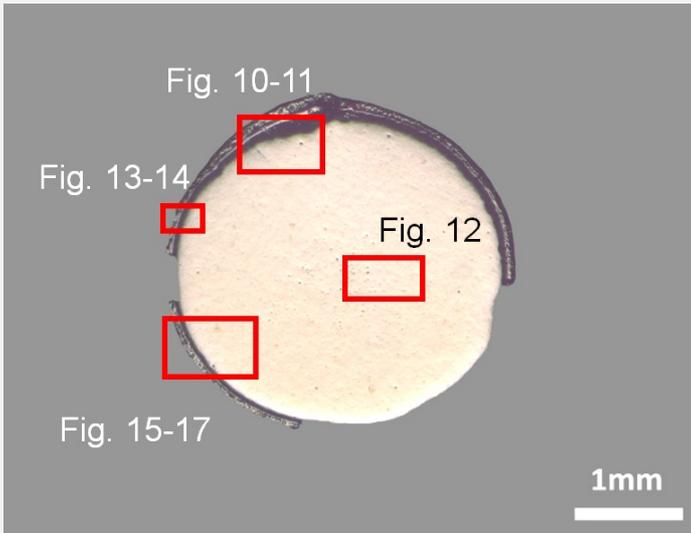
Fig. 9: Micrograph of the cross-section of the sample taken from the pin without head showing the location of Figs. 10 to 17,

Description of sample	The cross-section is circular and is a complete section through the pin (Fig. 3). It is covered with a rather thin and regular (in thickness) corrosion layer (Fig. 6). On the sample, one third of the corrosion layer is missing (Fig. 9).
Alloy	Tin Bronze
Technology	Annealed after cold working
Lab number of sample	MAH 87-194
Sample location	Laténium, Neuchâtel, Neuchâtel
Responsible institution	Laténium, Neuchâtel, Neuchâtel
Date and aim of sampling	1987, metallography and corrosion characterisation

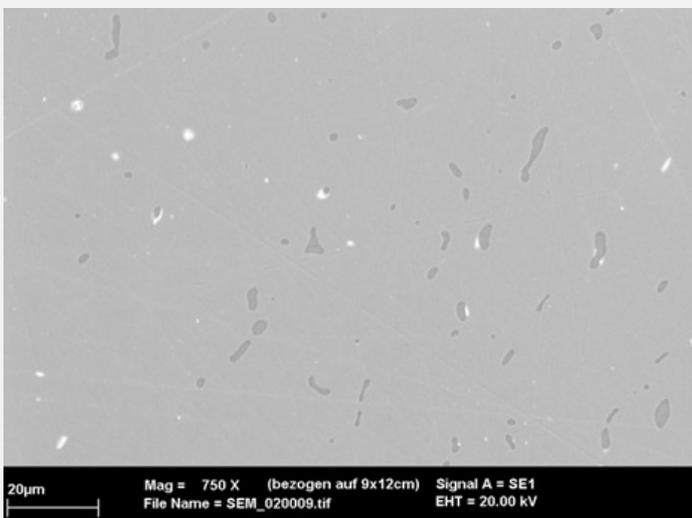
ICP-OES analyses of the remaining metal show a tin bronze as suggested in Table 1 (point 1). The metal also has copper sulphide as well as heavy metal (Pb-rich) inclusions (Figs. 10 and 11). Close to the surface of the remaining metal, copper sulphide inclusions are elongated and form rows (Fig. 10). The etched structure of the tin bronze shows polygonal grains; some of them are twinned (Fig. 12). In the centre of the sample and on the edges, the grains are smaller. The copper sulphide inclusions are located at the grain boundaries and in the grains. The average hardness of the metal is about HV1 110.

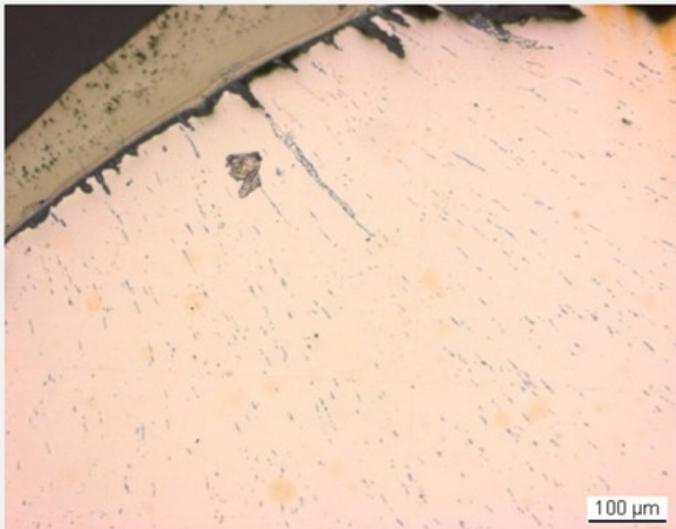
Fig. 10: Micrograph of the metal sample from Fig. 9 (detail), unetched, bright field. Rows of elongated copper sulphide inclusions can be observed,

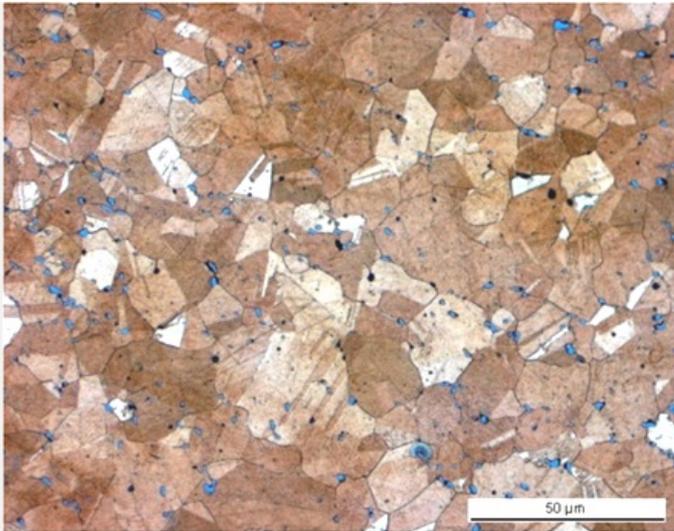
Fig. 12: Micrograph of the metal sample from Fig. 9 (detail), etched, bright field. The metal shows a structure of polygonal and twinned grains. Copper sulphide

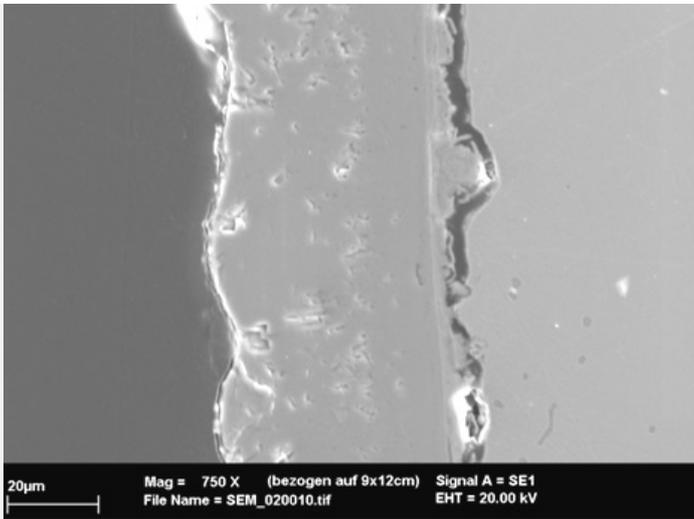
Fig. 13: SEM image of the metal sample from Fig. 9 (detail), SE-mode. The crack between the remaining metal and the corrosion layers is clearly visible,

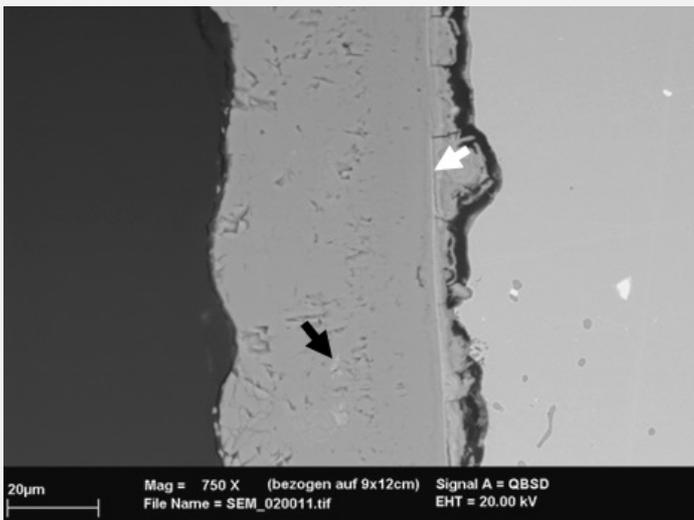
Fig. 14: SEM image similar to Fig. 13, BSE-mode. A thin line is visible (white arrow) differentiating the inner Sn-rich layer from the intermediate and outer chalcopyrite layers. The latter contains bright covelline inclusions (black arrow) and pores,

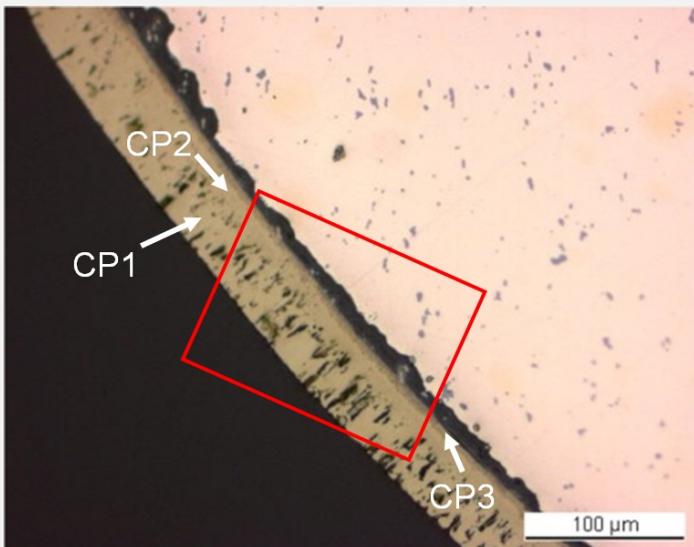
Fig. 15: Micrograph of the metal sample from Fig. 9 (detail) and corresponding to the stratigraphy of Fig. 20, unetched, bright field. The area selected for elemental chemical distribution (Fig. 17) is marked by a red rectangle,

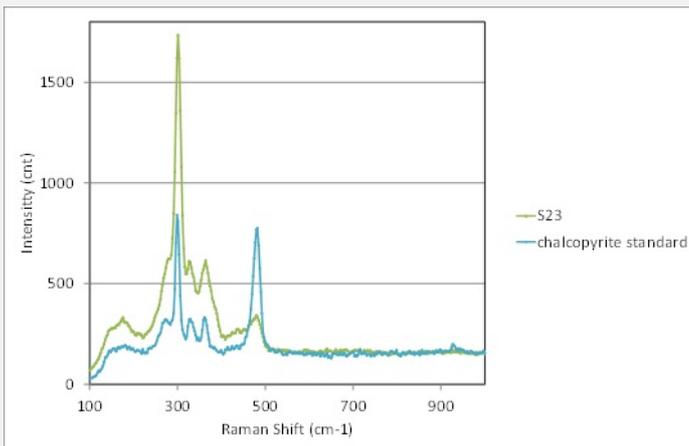
Fig. 18: Raman spectrum of the outermost layer (S23) of Fig.14 compared to a chalcopyrite standard spectrum. Settings: laser wavelength 532nm, acquisition time 50s, 4 accumulations, filter D2 (0.75-0.8mW), hole 1000, slit 100, grating 600. Method of analysis: Raman spectroscopy, Lab of Swiss National Museum, Affoltern a. Albis ZH,

Fig. 19: Raman spectrum of the inclusions of the outermost layer (S42) of Fig. 14 compared to a covelline / covellite standard spectrum. Settings: laser wavelength 532nm, acquisition time 10s, 5 accumulations, D2 (0.75-0.8mW), hole 500, slit 80, grating 600. Method of analysis: Raman spectroscopy, Lab of Swiss National Museum, Affoltern a. Albis ZH,
