PIN OR NEEDLE FRAGMENT HR-3031 – TIN BRONZE – LATE BRONZE AGE – SWITZERLAND

Artefact name	Pin or needle fragment HR-3031
Authors	Marianne. Senn (EMPA, Dübendorf, Zurich, Switzerland) & Christian. Degrigny (HE-Arc CR, Neuchâtel, Neuchâtel, Switzerland) & Naima. Gutknecht (HE-Arc CR, Neuchâtel, Neuchâtel, Switzerland) & Rémy. Léopold (HE-Arc CR, Neuchâtel, Neuchâtel, Switzerland)
Url	/artefacts/1363/

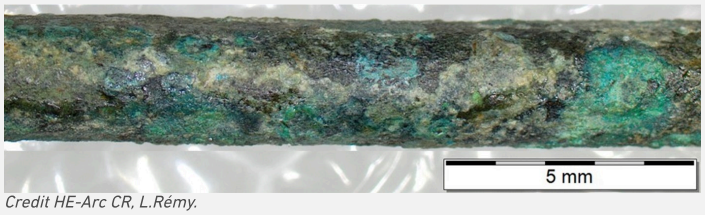
Fig. 1: Pin or needle fragment (after Rychner-Faraggi 1993, plate 74.11),

Fig. 2: Dark grey and dark green corrosion products (detail) of the pin or needle fragment near the top,

Fig. 3: Dark green corrosion product and sediments (detail) of the pin near the tip,

Description of the artefact	Pin or needle fragment (Fig. 1) with dark grey to dark green corrosion products (Figs. 2 & 3). Dimensions: L = 9cm; Ø = 2.5-2.9mm; WT = 3.6g.
Type of artefact	Jewellery
Origin	Hauterive - Champréveyres, Neuchâtel, Neuchâtel, Switzerland
Recovering date	Excavation 1983-1985, object from layer 1 (containing material from the Bronze Age until the 20th century)
Chronology category	Late Bronze Age
chronology tpq	1050 B.C.
chronology taq	800 B.C.
Chronology comment	Hallstatt A2/B
Burial conditions / environment	Lake
Artefact location	Laténium, Neuchâtel, Neuchâtel
Owner	Laténium, Neuchâtel, Neuchâtel
Inv. number	HR-3031
Recorded conservation data	Not conserved

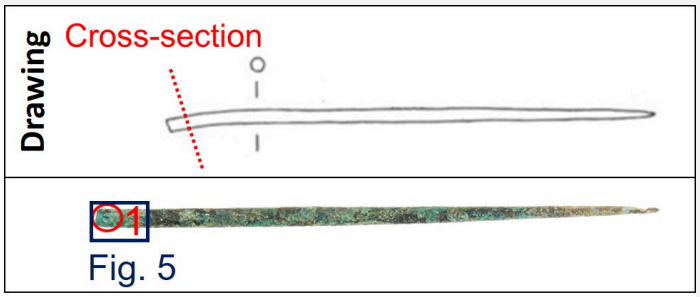
Fig. 4: Location of cross-section on drawing and indication of XRF analysis (red circle) and Fig. 5 (blue square),

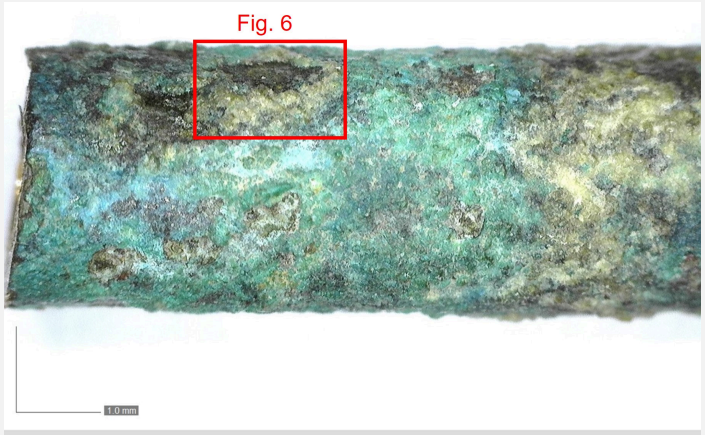
Fig. 5: Blue-green corrosion product (detail) of the pin from Fig. 4 with location of Fig. 6 (red square),

Fig. 6: Side view of the lacuna of Fig. 5,

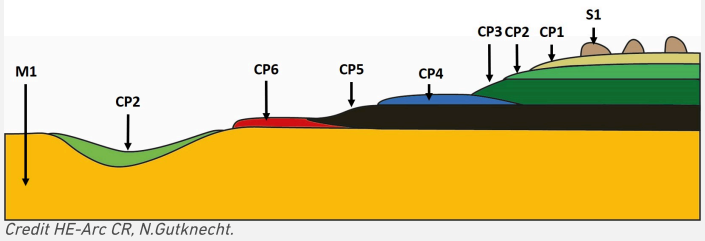
Fig. 7: Stratigraphic representation of the corrosion structure of the pin by macroscopic and binocular observation using the MiCorr application with reference to Fig. 8,

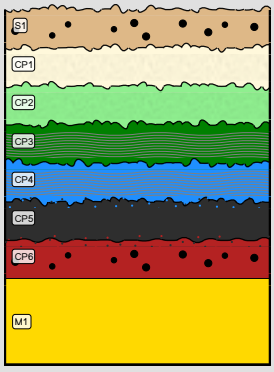
Fig. 8: Stratigraphic representation of the corrosion structure of the pin or needle observed macroscopically under binocular microscope using the MiCorr application with reference to the whole Fig. 7. The characteristics of the strata, such as discontinuity, are accessible by clicking on the drawing that redirects you to the search tool by stratigraphy representation, Credit HE-Arc CR., N.Gutknecht.

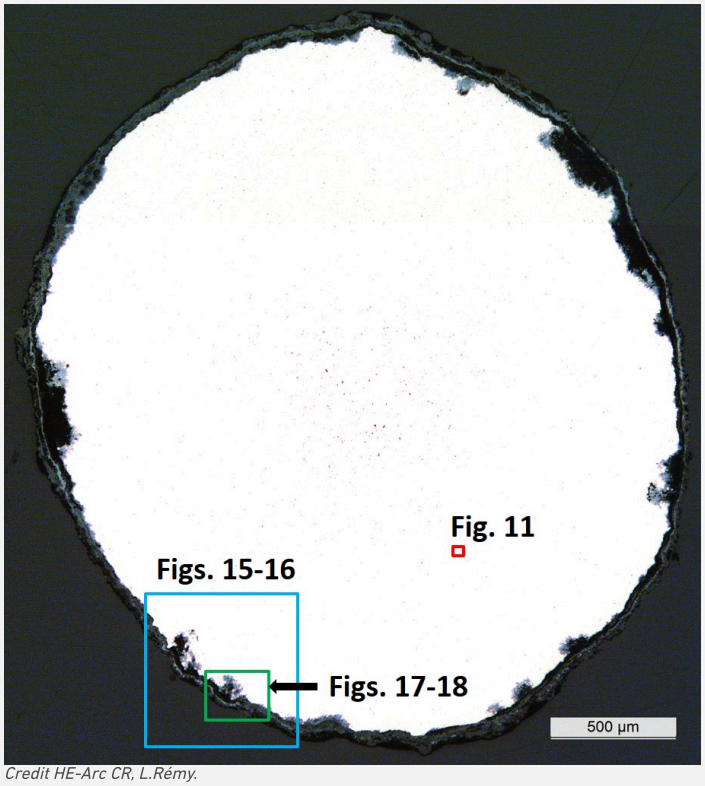
Fig. 9: Micrograph of the cross-section of the sample taken from the pin or needle fragment (Fig. 4), unetched, bright field with location of Fig. 11 (red square), Figs. 15 to 16 (blue square) and Figs. 17 to 18 (green square),

Description of sample	The cross-section is circular and is a complete section through the pin (Fig. 9). The surface is completely covered with a rather thin corrosion layer of irregular thickness (Fig. 10). At the center of the cross-section, the metal seems to have more porosities and/or inclusions.
Alloy	Tin Bronze
Technology	Cold worked with partial annealing
Lab number of sample	MAH 87-195
Sample location	Musées d'art et d'histoire, Genève, Geneva
Responsible institution	Musées d'art et d'histoire, Genève, Geneva
Date and aim of sampling	1987, metallography and corrosion characterisation

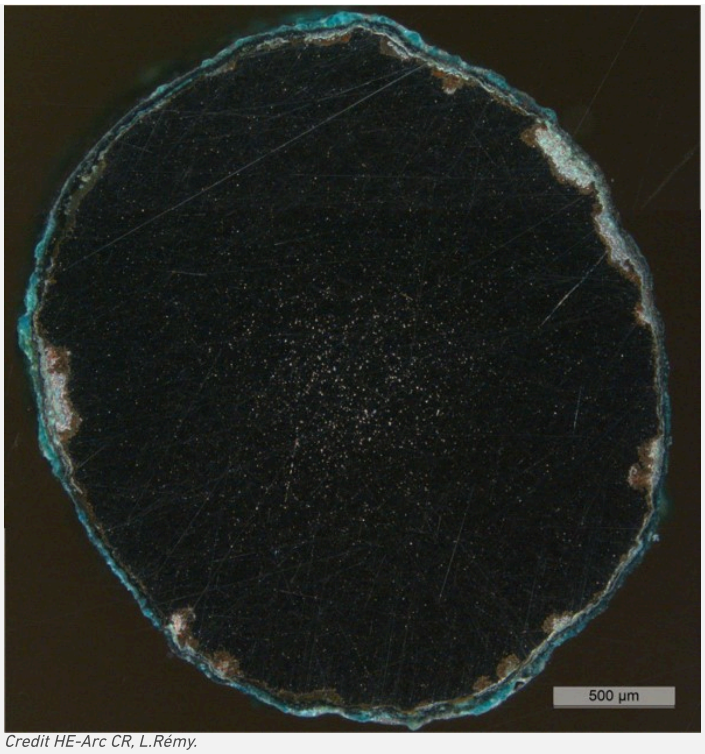
Fig. 10: Micrograph of the cross-section of the sample taken from the pin or needle fragment similar to Fig. 9, unetched, dark field,

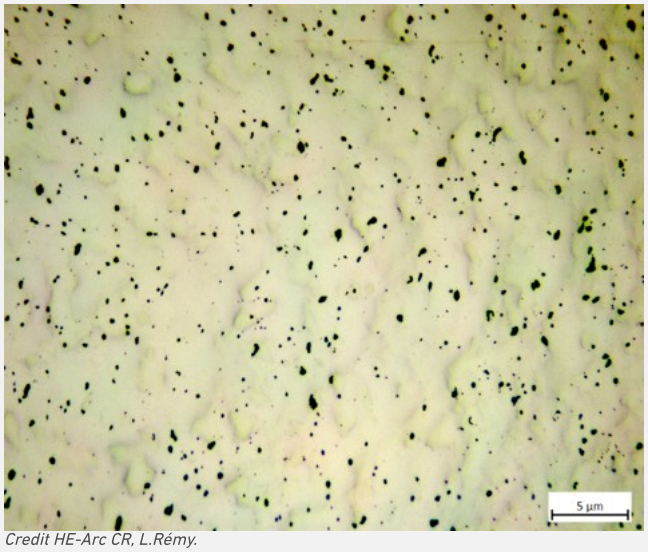
Fig. 11: Micrograph of the metal sample from Fig. 9 (detail), unetched, bright field,

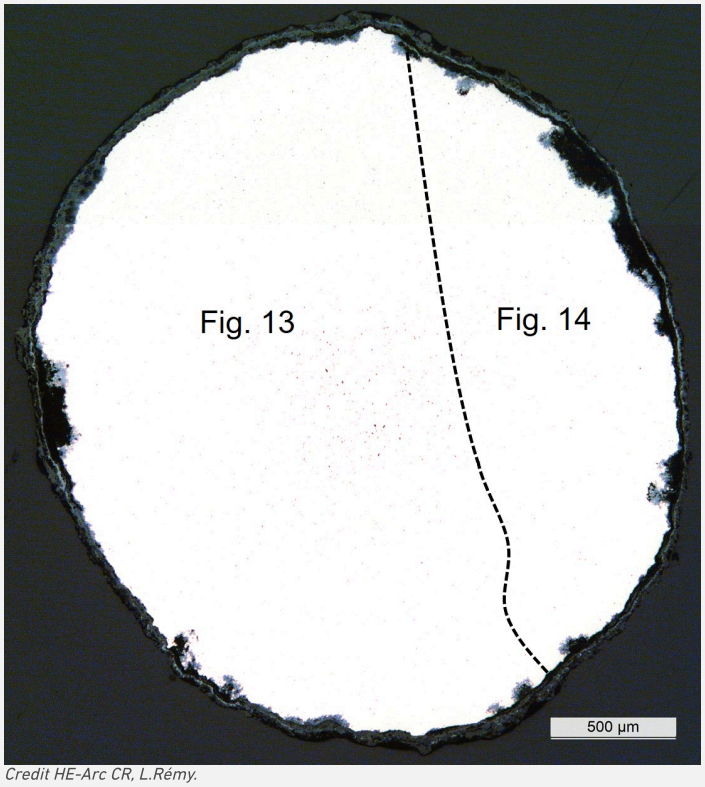
As suggested by XRF analysis, the remaining metal is a tin bronze with some Sb (Table 3), porosities and small copper sulphide inclusions (Table 4). The etched structure of the tin bronze shows two zones (Fig. 12): more than one half of the section is constituted of re-crystallised and angular grains, some of them with twins (Fig. 13), while the other half shows the presence of strain or slip lines in the grains (Fig. 14). They indicate a final cold working without annealing. Copper sulphide inclusions are found both at the grain boundaries and inside the grains (Figs. 13 and 14). The average hardness of the metal is about HV1 120.

Fig. 12: Micrograph similar to Fig. 9 indicating two zones with characteristic microstructures: Fig. 13 where re-crystallised and angular grains with some twins are visible and Fig. 14 where slip lines are more prominent,

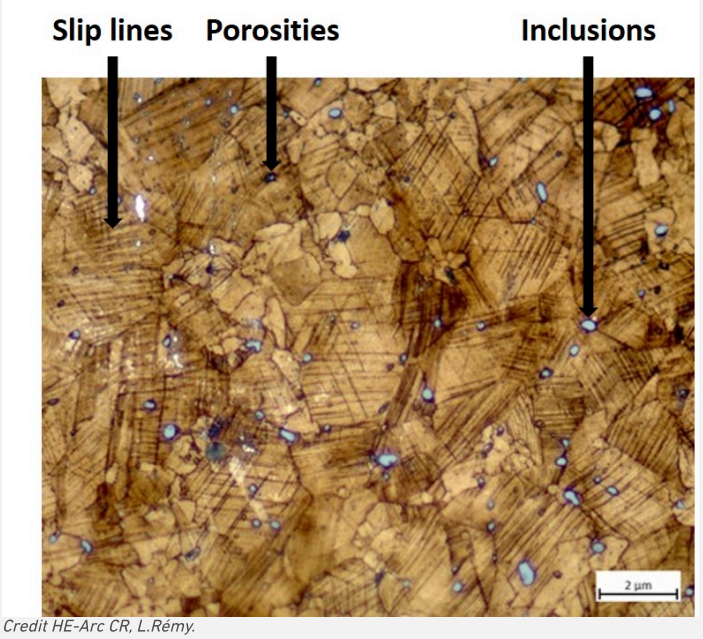
Fig. 13: Micrograph of the metal from Fig. 12 (detail), etched, bright field. Twin lines are visible. Grey copper sulphide inclusions are observed, as well as dark porosities,

Fig. 14: Micrograph of the metal from Fig. 12 (detail), etched, bright field. Polygonal grains with slip lines are observed, as well as grey copper sulphide inclusions and dark porosities,

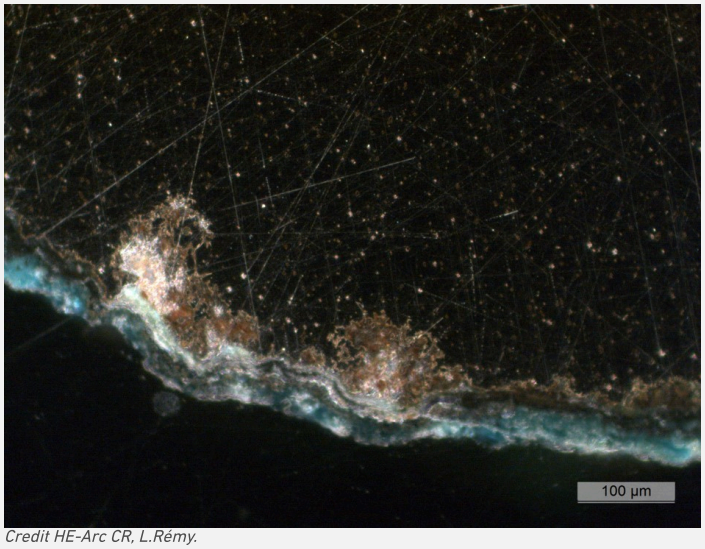
The corrosion layer has an average thickness of about 50µm (Fig. 15). The observation of the sample in cross-section (Figs. 15 and 18) shows the presence of a succession of layers (Figs. 17 and 18): S1 sediment at the top surface, discontinuous layer, black in bright field and light yellow in dark field; CP1 medium continuous layer, extra dark grey in bright field, dark turquoise in dark field; CP2 thin continuous layer, extra light grey in bright field, black in dark field; CP3 thin continuous layer, dark grey in bright field, extra light grey in dark field; CP4 thin continuous layer, extra dark grey in bright field, black in dark field; CP5 thin discontinuous layer, black in bright field, light green in dark field; CP6 medium continuous layer, light grey in bright field, dark orange in dark field; CM1 thin continuous layer;

Fig. 15: Micrograph of the metal sample from Fig. 9 (detail), unetched, bright field,

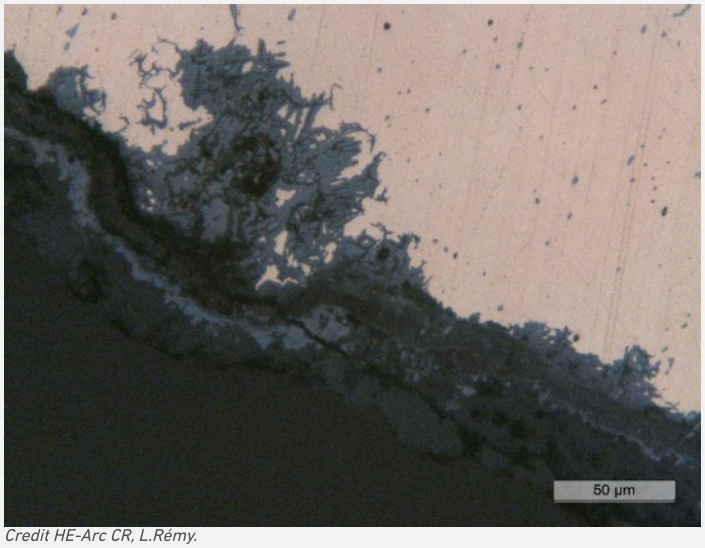
Fig. 16: Micrograph of the metal sample similar to Fig. 15, unetched, dark field,

Fig. 17: Micrograph of the metal sample from Fig. 9 (detail), unetched, bright field,

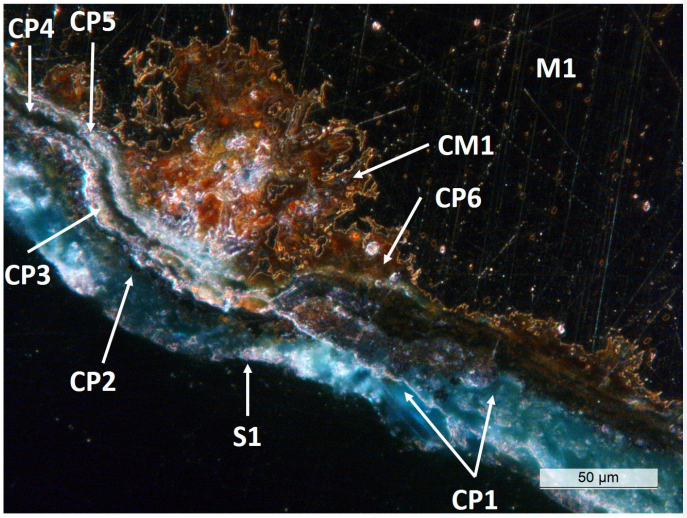
Fig. 18: Micrograph of the metal sample similar to Fig.17 (detail), unetched, dark field, and corresponding to the stratigraphy of Fig. 21,

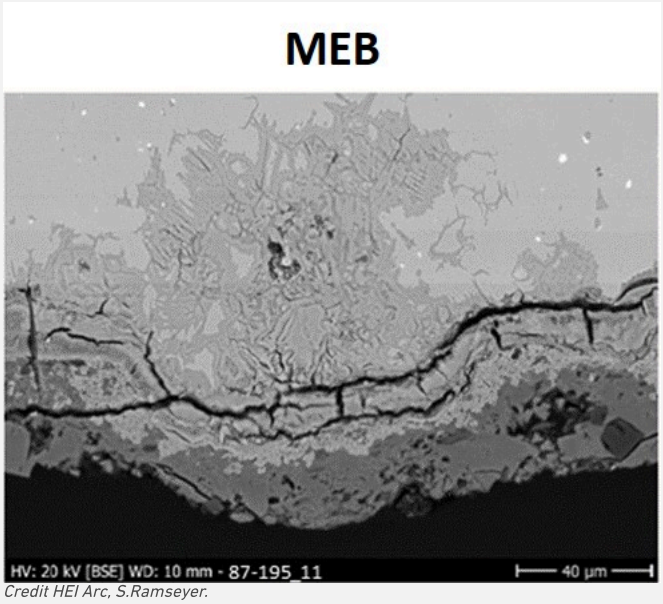
The EDX elemental mapping (Fig. 20) of SEM image (Fig. 19) of the visually identified strata in cross-section shows the following chemical distribution :
S1 has Al, Ca, Si, and O elements;
CP1 stratum contains Cu, O and S;
CP2 stratum contains Cu, S and Fe;
CP3 stratum contains Sn, O, Fe and S;
CP4 stratum contains Cu, Sn, O, Fe and S;
CP5 stratum contains Cu, Sn, O, Fe and S;
CP6 stratum contains Cu, Sn, O and S.

Fig. 19: SEM image, BSE-mode from Fig. 17 (detail, reversed and rotated). Method of examination: SEM/EDS, Microcity,

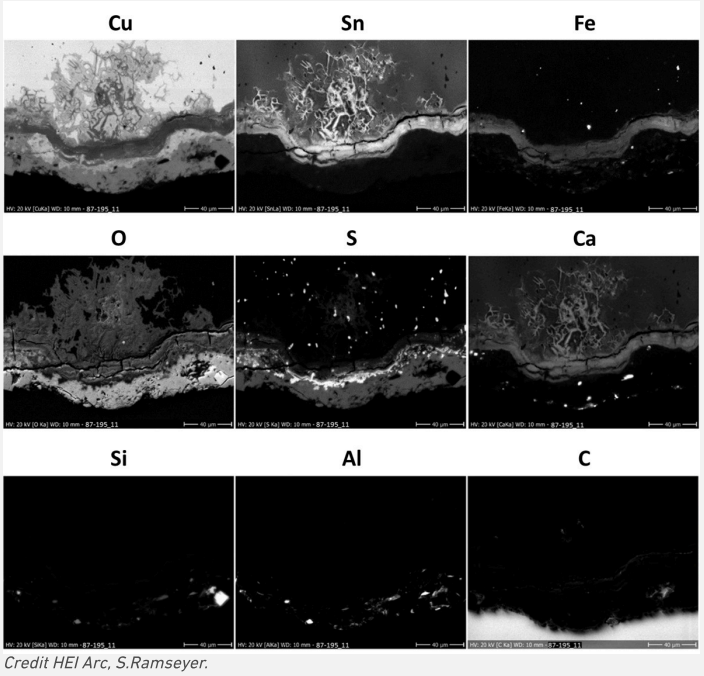
Fig 20: Elemental chemical distribution of Fig. 19. Method of examination: SEM/EDS, Microcity,

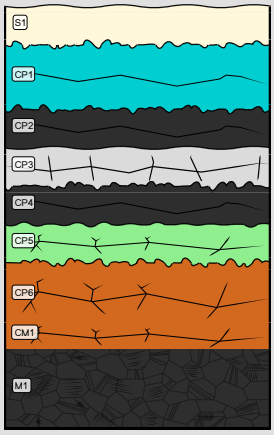
Fig. 21: Stratigraphic representation of the sample taken from the pin or needle fragment with green-blue patina in cross-section (dark field) using the MiCorr application. The characteristics of the strata are only accessible by clicking on the drawing that redirects you to the search tool by stratigraphy representation. This representation can be compared to Figs. 18 and 20, Credit HE-Arc CR, L.Rémy.

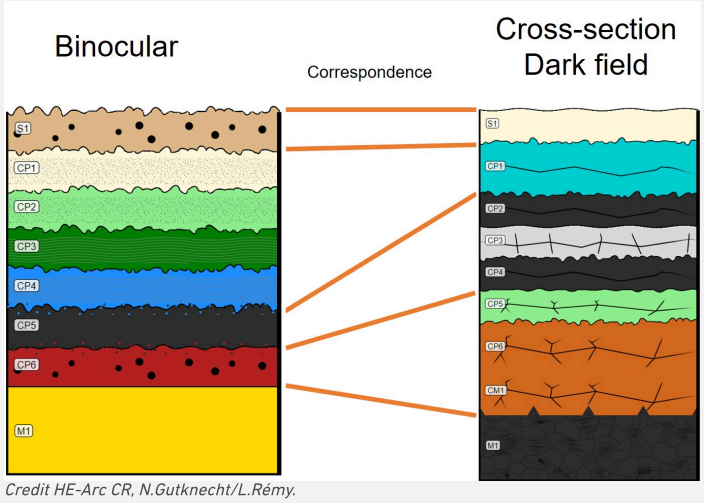
Sediment (S1) in binocular mode is documented as sediment (S1) in cross-section mode.
CP1, CP2, CP3 and CP4 in binocular mode are differentiated by their color. They match CP1 in cross-section mode.
CP5 in binocular mode matches CP2, CP3 and CP4 in cross-section mode.
CP6 in binocular mode seems to match CP5, CP6 and CM1 in cross-section mode.
On cross-section, it was possible to describe and analyze the microstructure of the metal.

Fig. 22: Stratigraphic representation side by side of binocular view and cross-section (dark field),
